SAINT ANTHONY'S CHAPEL FAÇADE PATHOLOGY DOCUMENTATION

Mario Gardiol¹, Ana Maria Pighini²

This work presents the results of a process carried out with the aim of obtaining documentation on the pathology of the Saint Anthony's chapel façade. A photogrammetric survey was conducted during which low-cost equipment was used. 71 control points (natural and artificial) were surveyed and 51 photographs were taken. The Photomodeler software allowed us to generate the vectorial model and orthophotos. These results were imported to the CAD application in which the main morphologic characteristics, the major pathologies and the degrees of severity of those deteriorations were interpreted. Information on the pathologies was represented in the cartography in order to create a restoration plan.

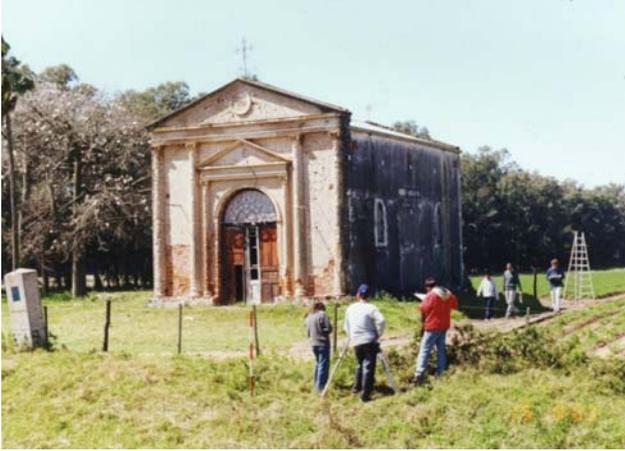
Figure 1. Saint Anthony's chapel façade

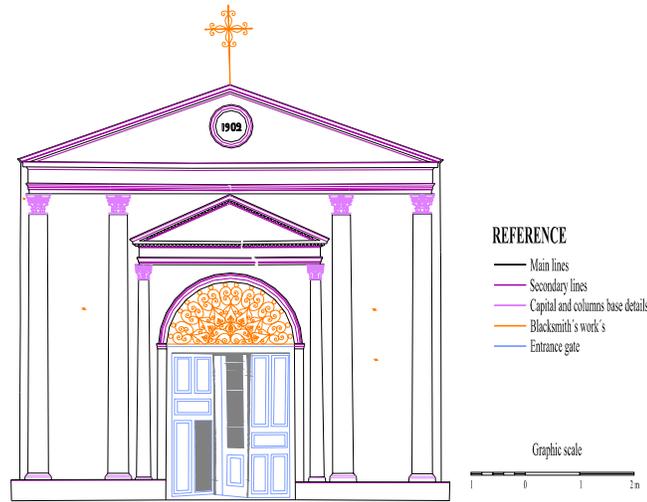
Figure 4. Morphologic features.

From the standpoint of morphology, the support base of the right columns is shorter than the support base of the left columns. The main entrance door has missing portions and has been poorly repaired. The capital of columns and the main details are well kept (Figure 4).

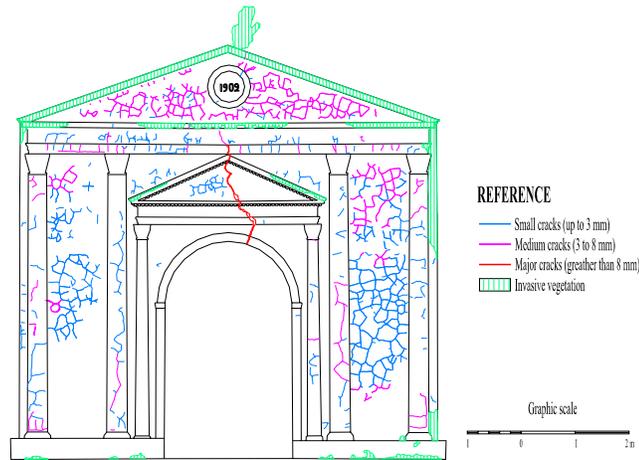
Figure 5. Distribution of cracks and invasive vegetation

With regards to pathologies, the major cracks are located mostly between the two main right-hand columns and in the upper triangle of the façade. Seemingly, the major crack, which is in fact a fissure through the brick, is affecting the structure of wall, since the façade details are displaced vertically. (Figure 5).

Invasive vegetation, such as lichen and moss, grows around the Chapel and now is on the edges of the façade upper triangle, and a lower amount of it can be seen in the small triangle. Grass and bracken has grown in the support base fissures. We also detected herbaceous plants on the roof, beside the cross.

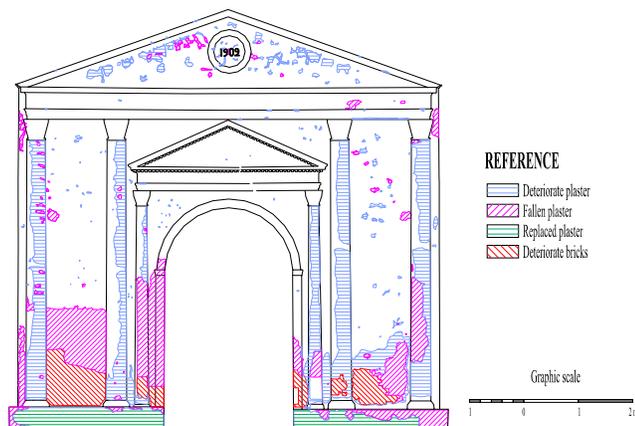
Figure 6. State of plaster

The fallen plaster, i.e. the exposed brick wall, is found chiefly in the lower section of the façade, and the most damaged areas are around its left side. These same sections are where deteriorated bricks show, and also where a few affected areas have been put plaster on in recent years.

Deteriorated plaster is seen almost in every area of the façade. Nevertheless, when we look at the four main columns, it is noticeable that their right-hand sides are the ones which present deteriorated plaster. This situation might be explained by the fact that the Southern wind is the prevailing wind in that region and, consequently, the column sides facing South are more severely affected than its other sides. (Figure 5).
