Deformation Measurement of the Bandai Bridge
by Close-range Photogrammetry

1. Introduction

From 1984 to 1986, the deformation measurement of the Bandai Bridge was regularly carried out by means of close-range photogrammetry. The measurement was done in summer, 1987, and will be done in winter the same year and continued subsequently. The present paper gives the results of the measurement during the past 3 years as an interim report.

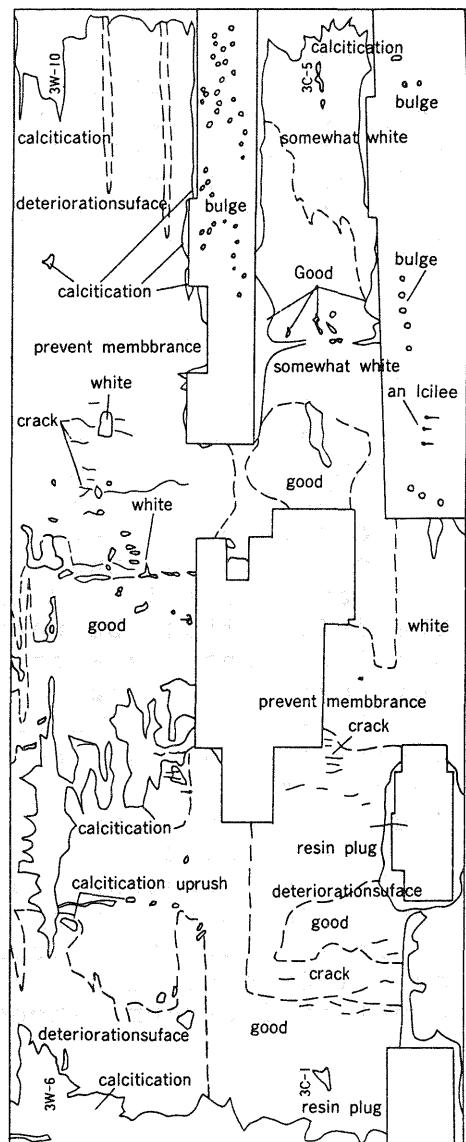
fig4 under view

Under and side views were prepared for judgement data of under and side surfaces of the bridge. Fig.4 shows the state of deterioration of an under surface. According to the standard on cracks of concrete slab, most of spans seem to need repair works. Especially span No.2 and No.7 are desired to be repaired urgently.

The partial changes like scratches by boats were seen, but there was no great change on span surfaces from 1985 to 1986. It seems that leakage of water decreased after the repair of road surface.

The repair work of under surface is scheduled to be completed in 2 or 3 years. The progress of deterioration after that will be observed by photogrammetry.

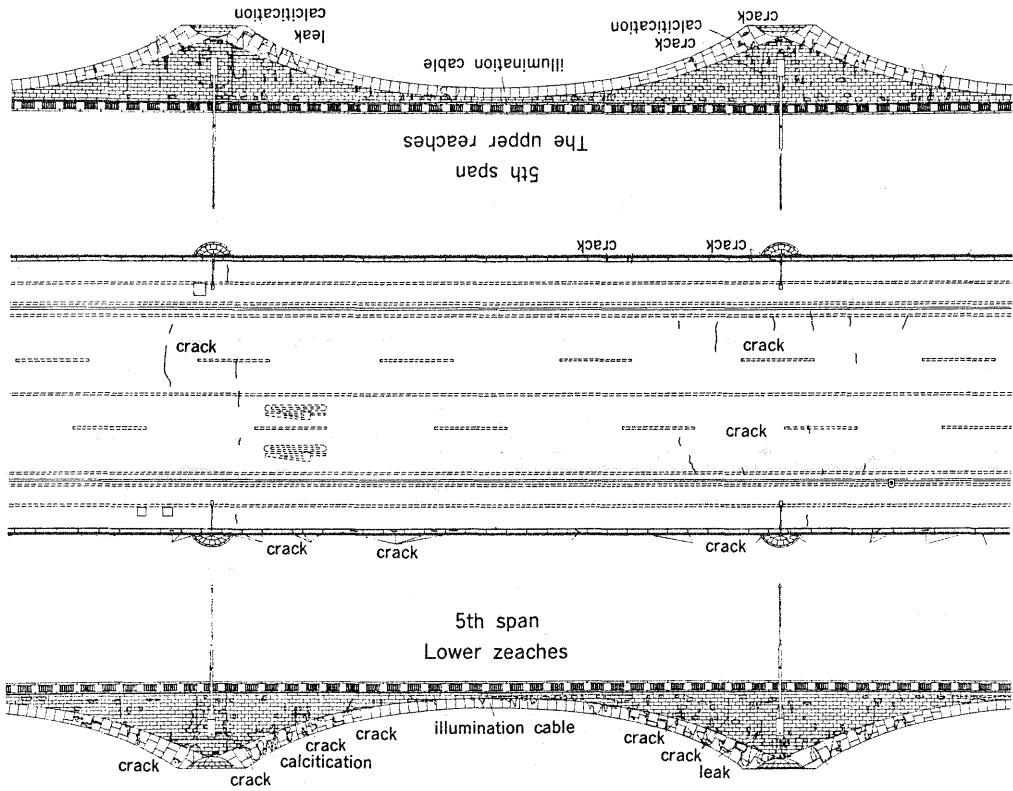
fig5 Plan side view

The factors of deformation of bridges (live load, vibration, fluctuation of temperature, wind, ground subsidence, etc.) are so complicated that it is very hard to measure them separately. Trends of changes can be understood by regarding the differences of data on one point as the values of changes of the year. The example is shown in Fig.5. Fig. 5-1 shows the state of deterioration of upper and side surfaces, and Fig.5-2 shows the deformation of arch bottom corner points on under surface.

Span No.1 and No.8 based on the land had hardly deformed. The deformation between span No.2 and No.7 indicated the similar trend between the upper stream and the downstream, but that of each span is different respectively.
