MEASUREMENT OF GROUND DEFORMATION INDUCED BY LIQUEFACTION AND FAULTING IN THE 1999 KOCAELI EARTHQUAKE AREA

V. O. Atak ^a, O. Aksu ^a, Ö.Aydan ^b, M. Önder ^a and G.Toz ^c

Commission VII, WG VII/5

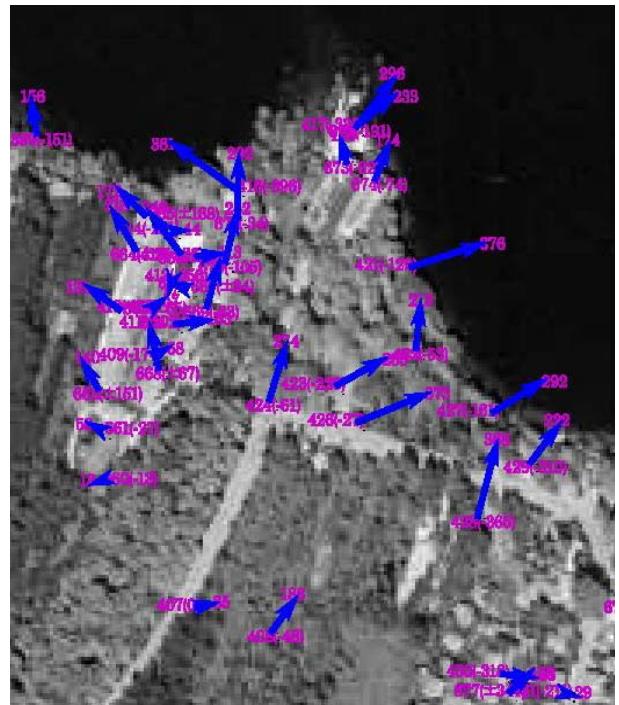
Figure 2. Displacement vectors around the Sapanca Hotel

Vectors obtained from Esme measurements show a displacement implies especially with faulting in the east and southeast direction. Obtained vectors from the west corner of Sapanca Lake do not show a unique direction. There is a similar movement with that of Esme in the north of the model, while sparse movement in the south of model because of varying soil structure and locating fault. And vectors in the area of Sapanca Otel have directions mainly to north, upward the Lake because of the liquefaction (Figure 2). To explain the results better, detailed measurements have been made at coastline area of first measurement regions too.

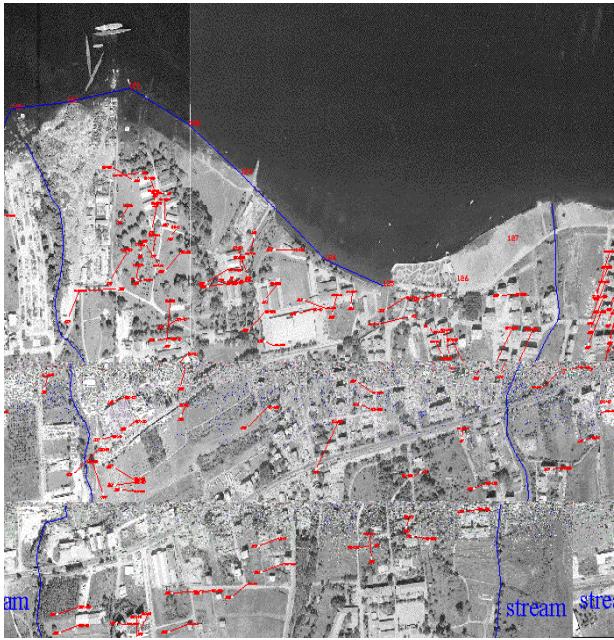
Figure 3. Displacement vectors at Seymour

Displacement vectors obtained from İzmit Bay measurements show a displacement mostly with faulting, but implies especially at coastline area with liquefaction too (Figure 3).

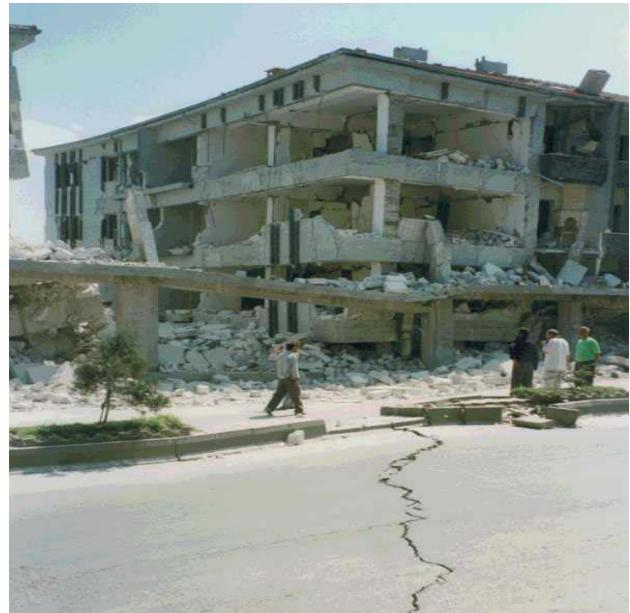
Figure 4. Displacements around Sakarya

Displacement vectors obtained from Sakarya measurements show ground deformation associated with faulting in the east and southeast direction (Figure 4).

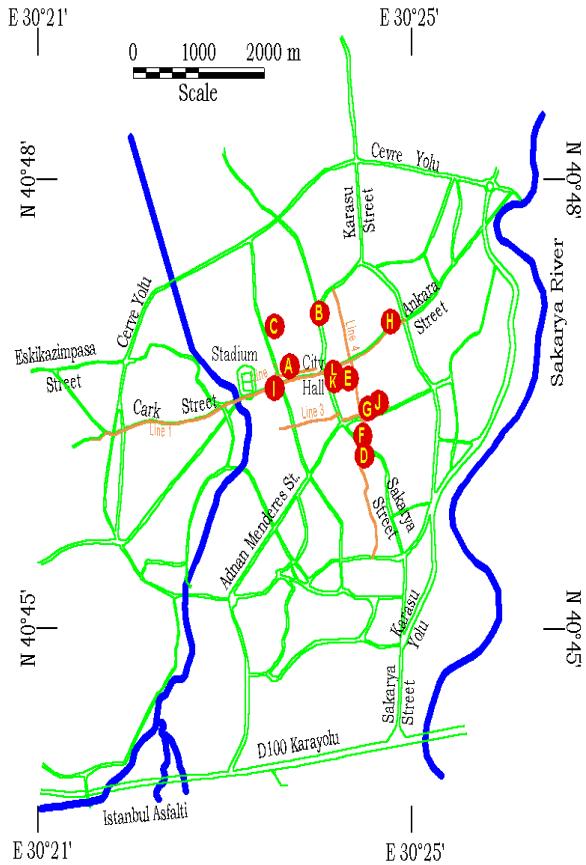
Figure 5. Measurement sites in Sakarya

But at the same time, the effect of liquefaction can be seen in the changes of vertical coordinates. The detailed results are still being interpreted (Figure 5).

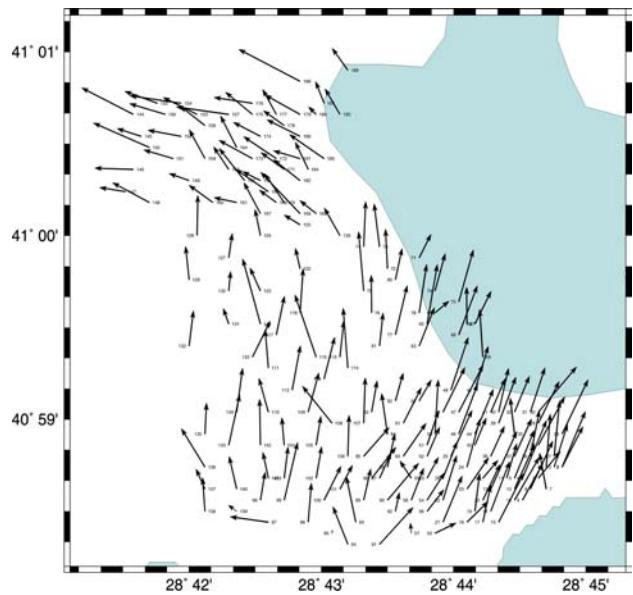
Figure 7. Displacement vectors for horizontal coordinates between the years 1999 and 1987

These results show us that the movements have different characteristics in these measurements. The displacements between the years 1998 - 1993 have a reverse direction when they compared with the displacements between the years 1993-1987. And of course the displacements between the years 1999 and 1998 have also another characteristic because of the earthquake. But it is interesting that the displacements between the years 1993 and 1987 have same directions with the displacements occurred in the earthquake in horizontal coordinates (Figure 7 and 8).
