VISIBLE AND THERMAL IR DOCUMENTATION OF A MASONRY BRICKWORK BUILDING

J.L. Lerma ^a, C. Mileto ^b, F. Vegas ^b, M. Cabrelles ^a

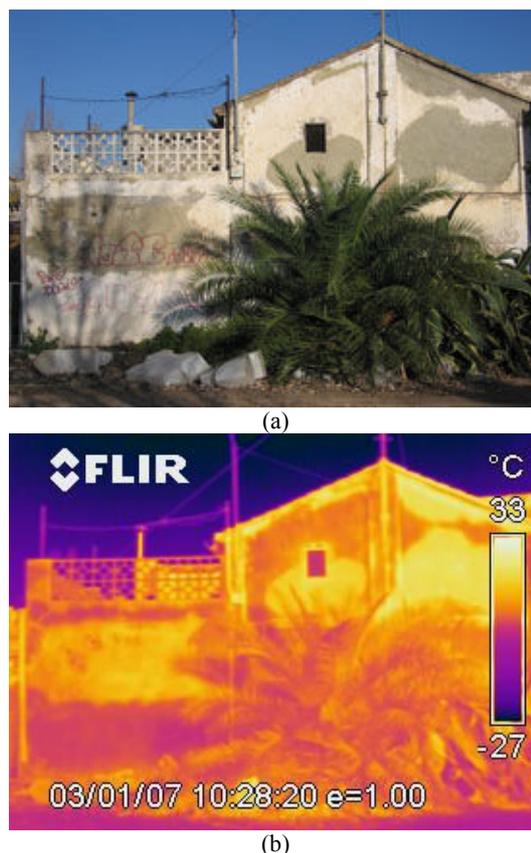
This section shows different building inspections on the aforementioned country house, corresponding to both inner and outer building parts. The first set of images (Fig. 3) tackles the southern façade. They were taken on a sunny day, late in the morning and in January, 2007. It is obvious on both images the lack of whitewash due to the partial cement mortar rendering. Meanwhile this difference in colour is apparent on the visible image (Fig. 3a), the thermal one (Fig. 3b) shows cement mortar areas warmer than their surroundings. Metallic features such as tubes behave in a similar way.

Figure 3. Southern façade: (a) Visible; (b) Thermal IR.

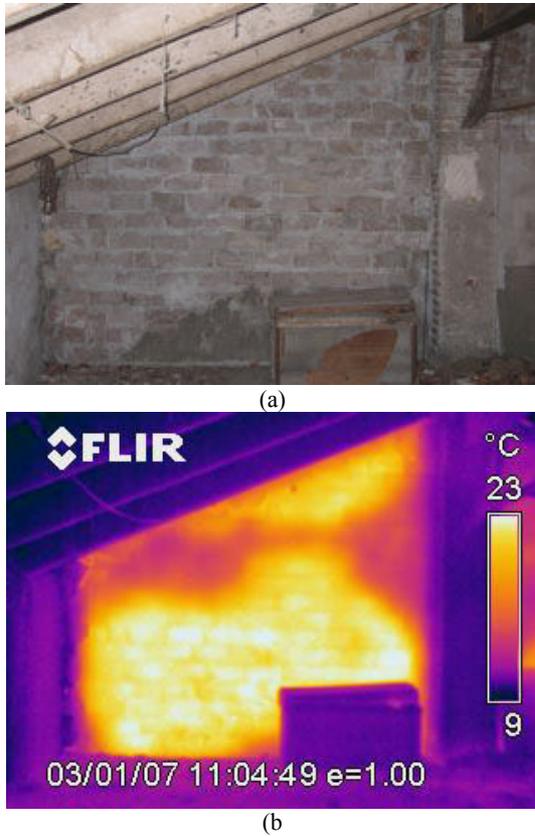
Analysing the same façade from inside, first storey (Fig. 4), similar results are obtained for the thermal image in spite of spatial resolution (Fig. 4b). However, the information regarding this heat transfer difference is not achieved at all from the visible image. This thermal image would suggest some need of painting to avoid heat losses in the future. Bricks structure is well-defined in the visible image and can also be guessed from the thermal IR image. On the other hand, mortar rendering on

this side of the wall does not affect heat transfer from the exterior of the building. Particularly interesting is the cool stripe area on the left hand side of the image reflecting some moisture presence in the corner. Besides, wood trunk's cover shows thermal differences because of the inner framework.

Figure 4. Outer wall pictures taken from the first storey: (a) Visible; (b) Thermal IR.

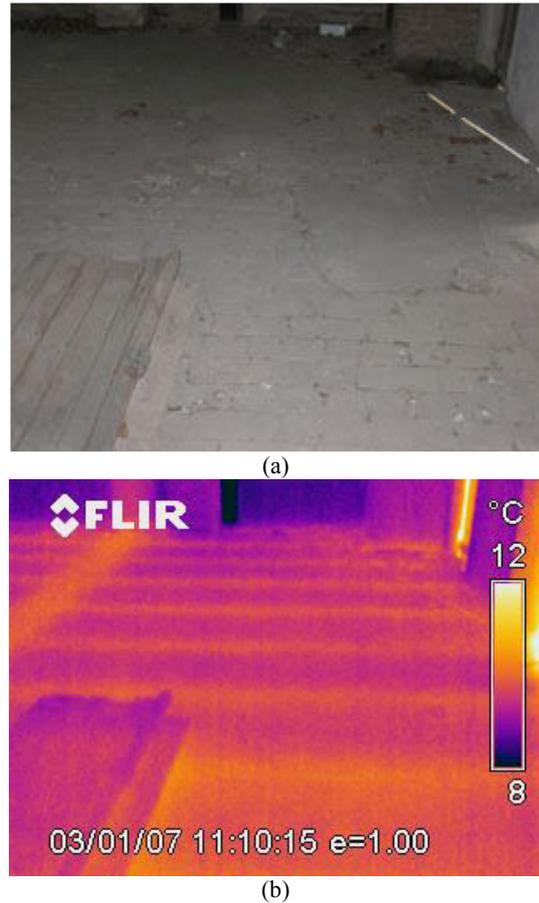
Next set of images was taken inside and empty room on the first storey in order to reflect the floor structure of regular beams. It was even possible to report beams by means of thickness. Fig. 5 shows one out of seven pairs of images (visible and thermal), used to build up a vector map about the structural analysis on this level (Fig. 6). For that purpose, visible images were rectified without control points by making use of a wooden square target and mosaiced to create a continuous raster image. In a similar way, thermal IR images were also rectified over the visible mosaic to overlay beams drawings (in AutoCad format).

Figure 5. First floor pictures taken from the first storey: (a) Visible; (b) Thermal IR.

It is interesting to notice how the heat transfer from the beams is transmitted outwards in a way that is hardly dependent on upper materials with small thickness (diameter smaller than 4 cm) such as bricks and plaster.

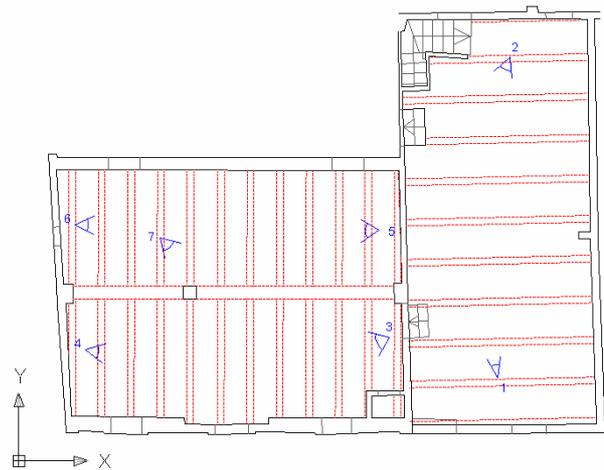
Figure 6. AutoCad drawing of the beams framing the first story. This cad images was built up after acquiring seven pairs of images (check angular symbols)

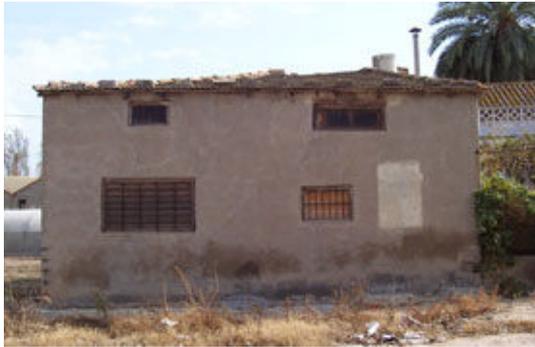
The last set of imagery was taken on the same building but on the Western façade (Fig. 7). They were shot in the morning before midday. The visible image allowed us to inspect the outer part of the building, finding a cement mortar wall with a

clear walled up (rendered with different colour on the right), four windows and some moisture shapes, some of them invisible to the eyes. Additionally, it was possible to locate some attachments near the ground as well as some plaster detachments. The thermal image also allowed us to both differentiate brickwork activities on the façade (the layout of the upper fourth of the wall is neatly different to the rest), and identify a pilaster in the middle of the facade, as well as some moisture spots as well as some water channels.

Figure 7. Western façade: (a) Visible; (b) Thermal IR.

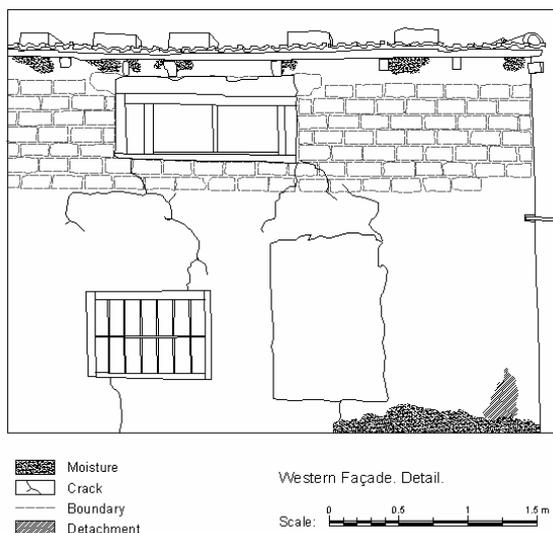
After rectification and merging of the visible and thermal IR imagery, it was possible to draw a vector elevation map with alterations and damages on the façade (Fig. 8).

Figure 8. Drawing of the upper right part of the Western façade.
