## PARTHENON RESTORATION PROJECT

N. Toganidis

Greek Ministry of Culture, Acropolis Restoration Service, 10 Polygnotou str. 10555 Athens, Greece (toganidis@gmail.com)

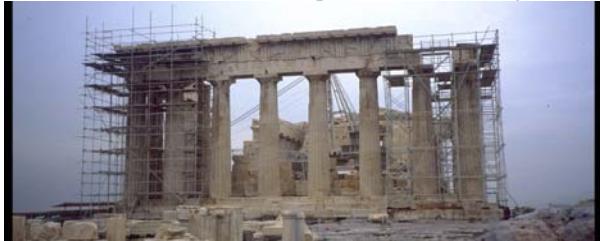
Figure 4

7. In 1984 starts the third extensive restoration work. The result of the strong earthquake that took place in 1981 affects the corners of the east side and obligates the authorities to take action. Fortunately, the first study for the restoration of the Parthenon by the architect Manolis Korres, already exists. The works are under the scientific supervision of the Committee for the Conservation of the Acropolis Monuments (figure 4).

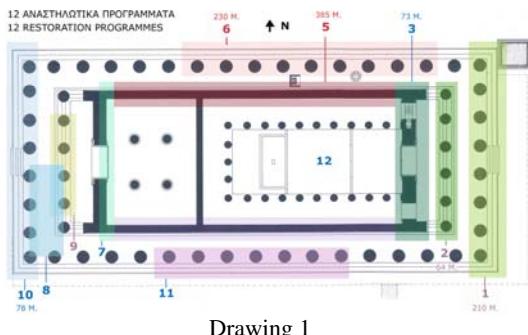
Drawing 1

Due to the extension of the works and the size of the intervention to the monument, the whole project is divided in 12 programs. Today some of these programs are already completed (Drawing 1).

1. EAST ELEVATION (finished 210 members)
2. EAST INNER EXASTYLE COLONADE (finished 64 members)
3. EAST WALL (73 members)
4. SOUTH WALL (partial 570 members)
5. NORTH WALL (partial 385 members)
6. NORTH ELEVATION (under construction 230 members)
7. WEST WALL (unknown)
8. PARTIAL ROOF OF THE WEST CORRIDOR (35 members)
9. WEST INNER EXASTYLE COLONADE (finished)
10. WEST ELEVATION (78 members)
11. SOUTH ELEVATION (partial 112 members)
12. FLOOR/CRIPIS (partial 36 members)

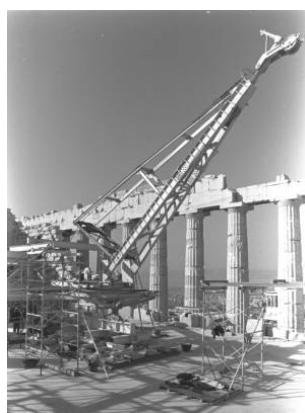
Figure 12

After the installation of a crane on the concrete working floor at the interior of the Parthenon (figure 12), the restoration works started from the East elevation, as a matter of major priority. The two corners suffered from the strong earthquake of 1981. After the dismantling of the members above the corner columns, the columns were released from the pressure, relaxed on their bases. The SE column together with its capital was rotated due to the earthquakes. To correct the curvature of the eastern architraves, we designed and executed successfully the rotation of the SE corner column to its original place. The total column weight is about 60 tons. This is a completely prototype work. We replaced all the original "metopes" and statues with concrete copies and we rearranged some members to their original position. Newly founded ancient fragments were added to the pediment.

In total, we removed, conserved and replaced in position more than 300 tons of marble.

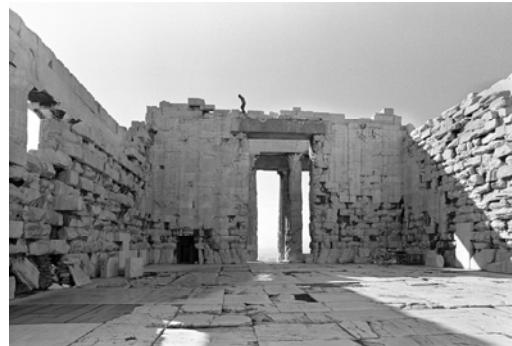
Figure 17

We continued with the long walls of the Cella (figure 17). At the beginning we noticed a wrong restoration of 20 stones at the base of the North wall. The area was corrected and completed with original material. Then we continued with the walls. It was clear that we found a wrong restoration. We took the approval to dismantle the restored areas. In this way we gathered a total of 750 stones – those dismantled and those scattered on the ground - looking for their original position. We developed a lot of techniques to approach the solution. One of them was the design of a special computer program. Finally, we approached the solution with an optimum total of 52 criteria per member, using excel tables.

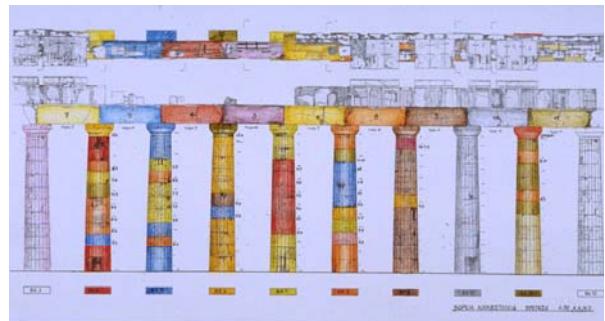
Figure 23

This is the first time that we are restoring colonnades using marble completions and not concrete ones. A lot of scattered fragments are returning to their original position. It is also very important that rearranging the positions of the drums between columns succeed to the correct position for the drums and the correct height for the columns (figure 23).

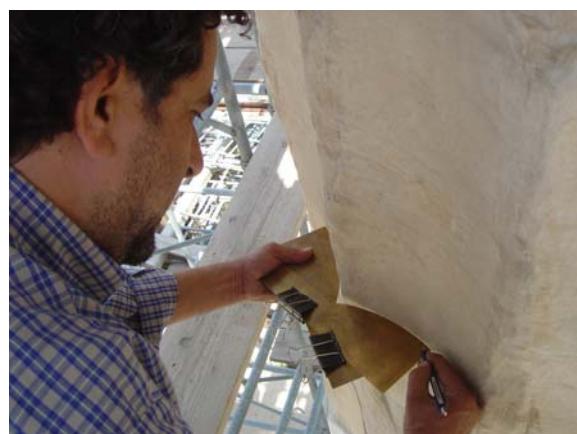
Figure 32

- The inadequacy of structural connecting elements on the original broken architectural members creates a serious problem in determining the correct member order in the construction. We have noticed that the plantation roots grown between marbles mark the neighboring members. Comparing these marks, sometimes we get the proper answer (figures 32, 33, 34, 35).
