LASER SCANNING FOR HISTORICAL AND GEOTECHNICAL STUDIES AT POINTE DU HOC

R.B. Warden^{a,*}, R. Burt^a, J-L Briaud^b, M. Everett^c

^a Texas A&M University, Center for Heritage Conservation

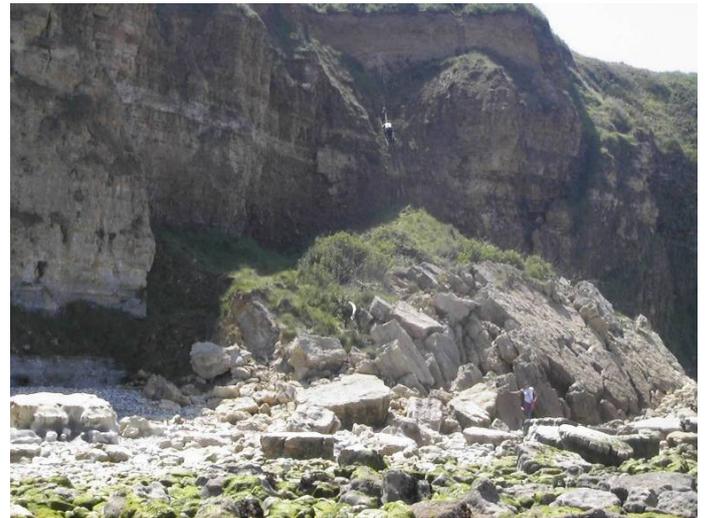
The site reconnaissance revealed the following observations: The O.P. which is nearest to the cliff edge appears to be intact; however, some cracks in the O.P. walkway and entrance stairs were identified. Massive rock failures (Figure 2) were observed along the beach, all of them had a vertical plane of failure. The West side of the cliff head was found to be more concaved than the East side; this may indicate that the predominant wave and wind direction is from the west. The rock bedding is nearly horizontal, dipping down towards the north with an approximate angle of 5°. Fresh water seepage from the cliff face was noticed in several places at a level of approximately 2-3 m above the base of the cliff and sometimes higher. The predominant conjugate perpendicular joints on the West side of the Pointe appeared at an orientation of Azimuth angles 30° and 120°, yet on the East side, another set of conjugate perpendicular joints appeared at an orientation of Azimuth angles 0° and 90°. The observed joints' spacing ranged between 1 and 2 m. On the East side of the Pointe, just under the O.P., two extended joints appeared at the cliff face with the possibility that they coincide with the O.P. walkway cracks. Some large size undercutting and caverns were found to have heights up to 3.5 m and depth (i.e. perpendicular to the cliff face) from 3 to 4 m (Figure 3). The high tide level may reach up to 3 m from the cliff base at some locations and the waves may add another 6 m of water attack above that. Calculations of the erosion rate over the years from aerial photos indicate that at the most aggressive locations, the Pointe Du Hoc site experienced about 10 m of erosion due

Figure 2: Massive collapse about 300m west of the O.P.

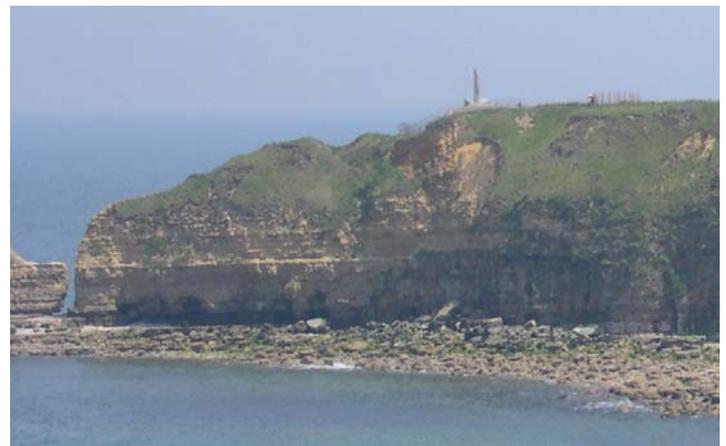
Figure 3: Caverns near the Observation Post (West side)

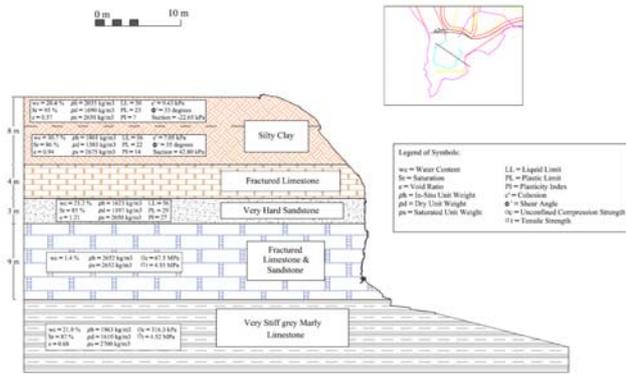
The reconnaissance work included the drilling of six bore holes numbered from B1 to B6 to a depth of 30 meters. B1 and B3 were equipped with piezometers and B4 was equipped with a settlement benchmark. B1 and B5 were core drilling boreholes, and the rest of the boreholes were destructive drilling. In the destructive boreholes, the following drilling parameters were recorded during the drilling: instantaneous penetration speed, pressure on tool, rotation torque pressure, and drilling fluid injection pressure. One part (12 samples) of the intact samples taken during soundings B1, B1', and B5 was sent to the FUGRO Geotechnical Laboratory in France. The second part (10 samples) was sent to Texas A&M University, College Station, Texas, USA. The boring logs lead to the stratigraphy shown in Figure 4.

Figure 4: Stratigraphy and soil/rock properties at boring B1

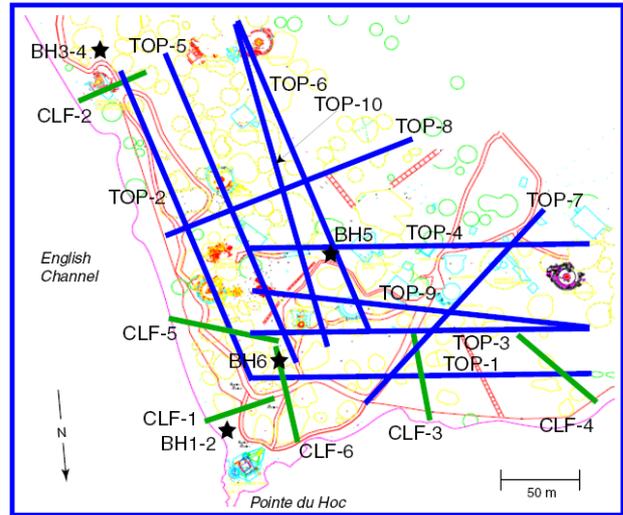
Figure 5. Pointe du Hoc 2006 Geophysical Site Map

A grid of ten top-side and six cliff-side multi-resistivity (MER) profiles were acquired (Figure 5). Two—dimensional resistivity fence diagrams have been assembled, from which suggested routes of groundwater infiltration into the fractured chalk are identified. We provide final 2D geological interpretations of the individual MER profiles and a quasi—3D synoptic interpretation based on the fence diagrams. We also present a fully 3D resistivity tomogram constructed from the entire data set, along with an interpretation of the tomogram in terms of the geostability hazard.

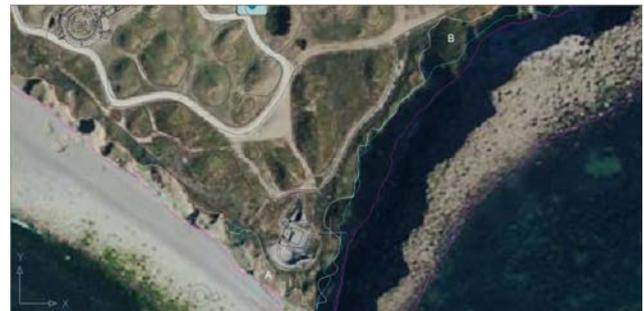
Figure 6: Cliff Line Comparison

The two areas are indicated in Figure 6. The area marked “A” near the Observation Post (O.P.) is on the east side of the point stack. The area marked “B” is on the west side of the stack about 85 m east of the O.P. The cyan line marks the outline of the cliff-top in 1942. The white line marks the current outline of the cliff-top as given by laser scanning while the magenta line marks the cliff-base from the laser scans. On the east side at “A” we see a significant loss of cliff-top (difference between white and cyan).

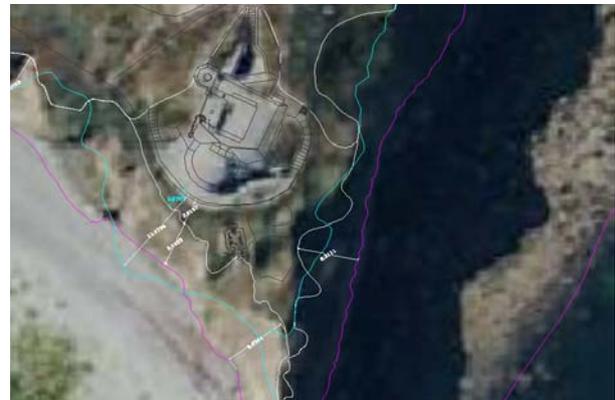
Figure 7: Cliff Edge Dimensions

Figure 7 details some dimensions in this area. We see the distance from the front of the O.P. walkway to the 1942 line is about 12.9 m. The distance from the same walkway to the current cliff line is 3.8 m, thus demonstrating a 10 m loss of cliff over 64 years. However this loss is not the full height of the cliff. We see a 3m difference from the 1942 line and the current cliff-base line suggesting that that most of the 10 m loss was in the softer soils above the base.

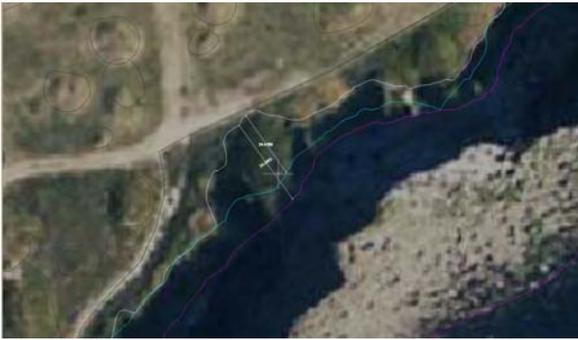
Figure 8: Cliff Dimensions at 'B'

Figure 8 shows that on the west side at “B” we see about a 15m loss since 1942 in the upper 11m of cliff with about a 5m difference between the current cliff-base line and the 1942 cliff-top. In both cases we see about a 3m-5m difference between 1942 cliff-line and the current cliff base in most places along the cliff, though the west side shows an area at “C” in Figure 9 with about a 10m difference. This suggests that basal erosion on the west side is greater than on the east.

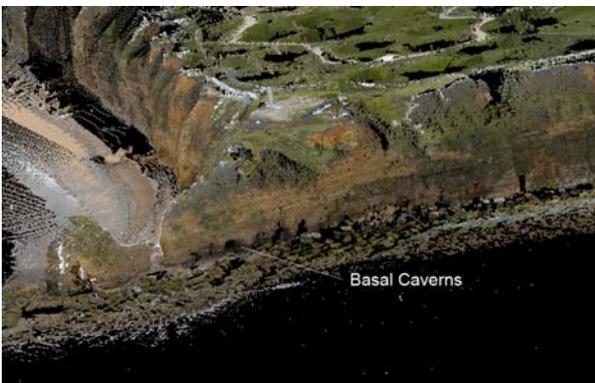
Differences in historical cliff lines between the east and west sides of the point stack are significant because the west-side cliff base shows evidence of basal notching (Figure 10) and deep cavern formation which is absent on the east side (Figure 11). This observation, taken alone, suggests that any failure from basal cavern formation should occur only on the west. The lack of observable cavern formation on the east side of the

Figure 10: Scan Showing Basal Caverns West

Measurements of previous cliff-base failures on the west indicate that when a cavern reaches an unsupported depth of about 4 m a failure is likely to occur. Observation and measurement of caverns on the west with depths approaching 4 m raises a caution about the future stability of the cliff in those areas. Cavern formation is a complicated process that involves the long-term dissolution of the limestone by acidic groundwater circulating within and enlarging the pre-existing cracks and voids of primary tectonic genesis. These avenues for continued groundwater action create a wide network for possible groundwater flow within the vadose, or unsaturated, zone to the cliff face. As fissures at the cliff base widen, large blocks of stone become vulnerable to significant mechanical action of the sea eventually causing their removal.

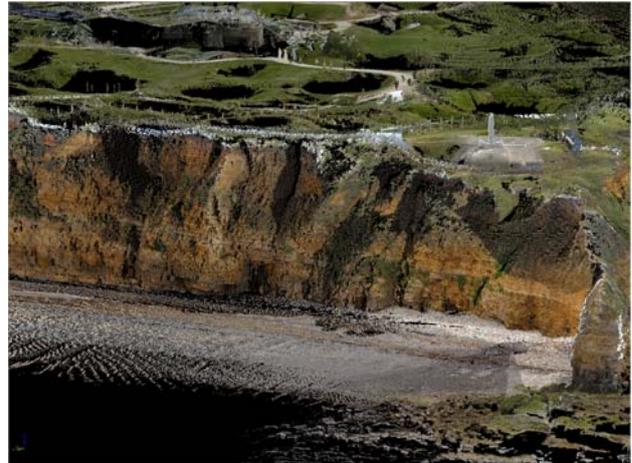
significant westerly direction of the tide, the sea action on the leeward east side of the stack has much less erosive power than it does on the exposed, windward west. This difference has caused a gravel spit of significant thickness to accumulate on the east. The spit, or shingle, has raised the apparent level of the cliff base by 3 m above that of the west. It is possible that caverns similar to those found on the west occur on the east but they evade observation due to the elevation of the gravel. Nevertheless, putative east-side caverns are effectively shielded from sea attack by the gravel and, should they exist, are not likely to be enlarged at an appreciable rate that would threaten the historic buildings at the cliff edge.

Figure 11: East Scan with Pointe Stack

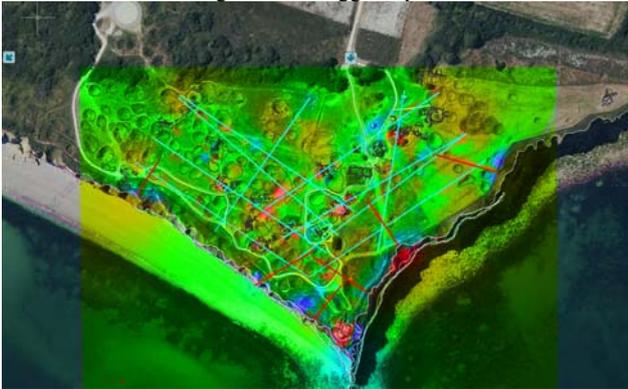
Wedge failure of the upper cliff at "A" represented by the 1942 line is suggested by the 3D resistivity tomogram overlaid on the

site survey (Figure 12). A significant, likely persistent, source of ground water is apparent in the upper layers of the cliff near the O.P. The 3D tomogram also suggests possible

Figure 12: 3D Resistivity Tomogram with Site

karstic action in the form of enlarged voids on the lower east side near and beneath the O.P. The tomographic evidence is consistent with observation of groundwater seepage from beach gravel at low tide. It is also consistent with drilling logs in boreholes near the O.P. that show a 2 m drop in the bit indicative of a subterranean void, at about 20 m depth. It is possible that caverns or voids would be visible on the east face of the cliff if the beach gravel were removed. The top of the voids on the west cliff face lie at -23.8m with respect to our established benchmark while the gravel intersection with the cliff on the east occurs at -24.1 m from the same benchmark. Still, it is unlikely that any void formations on the east would be as significant as those on the west because of protection afforded against tidal action by the gravel and the reduced force of wave action on the east side of the point stack.
