Applications Of Remote Sensing Imagery  
Interpretation In Railway Surveying

Zhuo Baoxi  
The Professional Design Institute of  
The Railway Ministry, Beijing,  
China  
Commission VII

(ABSTRACT) This paper described briefly the applications of remote sensing technique to railway surveying in China. Typical examples were cited and our experiences on the work were highlit.

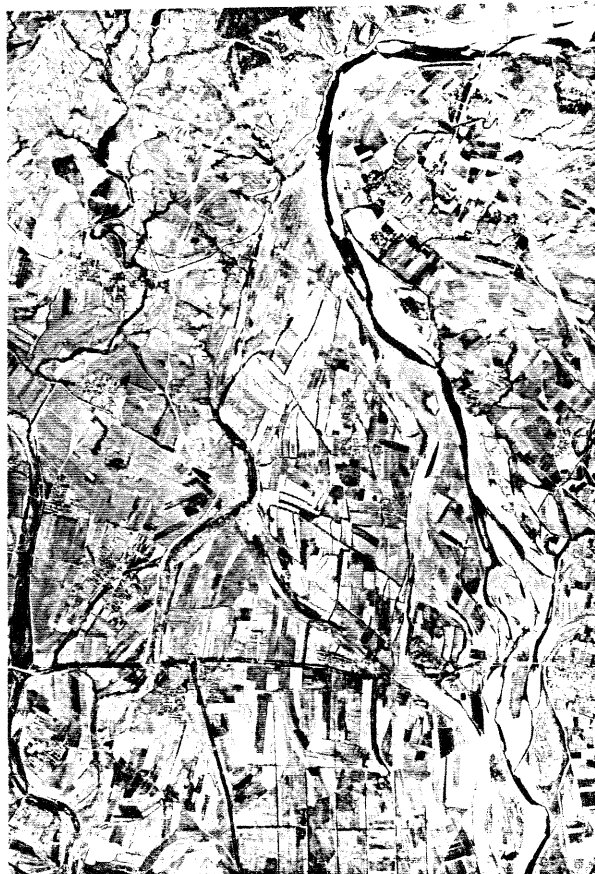
Fig. 1a Aerial photograph

b. In a northern area, a railway in plan passes through a varied river section, where the river bed is wide and shallow with lots of sand banks. The current is unstable and especially so during swollen periods. The complete appearance of the river course was difficult to be located from the ground. Aerial photos taken after flood season were used for selection of bridge sites, as the course and the distribution of sand banks along with sheet flood and traces of ancient river courses could be clearly interpreted from the photos (See Fig.1)

During the planning phase, four bridge sites were considered and evaluated according to photo interpretation:

. Profile A (a highway bridge) As it is a diffusive reach, more bridges would be required. The river banks are incomplete owing to the rush of the current and the hydrological condition is relatively poor.

. Profile B Here bridges would still be at the sheet flood section. More bridges and protecting engineering work are necessary.

.Profile C Though it is the concourse of the main branches, there is still a 6km sheet flood section along the right bank. The hydrological condition is rather poor.

.Profile D is the place the river is narrowed up and there is no sheet flood any more. It is the optimum location for building a bridge.

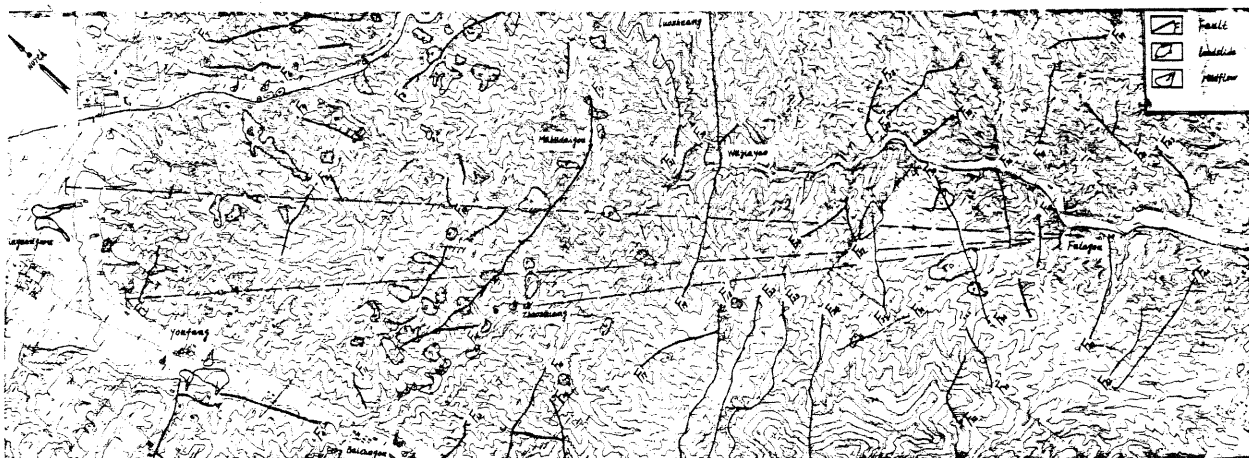
The Landsat image and aerial photos were interpreted and a aerial photo map at 1:10,000 scale as well as a 1:10,000 geological interpretation map of remote sensing image were prepared before field work(See Fig.3).

Fig.3 Engineering geological interpretation map of YMG tunnel area, prepared from remote sensing images

in laboratories to derive information to guide field work. During the field checking, it was proved that only one fault(F19) crosses through the tunnel and would not cause serious influence on it. A fault(F8), in addition to F19, does exist but not cross the tunnel as it was suspected. While the third suspected fault is actually not existing. Instead, a fault(F13) which was not labeled on the existing geological map is found lying across the tunnel. This fault has relatively strong influence on the tunnel engineering. As the dikes questioned were disproved after detailed interpretation at large scale aerial photos and field checking. Lastly, no groundwater appearance was found in the questioned area during the interpretation and ground work. The applications of remote sensing image interpretation for tunnel engineering are summarized as following:

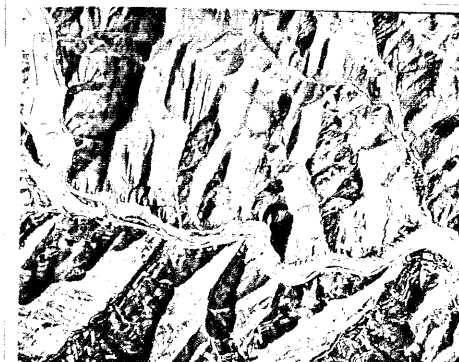
- . Make a thorough evaluation on engineering geological conditions of the tunnel:In the southern part, the direction of the stratum is approximately orthogonal to the tunnel and rock body is comparatively complete. The geological condition here is much better as compared to other places(Fig.5). While in the northern part, the occurrence of rocks are disorderly and a lot of ill-geological phenomenon can be found. The engineering geological condition is comparatively poor.

Fig.5 Stratun orthogonal to the tunnel
