PHOTOGRAMMETRIC METHODS IN GEOMORPHOLOGICAL  
 PROCESS STUDIES. A CASE STUDY FROM ROMANIAN  
 SUBCARPATHIANS. N.Neguț, D.Bălțeanu, G.Mihaiu,  
 L.Căplescu, P.Bălănescu, Cornelia Săvulescu.  
 Institute for Studies and Design of Land Reclama-  
 tion Projects, Institute of Geography București  
 Romania  
 Comission VII

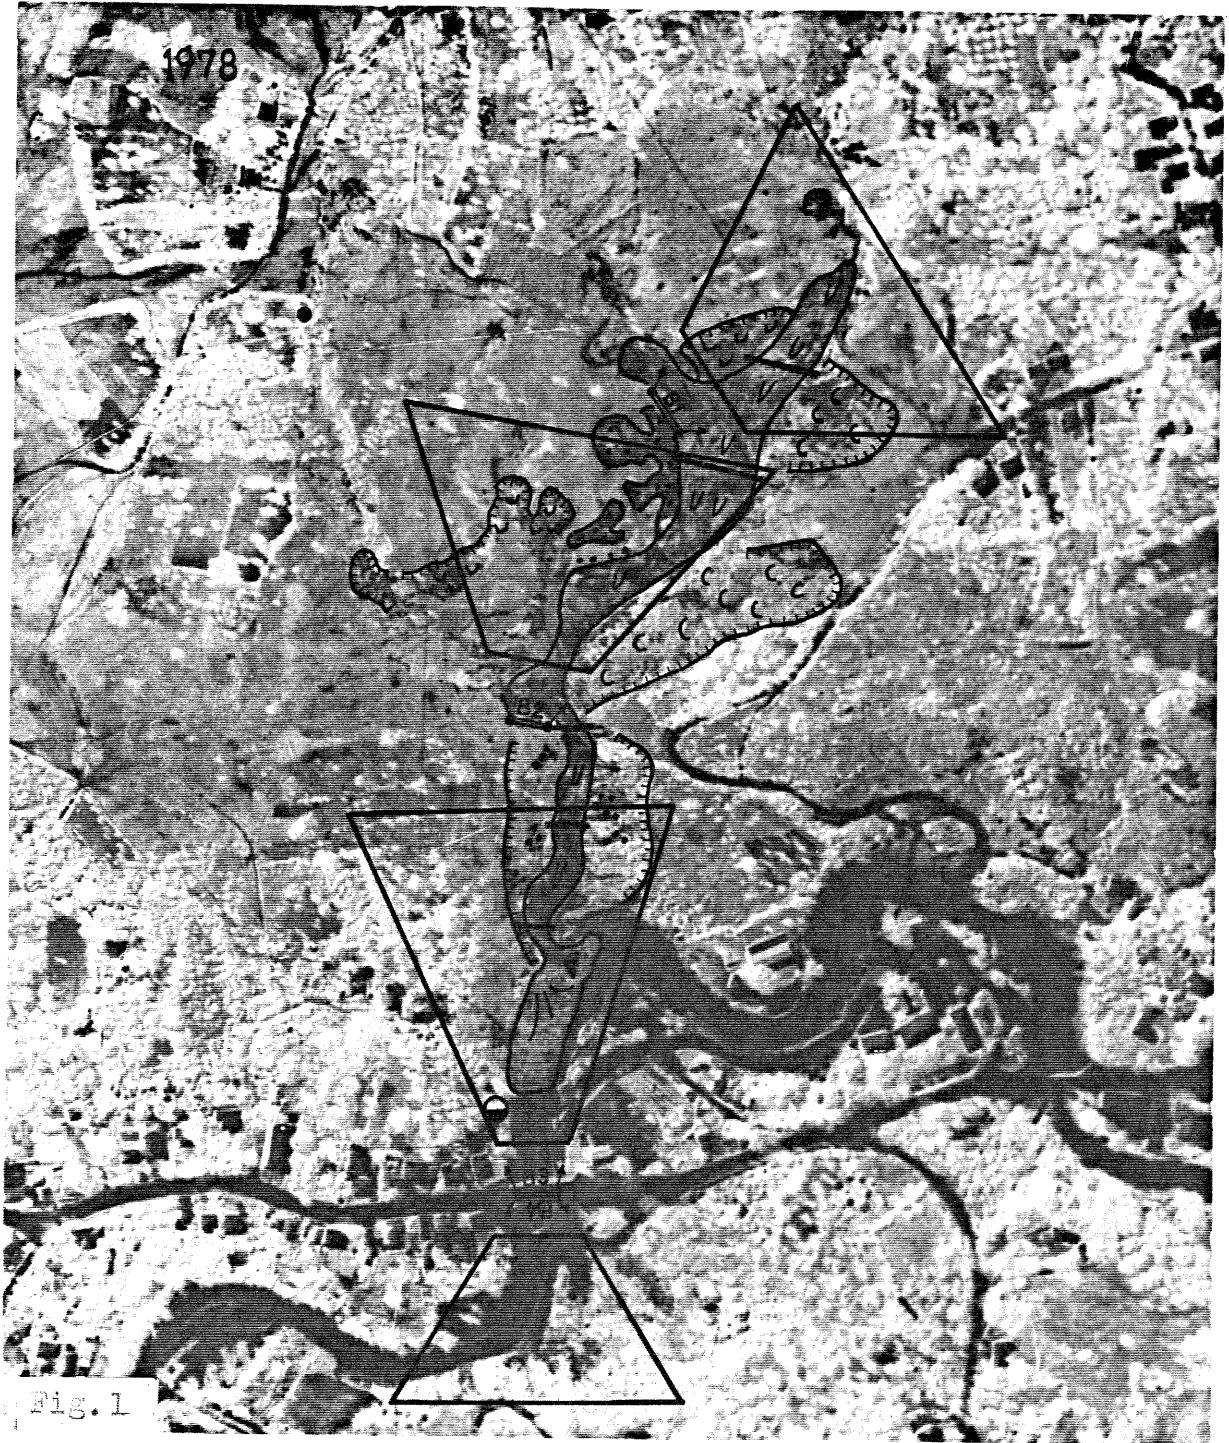
Fig. 1

Study area with photogrammetric bases and points of measurements 1, photogrammetric bases; 2, areas with repeated terrestrial photographs; 3, rain recorder; 4, stake lines; 5, points to measure concentration of dissolved and suspended matter; 6, measurement of ground water level; 7a, mudflow; 7b, mudflow fan; 8, active landslides; 9, steep slopes, landslide scars; 10, piping processes.

Relaying on the aerial photographs, orthophotograms and field investigations, we selected three representative samples for different present-day geomorphological processes (Fig 1 and 2) These areas were studied in detail with the help of terrestrial photogrammetry. Three concrete-built photogrammetric

The final geomorphological materials involved also detailed field investigations, which had started in 1968, based on detailed geomorphological mapping, measurements of some stake profiles, measurement of ground water level, chemical analyses of water and determination of suspended matter, as well as geo-technical analyses (Fig 1).

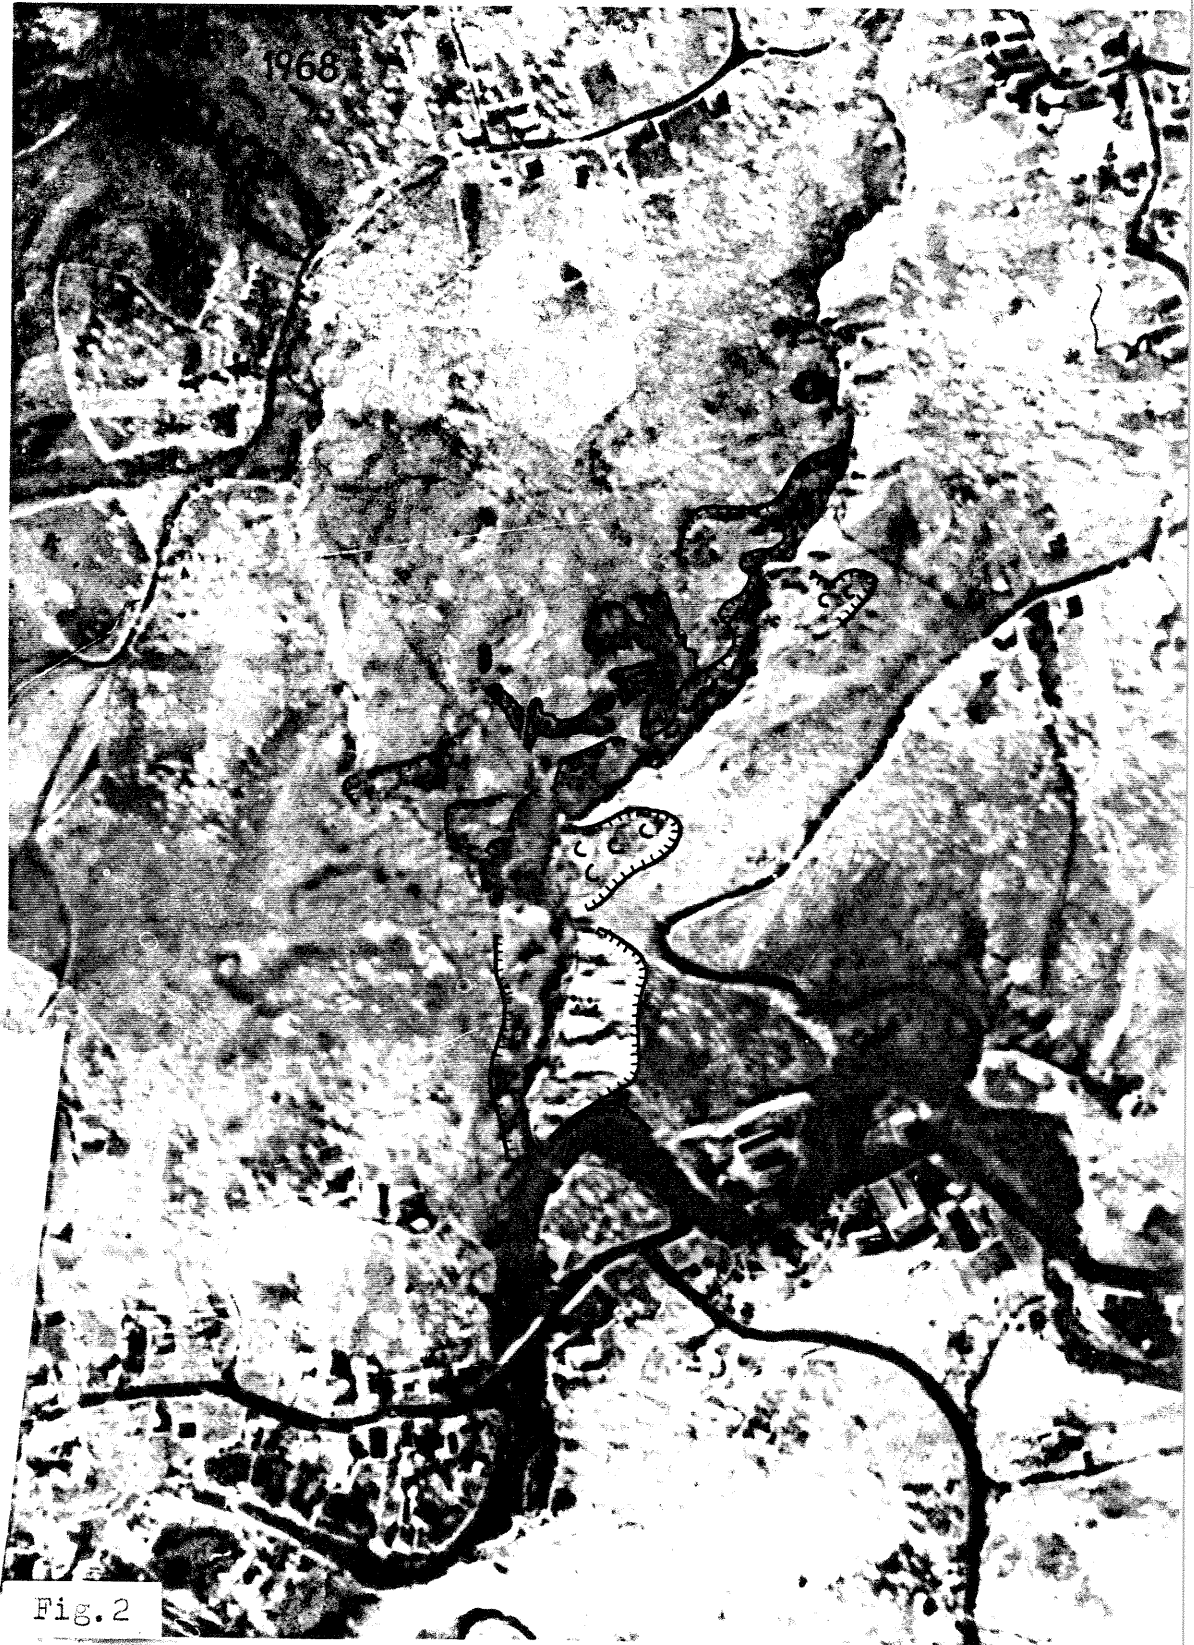
Southern slope of Blidişel Hill in 1968 (same legend with fig. 1)

In the years 1954 - 1968 the slope shows, in general a relative stability. The main valley is affected by small lateral landslides and the thalweg is deepened down to the bedrock. The area is used as pasture land and the water drainage is organised on older landslides (Fig 2).

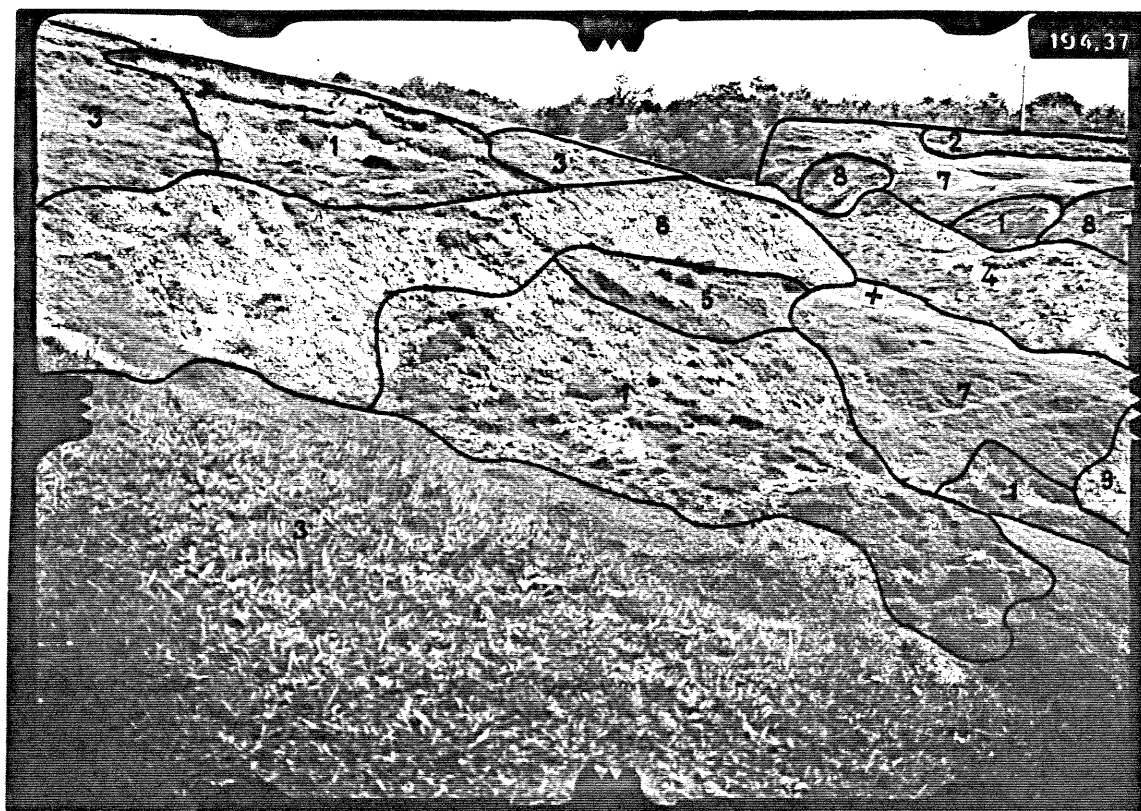
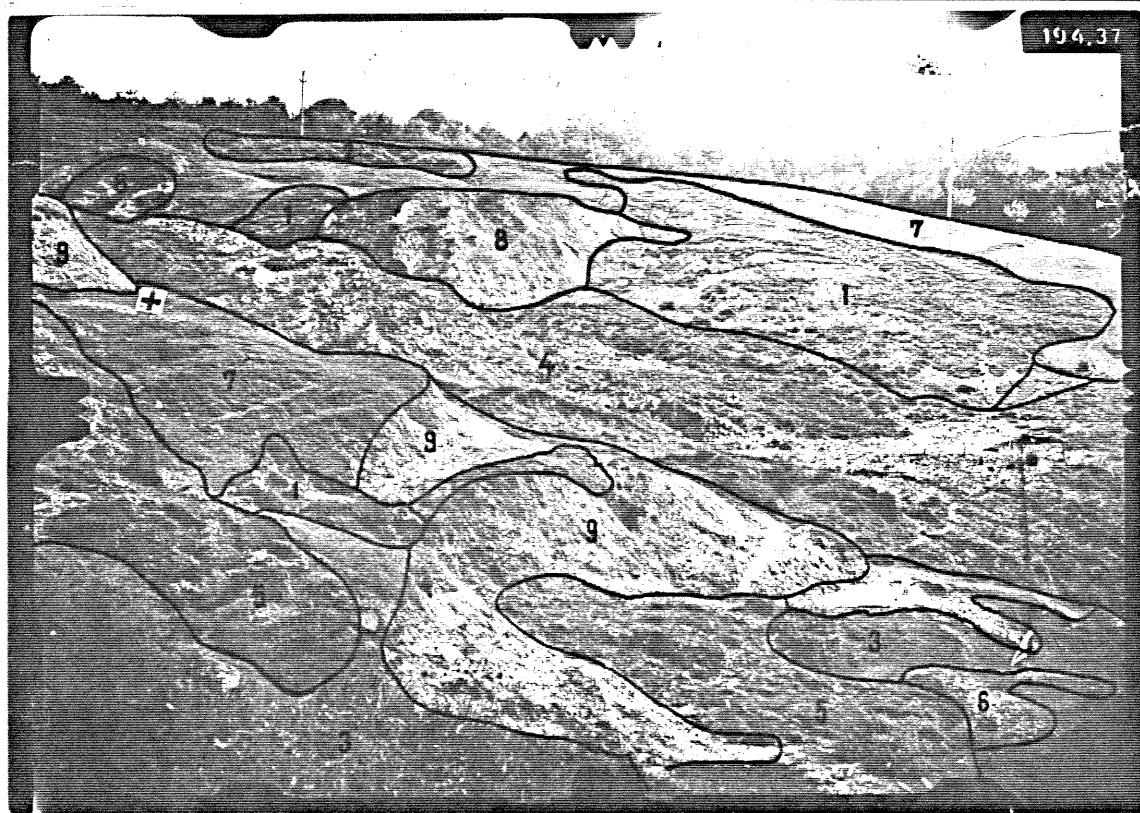
Fig. 4

Terrestrial photographs of the sector B 1 (legend at fig. 5)
