## RECORDING THE DAMAGES OF NATURAL STONES

Jürgen Heckes, Landolf Mauelshagen, Mustapha Skalli

Deutsches Bergbau-Museum  
Am Bergbaumuseum 28, D-4630 Bochum  
Federal Republic of Germany  
Commission V / CIPA

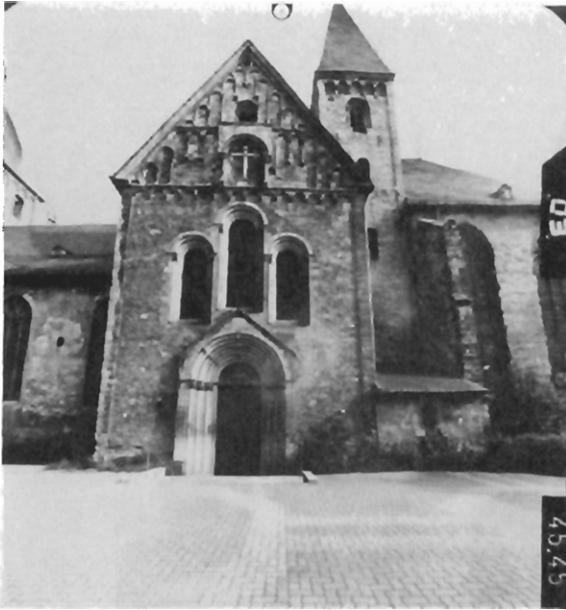
Fig.2 The southern transverse building of the Great Maria Church at Lippstadt

In the course of a planned perfect restoration of all outer facades of the church extensive investigations and documentations will be conducted, which in cooperation of all contributing authorities and institutions shall lead to a logical overall concept. With the help of photogrammetry a lot of fundamentals can be produced for damage assessment and damage mapping (c.f. /Carbonnell 1976a and 1976b, Dallas et al 1987/), for the appointment of various stone types, plaster and mortar analysis, appointment of pigments and binders, investigations into the layer sequence of the up-going masonry and finally the art- and architecture-historical integration. The actual amount of all outer walls of the church were recorded by terrestrial photogrammetry (see Fig. 1 - 3). A partial-metric camera Rollei 6006 Réseau with automatic aperture, using the lenses Distagon 40mm and Planar 80mm, and a Wild P31 with a lens of 45 mm were at disposal. To avoid invisible spaces and much too oblique photographs a ladder of the fire-brigade was in use, which served for shooting photos (free positioning)

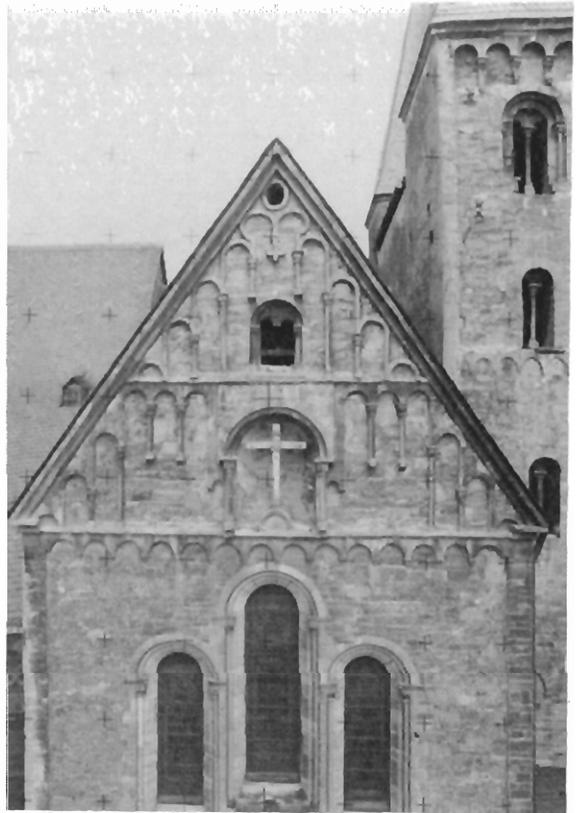
Fig.3 The gable front of the lateral building from the Great Maria Church at Lippstadt

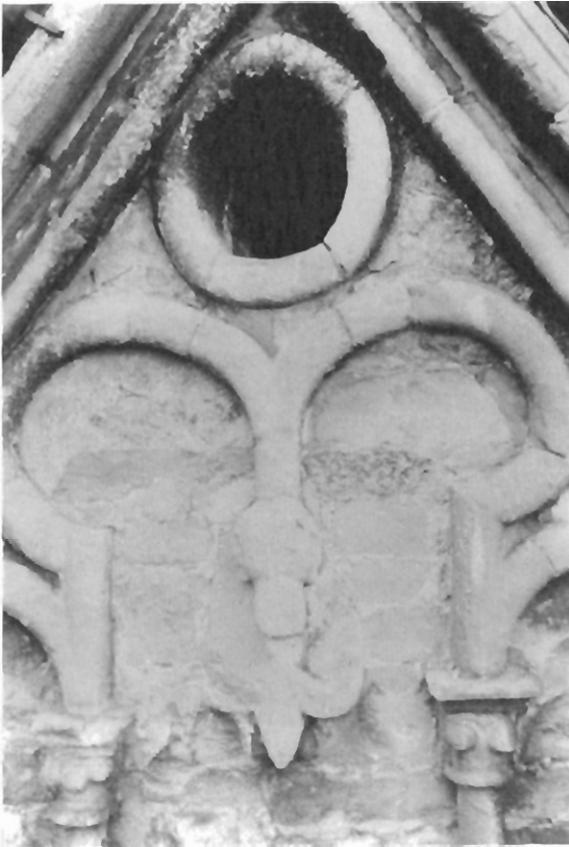
Fig.4 Stone damages at the upper gable of the church

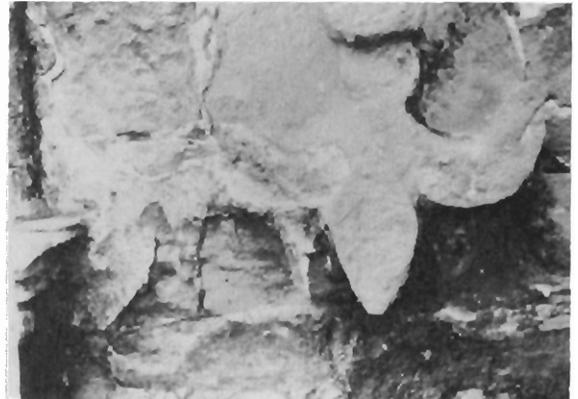
Fig.5 Details of stone damages at the upper gable of the church

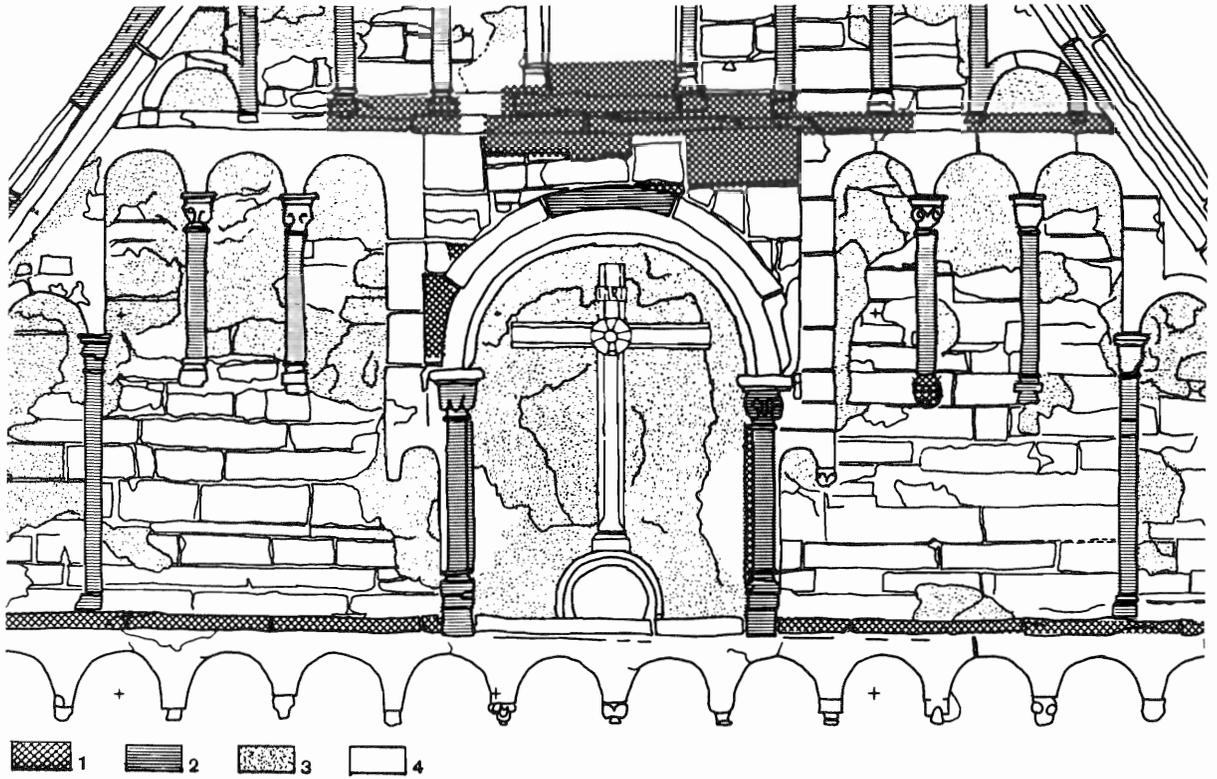
Fig.6 Detailed photogrammetric mapping of the different stone damages at the gable of the church: 1.. big damages, 2..middle damages, 3..plaster, 4..in relatively good condition

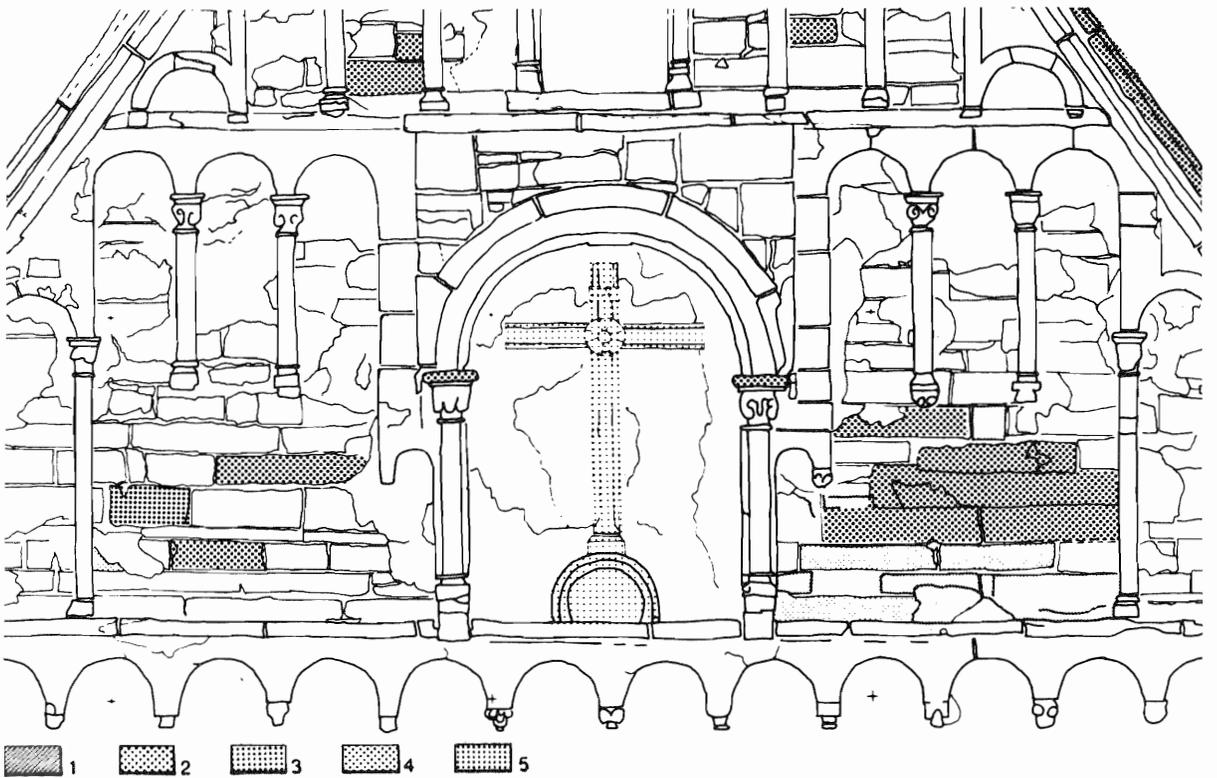
Fig.7 Detailed photogrammetric mapping of the individual stone types at the gable of the church: 1..green sandstone of Soest - clayey, 2..green sandstone of Soest - limy, 3..green sandstone of Soest - limy with iron crust, 4..plänen limestone, 5..sandstone - beige

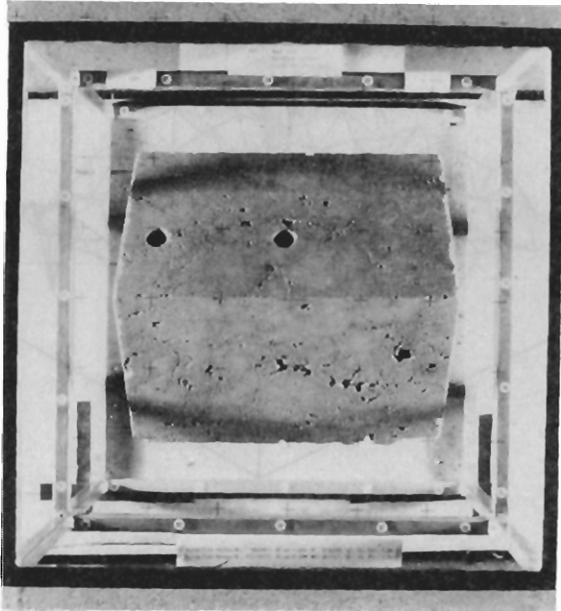
Fig.8 Stone prism of limestone ("Auer Kalk") inside the check point frame

For that purpose ten individual stone types (sediments) of a prismatic shape (Fig. 8) have been exposed to the open air at six sites in the FRG with an official weather and emission measuring station, different pollutant emissions and meteorological conditions. One of each stone specimen was leaved naturally, fourteen additional specimen were treated with stone preservatives. The preservatives are composed of varieties of two different compounds: silicon-organic and chemical reacting resp. physical drying systems. One prism side has been lightly stone-cutted for studying the influence of mechanical treatment at the surface to the weathering reaction. Two inclined holes at one prism facet shall simulate a long-term accumulation of moisture (backwater). Before being exposed to natural conditions all samples were stereophotogrammetrically documented from either side with regard to shape and colour. A Rollei 6006 Réseau partial-metric camera with a Distagon 80 mm was used at a base-distance-ratio of 1 : 5 or less. As the lens can be focused at the respective distance the earlier close-range problems caused by metric cameras with ancillary lenses are overcome. This fact is even more important for the following example of application. For checking the calibration of the camera by bundle adjustment before, during and after the recording period a control point frame (Fig. 9) was photographed. The degree of surface weathering shall be determined in regular intervals, above all if the samples show a strong reaction. The surfaces will be described and plotted by digital models and/or contour lines and/or profiles.

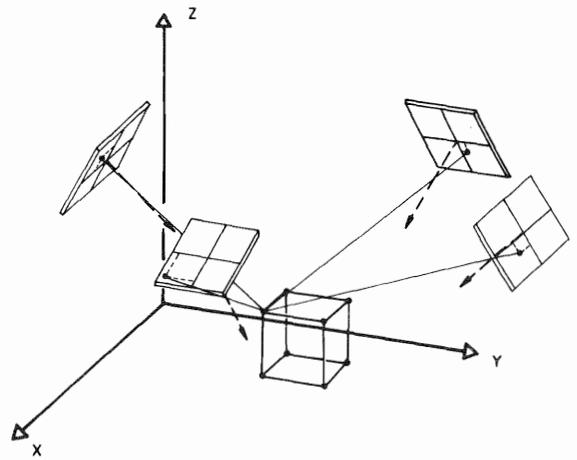
Fig.9 Configuration of photos for the bundle triangulation process, c.f. /Wester-Ebbinghaus 1986/

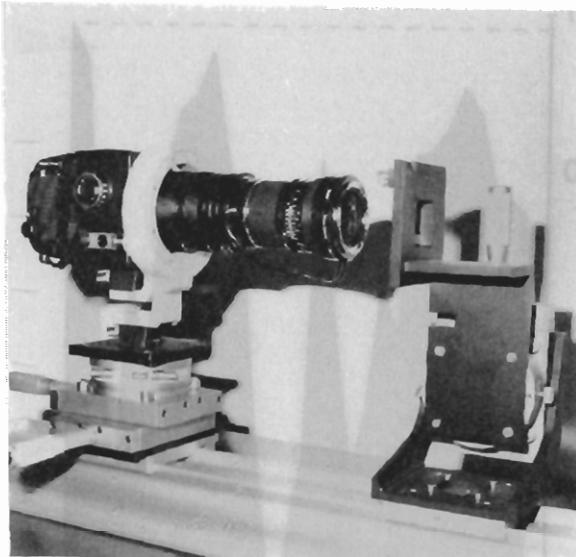
Fig.10 Bench mounting for photographing the small sandstone platen (Rolleiflex 6006 Réseau with extension tubes and retro-adapter)

and the base length have to be defined by the measuring devices. It was necessary to make the recording configuration reproducible. The used partial-metric camera Rollei 6006 Réseau can be equipped with extension tubes and retro-adapter. Taking a Distagon 50 mm lens and four tubes the photo scale is 4 : 1, but the depth of field is only very small. The digital models of the surfaces produced by the analytical plotter Zeiss Planicomp 100 will be plotted by a CAD-system to get a quantitative analysis (e.g. changing grain structure, erosion, change of volume) and to compare the results to other registration methods, as hologram interferometry, which is worked out by the University of Oldenburg. For testing the adapted plotter software simulated digital model data were used (Fig. 12 - 14).

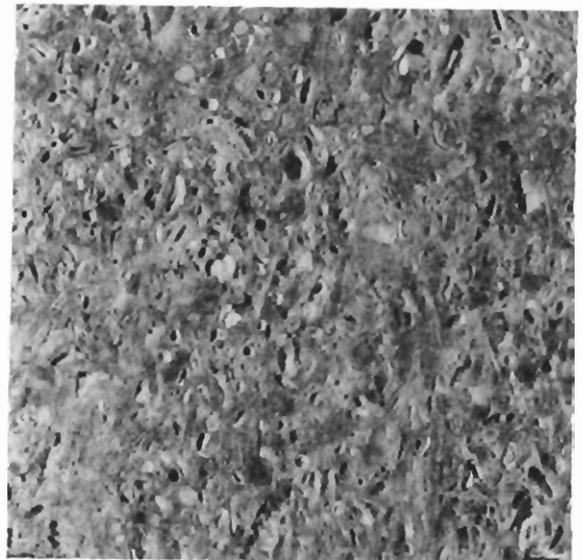
Fig.11 Enlargement of a shell lime stone platen (conglomerate), scale ca. 4:1

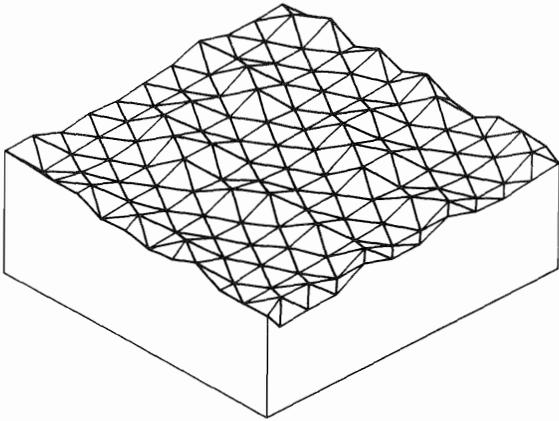
Fig.12 Plot of a simulated smooth stone surface

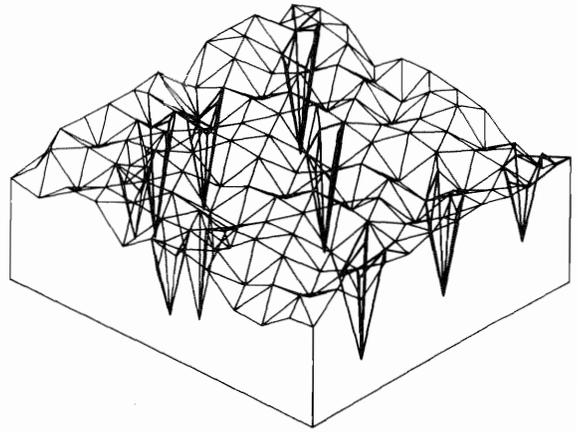
Fig.13 Plot of a simulated rough stone surface with cuneiform holes

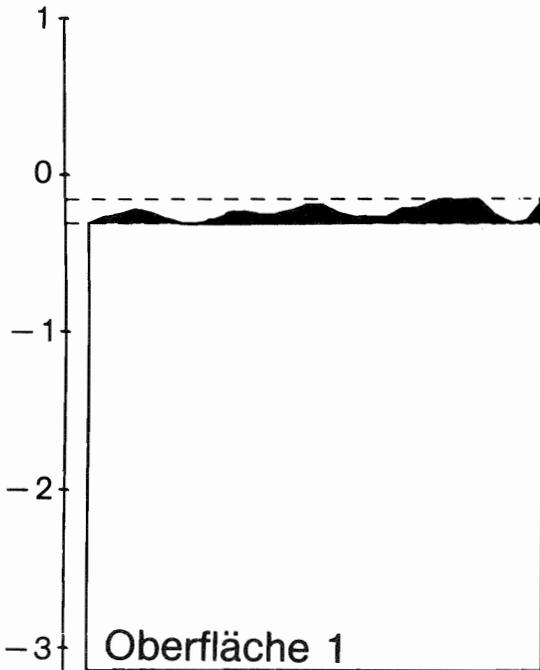
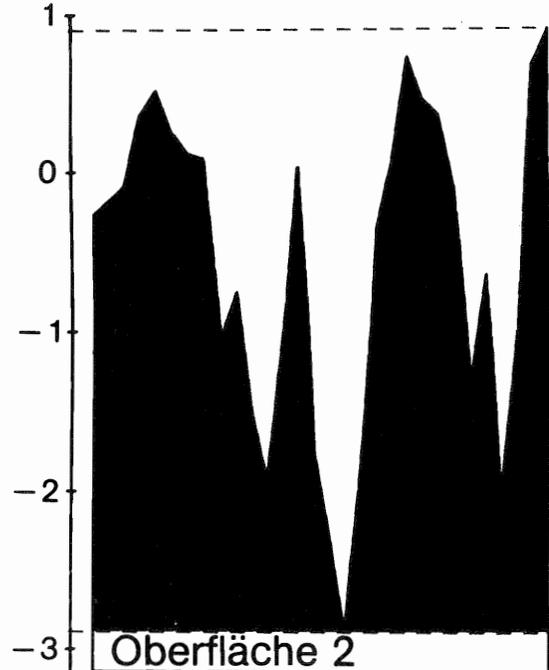
Fig.14 Cross sections of the simulated smooth and rough stone surfaces
