# DISPLAYING EARTHQUAKE DAMAGE AN URBAN AREA USING A VEGETATION-IMPERVIOUS-SOIL MODEL AND REMOTELY SENSED DATA

## Commission VII, WG VII/5

**KEY WORDS:** SPOT HRV data, earthquake, land cover, Vegetation-Impervious-Soil model, Adapazari, classification

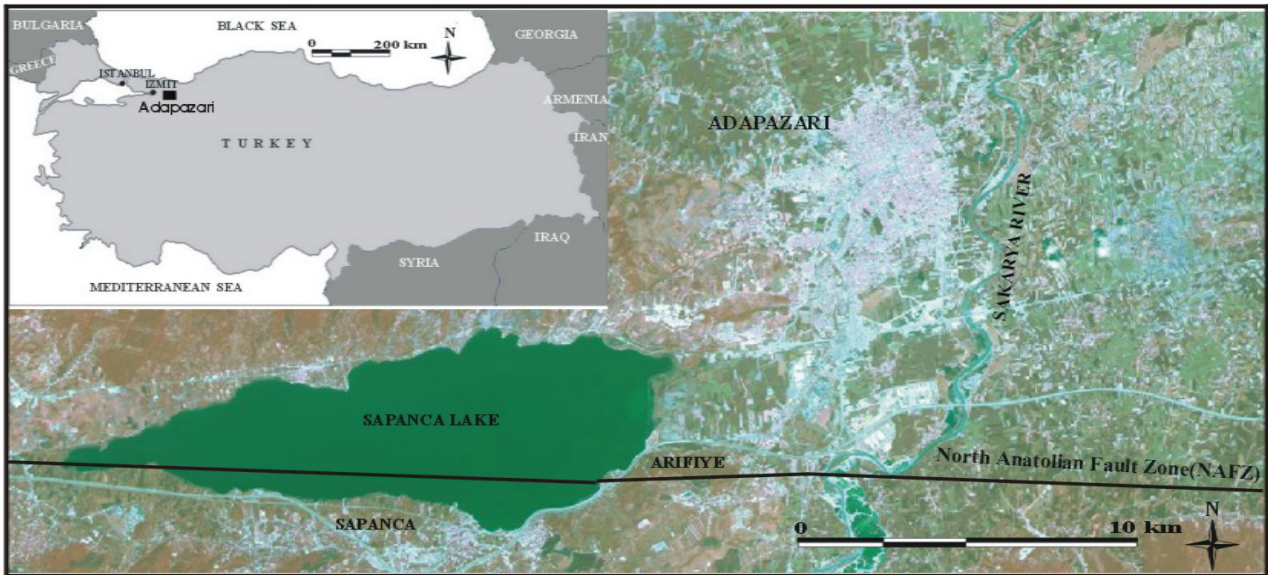
Figure 1. Study Area.

The earthquake started in the west, lasted for 12 seconds, paused for approximately 18 seconds and was followed by rupture in the east for 7 seconds (Barka, 1999). The maximum offset along the surface break was measured near Arifiye, east of Sapanca (between Arifiye and Adapazari) (figure 1). The fault displaced a road horizontally by about 5 m and a railway horizontally by about 2.7 m and also vertically by about 1 m.

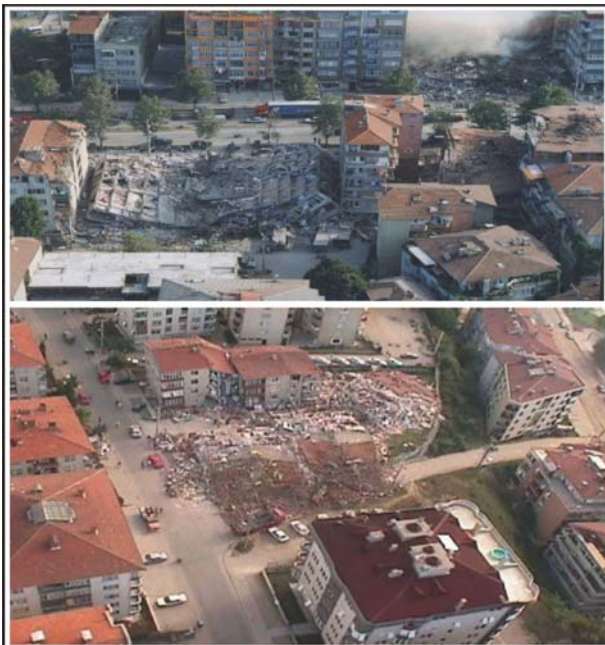
Adapazari suffered more damage as a result of building collapse than Izmit and Yalova (figure 2, table 1), as more of buildings were constructed on readily-liquefied sediments (Scawthorn, 1999; (Erken, 1999). During the earthquake, two buildings on pile foundations and 1-2 story buildings were largely unaffected but 3-6 story buildings, typically on shallow mat foundations, displayed a substantial amount of base settlement, rotation and

Figure 2. Ground photographs of 1999 earthquake damage.

collapse (Anderson et al., 2000; Bakir et al., 2000). Other causes of building damage were due to poor building control (<http://www.koeri.boun.edu.tr/deprenmuh/extent.htm>, 2003), for example:

1. Poor concrete quality;
2. Poor reinforcement;
3. Weak storey within a multi-storey building (e.g. open space at the first floor);
4. Structurally unsuitable alterations (e.g. added floor);
5. Long cantilevers with a heavy load;

6. Improper (unstable, corrupt, illegal) construction.

Illegal upward extensions that exceed the competence of the foundations (point 4 above) were a common feature of collapsed buildings. This poor building control was an indirect consequence of the recent rapid increase in population (8.8 %, 1990-1997 within the inner city boundary) (table 2). However, that pressure is no longer present, as between 1997 and 2000 (before and after the earthquake) the population decreased by 6.5 % within the inner city boundary.

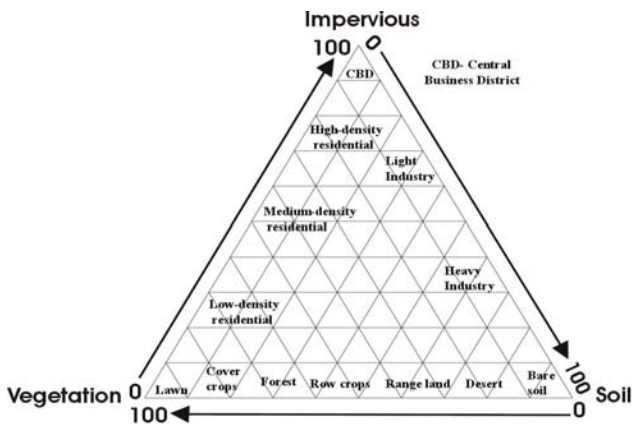
The Vegetation-Impervious-Soil (V-I-S) of Ridd (1995) (figure 3) describes the biophysical composition of an urban area as a function of three components: vegetation, impervious (surfaces such as buildings and roads) and soil (defined as surfaces that are neither vegetation or urban) (Madhavan et al., 2001; Phinn et al., 2002). As such it provides a means of assessing the trend and relative magnitude of land cover change in an urban area.

Figure 3. The Vegetation-Impervious-Soil model (Ridd, 1995).

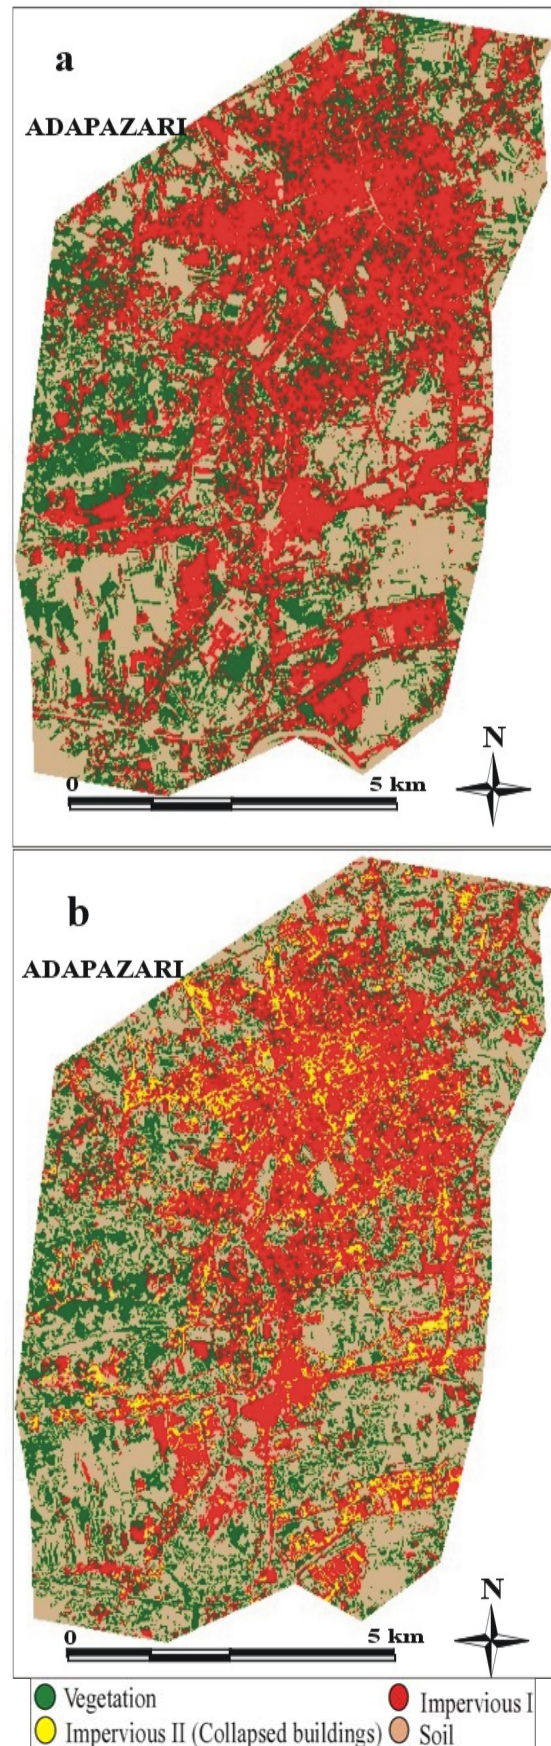
The inner city of Adapazari comprised 25.1 % vegetated, 33.7 % impervious and 41.2 % soil before the earthquake but 23.5 % vegetated, 32.7 % impervious (7.1 % were collapsed buildings) and 43.8 % soil after the earthquake (figures 4, 5). The area of collapsed buildings contained less shadow and more bright (concrete) surfaces than the other impervious areas and was distinguished readily by the classifier.

Figure 4. Four class images of Adapazari a) pre-earthquake and b) post-earthquake.

SPOT HRV XI images for 25 July 1999 and 4 October 1999 (spatial resolution of around 20 metres), were geometrically corrected using 26 ground control points derived from a 1:25,000 map of the area. Images were transformed to Universal Transverse Mercator (UTM) coordinates using a first order polynomial transformation and nearest neighbour resampling. The pre-earthquake and post-earthquake images were classified using the Iterative Self-Organizing DATA (ISODATA) classifier (without atmospheric correction). Twenty-five ISODATA spectral classes were combined to form 4 classes: (i) vegetation, (ii) impervious I (urban), (iii) impervious II (urban and collapsed buildings) and (iv) soil (neither vegetation or urban).

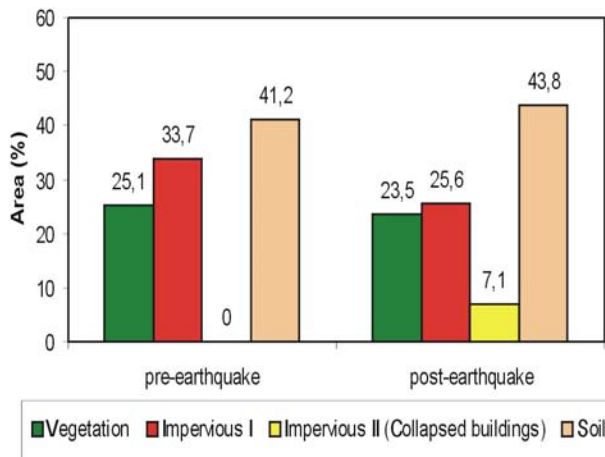
Figure 5. Land cover of Adapazari before and after the earthquake

The area of vegetation, impervious and soil remained essentially unchanged after the earthquake but the impervious class comprised two very different components: collapsed buildings and other impervious surfaces. To display this change using the V-I-S model the collapsed building class was added to the soil class, as it was no longer functionally urban (figure 6). The land cover change vector indicates in a standardised way the direction and the magnitude of land cover change that has occurred.

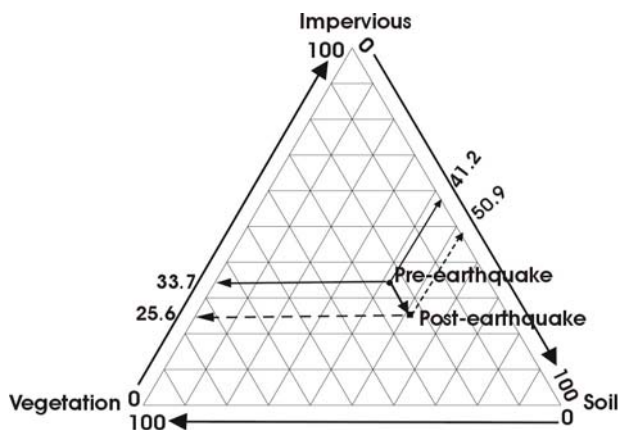
Figure 6. Trend of Vegetation-Impervious-Soil model from pre-earthquake to post-earthquake.

The Kocaeli (Izmit) earthquake caused catastrophic and dramatic changes in the land cover of Adapazari. In this study, using classification of pre-earthquake and post-earthquake SPOT HRV images, collapsed building areas were identified. The land cover change direction vector was determined by means of the V-I-S model using data from the classified images. It was concluded that SPOT HRV XI data and the V-I-S model could be used to provide a standardised means of representing earthquake-induced land cover change in an urban area
