## **DOCUMENTATION OF A VERNACULAR HOUSE WITH CLOSE-RANGE DIGITAL PHOTOGRAMMETRY**

İ. Akbaylar, M. Hamamcıoğlu-Turan

Izmir Institute of Technology, Faculty of Architecture, 35430 Urla Izmir, TURKEY -  
(ipekakbaylar, mineturan)@iyte.edu.tr

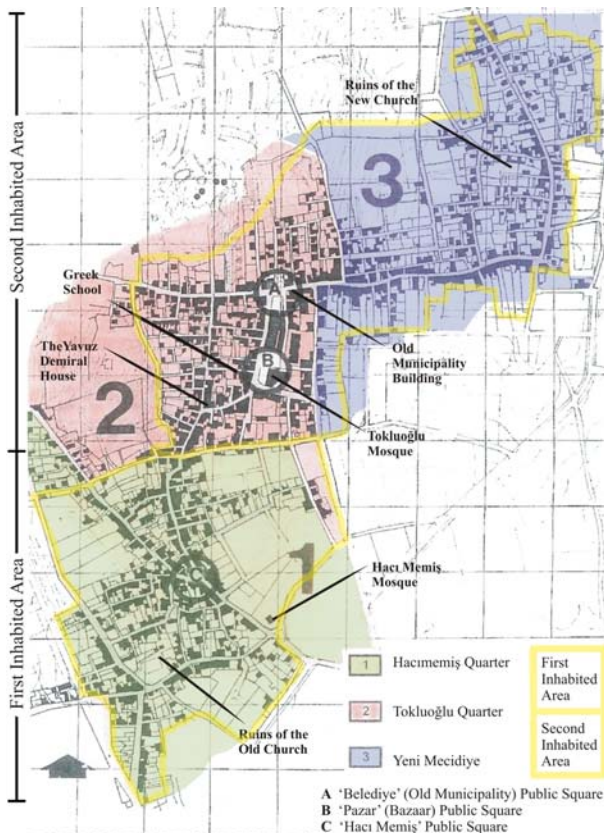
Figure 1. The development of the built areas (Alaçatı Municipality Archives, 2006)

The first inhabited area is at the southern part of the present settlement around Hacı Memiş Mosque, today known as Hacı Memiş Quarter. The secondary inhabited area is where the neighborhoods were located around the administrative (Old Municipality Building, built in 1873) and commercial center, today known as Tokluoğlu Quarter, in the second half of the 19<sup>th</sup> century. Following the Hacı Memiş Mosque, a number of monumental buildings were built as the town developed towards the northern direction. The residential buildings were built around the mosques and churches.

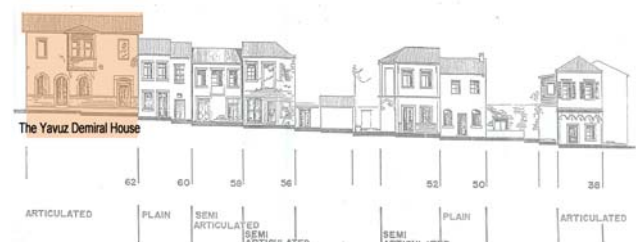
Figure 2. The Mektep Street and the Yavuz Demiral House (Şahin, 2006)

The house documented in this study is a late 19<sup>th</sup> century building located at the secondary inhabited area in Tokluoğlu Quarter. It is close to Pazar Public Square. It stands out with its corner location, having two façades oriented to Mektep Main Street and Mithat Paşa Main Street.

It is a two-storied vernacular house with a single prismatic mass, while there are fairly new houses constructed to both sides of it. It is a second degree listed building with the decision of İzmir Number 1 Conservation Council of Natural and Cultural Properties dated 1988. Among the other Alaçatı houses, it stands out with its corner position and without courtyard scheme. At present, the house is abandoned.

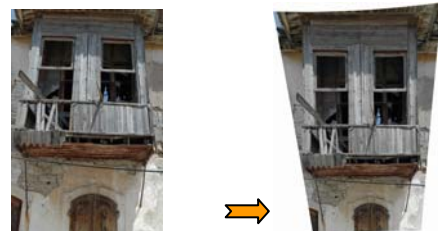
Figure 4. An original photograph and its orthoimage

Rectified images of the studied façade are brought together in Photoshop, and the orthoimage is created. For the scaling of the orthoimage, 3D measurements of a limited number of points (approximately 4 points for each photograph) are transferred from Pictran to CAD, and then to Photoshop.

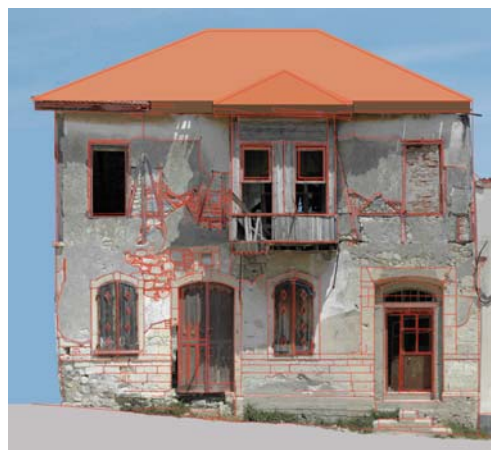
Figure 5. The orthoimage of the southern façade, overlapped with the 2D scaled drawing

The roof, which is an inclined surface, is not rectified since it is not shot parallel to its plane. Similarly, the eaves are not rectified because they are not viewed close to the center of any parallel photograph (Hanke et al., 2002). So, they all appear

white in color. Therefore, they are filled with realistic colors so that the façade can be perceived as a unity. The sky and the ground are also represented with realistic in-fills so that the gap effect is avoided. Nevertheless, the textures of the filled in parts and the rectified ones can be differentiated in close inspection.

At the end of the documentation phase, rectified images, an orthoimage, a scaled elevation drawing and thematic maps have been prepared. Taking into account a number of photographs (8 photographs) for a single façade (11x8 m.) gave way to the production of an accurate orthoimage, since the perspective of each architectural element could be controlled. The scaled elevation drawing was used to demonstrate the accuracy of the orthoimage. The thematic maps provide sufficient visual analyses for the guiding of conservation decisions.

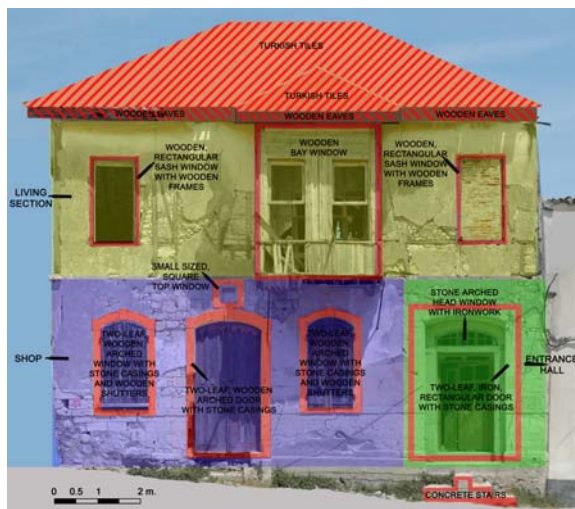
Figure 6. Analysis of Spaces and Architectural Elements

The legends of the thematic maps are determined as “Spaces and Architectural Elements” (Figure 6), “Structural Characteristics” (Figure 7), “Alterations” (Figure 8) and “Structural Failures and Material Deteriorations” (Figure 9). The analytic concepts, their graphic codes and detail photographs for each theme are gathered on separate tables. Then, the orthoimage is processed for each theme separately in the image evaluation software (Photoshop) and the thematic maps are produced.

| Shop (1) | | |
| Entrance hall (2) | | |
| Living section (3) | | |
| Turkish tiles (4) | | |
| Wooden eaves (4) | | |
| Two-leaf, wooden, arched doors with stone casings (5) | | |
| Two-leaf, iron, rectangular door having a stone arched head window decorated with ironwork (6) | | |
| Two-leaf, wooden, arched windows with stone casings and wooden shutters (6) | | |
| Wooden, rectangular sash windows with wooden frames (7) | | |
| Small sized, square top window (7) | | |
| Wooden bay window (7) | | |
| Concrete stairs (7) | | |

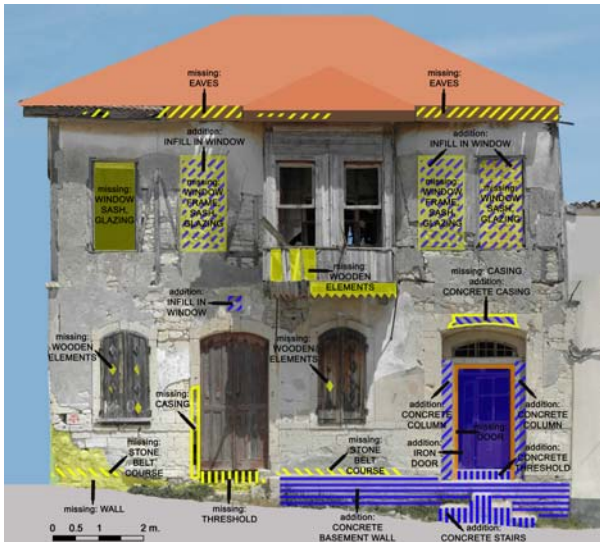
Figure 8. Analysis of Alterations

**VACANT SPACES**

- Shop
- Entrance hall
- Living section

**TOTALLY MISSING ELEMENTS**

**PARTIALLY MISSING ELEMENTS**

Eaves (1)

Window: Frame / Sash / Glazing (2)

Wooden elements on window shutters and bay window (3)

Stone belt course (4)

**ADDITIONAL ELEMENTS**

Concrete column (5)

Infill in window opening (6)

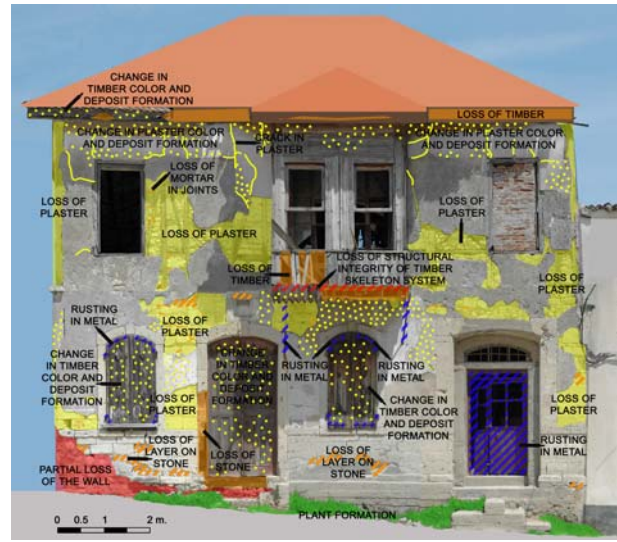
Figure 9. Analysis of Structural Failures and Material Deteriorations

**STRUCTURAL FAILURES**

Partial loss of the wall (1)

Loss of structural integrity of timber skeleton system (bay window) (2)

**MATERIAL DETERIORATIONS**

**Stone:**  
Loss of stone (3)

Loss of layer on stone (4)

**Mortar:**  
Loss of mortar in joints (5)

**Timber:**  
Loss of timber (6)

**Plaster:**  
Loss of plaster (5)

Crack in plaster (7)

**Metal:**  
Rusting in metal (8)

Plant formation (9)

For all recording levels, an initial photographic recording is a prerequisite. Depending on the operational needs of each house, the record should be detailed. The Yavuz Demiral House selected as the case study has conservation priority among the other listed houses within the settlement because of its highly damaged structural system due to abandonment. It requires both comprehensive structural interventions and installation of an appropriate use since it has been empty for fifty years. The documentation method developed for the case study can be easily adapted to other listed houses that have fewer problems at the discussed urban site, after appropriate calibration.
