## USE OF HISTORICAL IMAGES FOR THE DOCUMENTATION AND THE METRICAL STUDY OF CULTURAL HERITAGE BY MEANS OF DIGITAL PHOTOGRAMMETRIC TECHNIQUES

In particular are here described the studies conducted about the *Lararium* from the "House of the Skeleton" in Ercolano.

Three images of the 1927-1928 periods were chosen with the aim of creating a historical 3D model of the object, comparable with the actual model, derived by the photogrammetric survey conducted in the 2006 campaign.

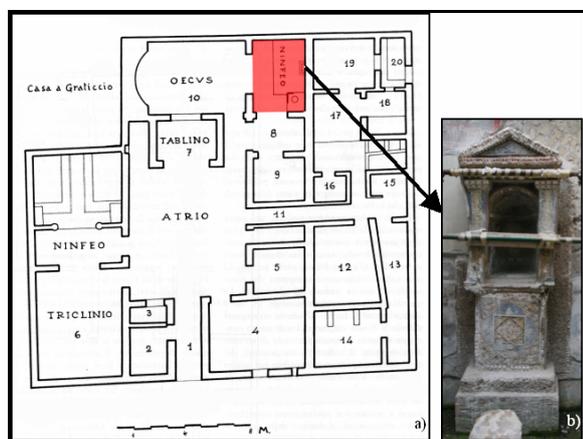
Figure 1. House “of the Skeleton” plan (a) and an image of *Lararium* (b).

In this paper the subject of interest is the *Lararium* of the house known as “of the Skeleton”, located in Ercolano (Figure 1)\*. The name of this house, partly excavated in the 19<sup>th</sup> century and completely unearthed in the period 1927 – 1929, derives from the skeleton found on the top floor on 1831 (Maiuri, 1958).

The house is characterized by a *Nymphaeum*, surveyed by photogrammetry during the 2006 campaign and, in a near small courtyard, a *Lararium*: a wall painting of a garden, surrounding a niche framed by an aedicula and decorated with mosaics and shells.

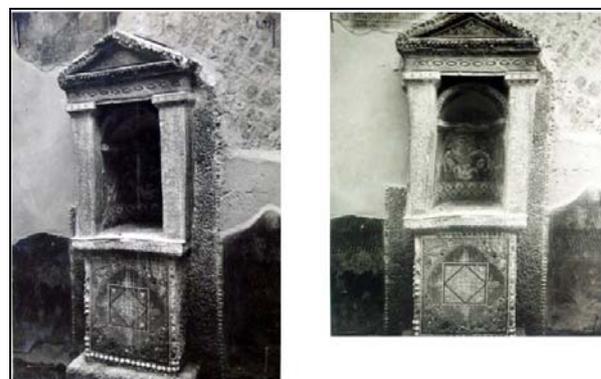
Figure 2. The two historical images.

The two calibrated images, realized maybe by means of different cameras, are here reported; any additional information is available.

Among the numerous available historical images of the *Lararium*, three were chosen for the processing; in particular these are dated about to the same period around the 1920, immediately after the excavations, and present a good convergence between the optical axes, important requirement for a good calibration. One image reproduces the object upper part, so it was used only to strengthen the solution, but was not calibrated, also because of its uselessness in object modeling.

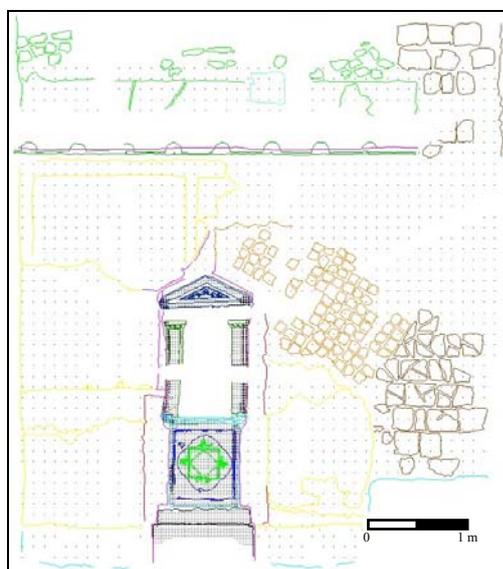
Figure 3. Vector restitution and DSM of the *Lararium* at the current state (2006 survey).

All these informations derive from the photogrammetric survey conducted in Ercolano during the 2006; in particular for the *Lararium* restitution, six images acquired by a calibrated wide-angle 8Mpixel digital camera Canon EOS 350D, were oriented and processed by the digital photogrammetric workstation Z-Map (Menci Software, Italy); the obtained final products, vector drawing (Figure 3), digital surface model (DSM) and orthophoto, present a medium scale of about 1:100.

From the current 3D model, seven points contemporary visible also on the historical images were measured in stereoscopic mode, with the hypothesis of considering these points unmodified during the elapsed time period (1920-2006).

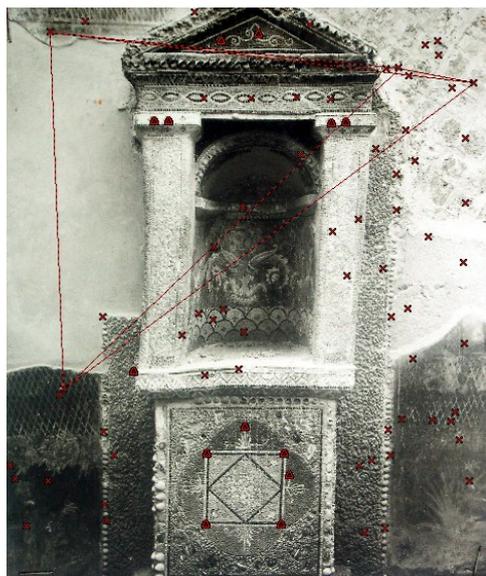
Figure 4. The geometric data used for historical images calibration (the triangles are the control points, the crosses are the tie points and the lines indicate the distance constraints).

All the geometric informations used for image calibration are shown in Figure 4.

Besides the control points, a large number of tie points (84) were collimated on the three historical images, in order to permit the convergence to a good solution; distance constraints on the wall were also considered.

Nevertheless the difficulties related to the discordance between the actual and the old situation, particularly for the wall pictures, the process succeeded.

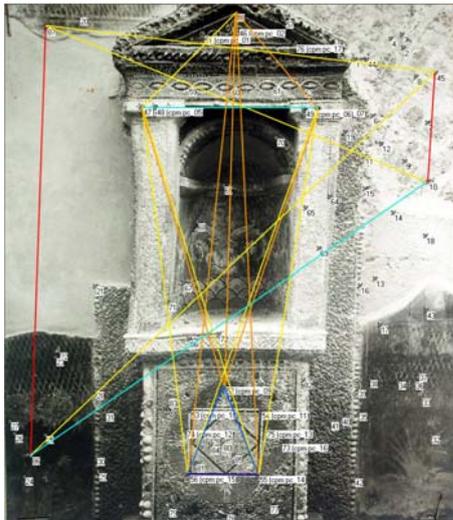
Figure 5. Graphical representation from the comparison of some differences in distances between current and old model; red and blue colors indicate problematic data in shrinkage and stretching respectively.

A statistical study about the differences between a large number of distances taken both on the actual and on the old model permitted a first accuracy evaluation (figure 5).

The comparison between the two models doesn't present particular discrepancies. It's possible to underline that the two historical images present, especially at the left and right sides, a general stretching, while in the basement central part there is a shrinkage from today to the past.

These deformations could be attributed to different causes:

- the object displacement during the periods among the shooting of the three images;
- the non-optimal geometrical distribution of the control points, due to difficulties in their choice;
- the historical digital images derive from a scanning process from book copy; the induced deformations have been not considered;
- lens radial distortion, here not solved because not considered by the calibration model adopted;
- the control points are measured in stereoscopic way on the current model, so their coordinates depend directly to the operator sensibility, and moreover they are not collected at the same time of the images.

The mean value of the differences between the most recent and the oldest model distances (figure 5) is in the order of 2 centimeters, but some large values are present due to the above mentioned causes.

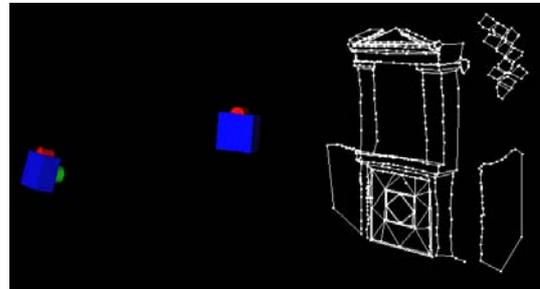
Figure 6. The points and lines measured for *Lararium* restitution and the cameras position.

After the calibration of the historical images, the restitution has needed the individuation of a conspicuous number of homologous points.

All the main discontinuities and some of the decorative elements have been plotted, without any interpretation or modeling by simplified geometric forms, but only measuring the visible points, with the aim of having a final product absolutely corresponding to the real state and suitable for an accurate analysis of the object.

The created model has afterwards been scaled by means of some distance deduced from the actual model.

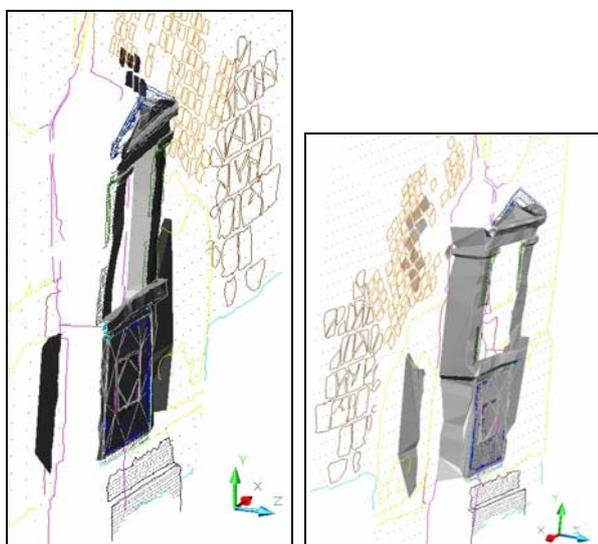
Figure 9. Superimposition between historical (gray color) and current (colored vector drawing) model (left view and right view).

As shown in figure 9, the historical model is well scaled, with only a little discrepancy on the right pilaster, resulting translated and lightly longer (2 centimeters on the entire length, 17 centimeters instead of 15).

Regarding the depth, a good check is possible on the basement and a little difference for the tympanum; besides for the pillars, it is evident a rotations, homogeneous in absolute value; the right holds out of 3 centimeters and the left comes within at the same value.

The two obtained models, historical and present, have been compared within a CAD platform, in order to make considerations about possible displacements or discrepancies. A similarity transformation with a scale factor of 1 has been applied to the historical model, in order to make coincident the *Lararium* basement, in particular the central decoration; this on the base of a qualitative analysis on the available images, that let think that the basement is the only part that doesn't suffer any re-movement during the restorations.

An analysis between the restituted portions on the wall was not possible, due to the not good accuracy of the points collimated in this area, presenting high residuals.

Considering that the orientation phase has pointed out errors in the order of some centimeters, it is difficult the attribution of the found discrepancies to a real object displacement, even if the qualitative analysis of the images seems validate the idea that the *Lararium* upper part has been taken off for restoration and then re-placed, while the basement presents evident decay, especially in the decorative apparatus.

From a metric point of view, comparing historical and actual model, it can be observed a correspondence of the bottom of *Lararium* and a rigid rotation of the pillars in the top that evidence a probable non accurate re-collocation after the restoration procedure.
