TOPOGRAPHIC AND PHOTOGRAMMETRIC RECORDING OF THE ACROPOLIS OF ATHENS

D. Moullou ^{a,*}, D. Mavromati ^b

^a. Greek Ministry of Culture, Acropolis Restoration Service, 10 Polygnoutou str. 10555 Athens, Greece (thmoullou@hotmail.com)

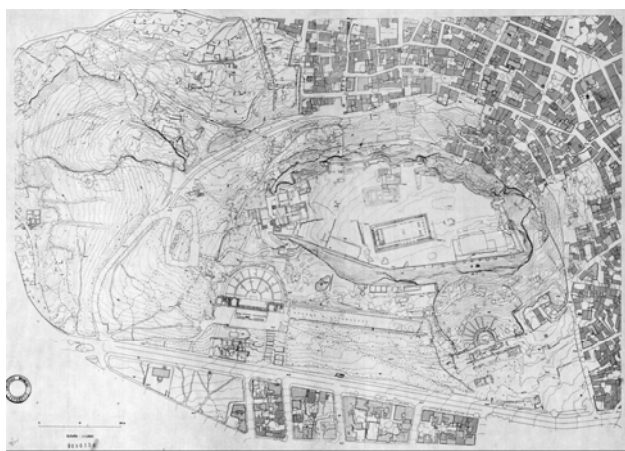
Figure 2. The first photogrammetric recording of the Acropolis. By the Insitut Géographique National in Paris-UNESCO

In 1971 and 1974 the first photogrammetric recording of the Acropolis and the immediate vicinity was carried out by the Insitut Géographique National in Paris-UNESCO at a scale of 1:1000 (Figure 2).

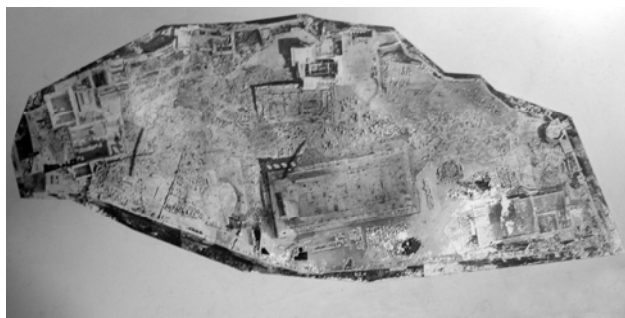
Figure 3. Acropolis. Photomosaic of the plan view. By the Photogrammetry Laboratory of the NTUA

In 1976 a topographical survey was carried out by the National Technical University of Athens (NTUA), a network of fixed points was established and the ground plan was drawn up at a scale of 1:100 and of 1:200. Also a photomosaic of the Acropolis area at a scale of 1:200 was created (Figure 3). The photographs used, were acquired from a balloon by the staff of the Photogrammetry Laboratory of the NTUA.

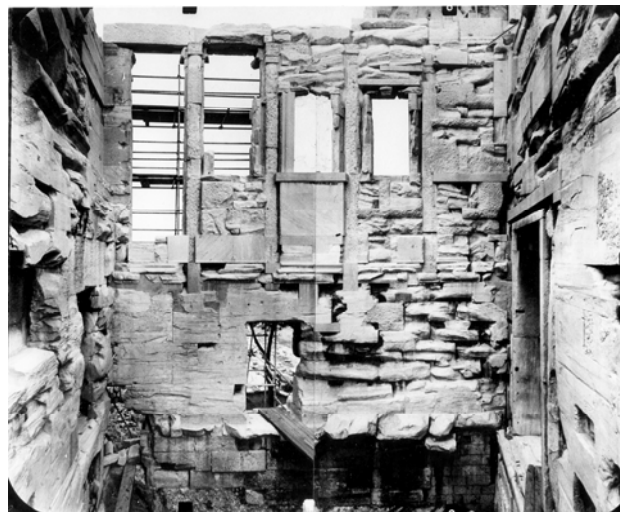
Figure 4. Rectified photomosaic of the Erechtheion interior west wall. By the Photogrammetry Laboratory of the NTUA

In 1977 the work of recording the Erechtheion began. A three-dimensional grid with units of one meter was used as the fixed system of coordinates, based on fixed trigonometric points on the Acropolis rock, thus it was made possible to check spots or areas where deformations were developing (geometric changes,

mechanical changes, deterioration of the surface). Photogrammetric line drawings were produced for the interior surfaces of the Erechtheion south and west walls where the type and extent of damage could not be gauged by means of classical methods (Casanaki et al, 1985). These line drawings also depicted contour lines of one centimeter. The images had been acquired from a distance of 6m and covered an area of 12X20m. Additionally, rectified photomosaics had been produced for both sides, inner and outer, of the south and the west wall. (Erechtheion Study, 1977) (Figure 4).

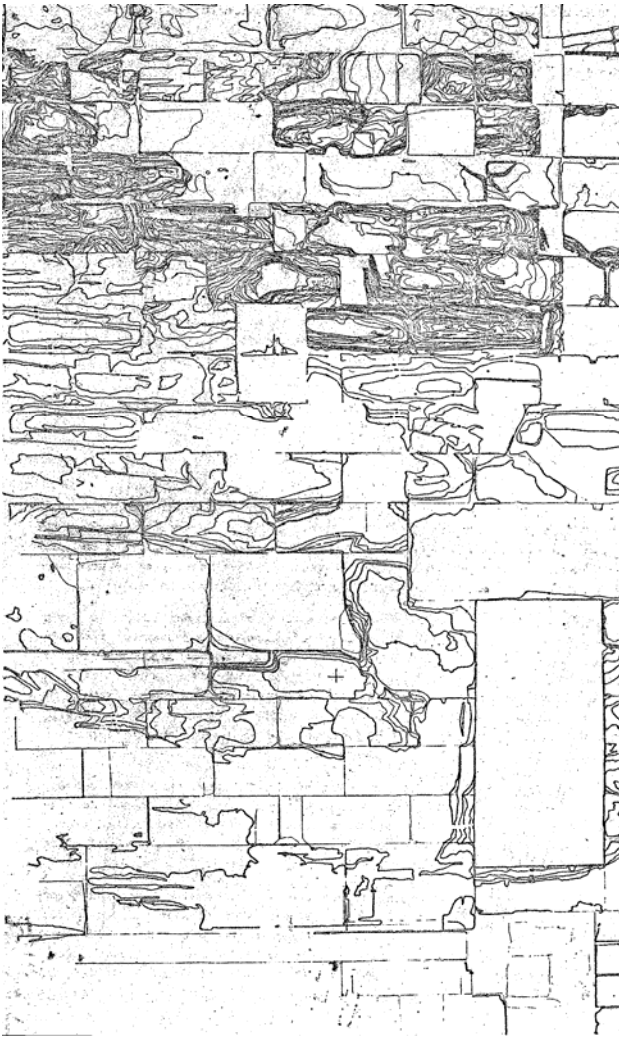
Figure 5. Erechtheion. South Wall. Photogrammetric line drawing of the westermont section of the interior. By the Photogrammetry Laboratory of the NTUA

At the beginning of the project, the application of photogrammetry was considered as the appropriate method of recording the monuments' areas, especially under high pressure of time. But the results, despite the initial enthusiasm, were inadequate. The drawings yielded only the general morphology of the surface together with the damage from fractures. Furthermore, they were not accompanied by qualitative analysis. Thus the final users were not able to understand the features represented. In many cases the interpretation of the elements recorded gave false representation and the final product had to be corrected and supplemented by observations made on the spot in order to supply specific information such as determining contours, the position of joints, preserved original surfaces and restorations, signs of later operations (Figures 5, 6).

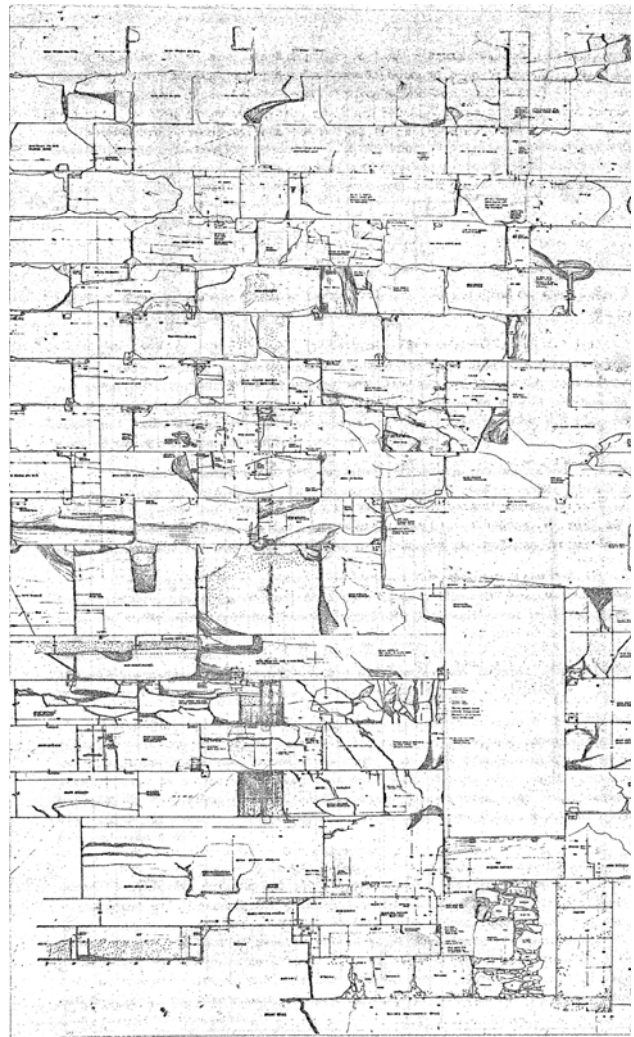
Figure 6. Erechtheion. South Wall. Line drawing of the of the westermont section of the interior on the basis of the photogrammetric survey supplemented by observations made on the spot. By E. Moutopoulos.

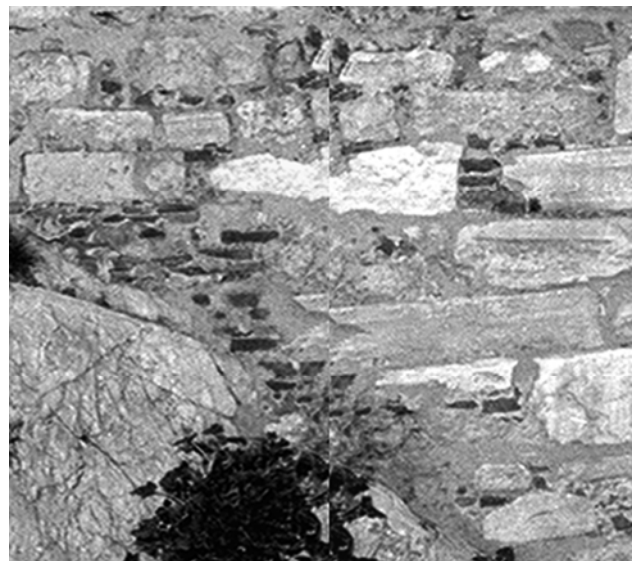
Figure. 7. South Circuit Wall. Detail of the rectified photomosaic. By E. Kapokakis

This was also an attempt crowned not with the expected success, since the south circuit wall was originally considered to be nearly flat and the method applied was planar rectification instead of orthorectification. This led to geometric errors and consequently to significant problems along the seam lines such as displacements and double visions (Figure 7).

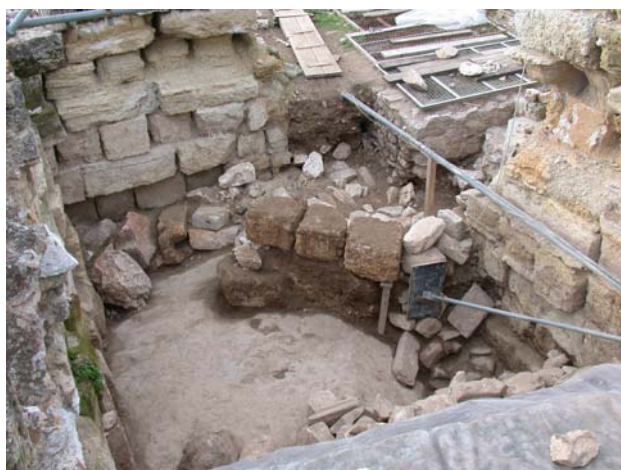
Figure 8. Arrephorion. Inside view from the west.

In 2006 the full geometric documentation of the poros remains of Arrephorion was carried out, the latter being a square building with a side of 12 m of length, dating from the 5th century BC. The detailed documentation was necessary because the monument had to be reburied for protection, since there was no other way of saving its remains. The first step, completed by now, was the production of a full 3D surface model in order to have all the necessary details and profiles. The site has been recorded using a CYRAX 2500 scanner at a resolution of about 5mm to 1cm (by L. Grammatikopoulos, E. Kalisperakis, and V. Pagounis). Due to the object's morphology it was impossible to avoid surface occlusions (Figures 8, 9). In some cases it was impossible even to place the scanner conveniently. For the future, the filling of the voids of the scanning process and the production of orthomosaics for the plan view and each façade of the monument are scheduled.

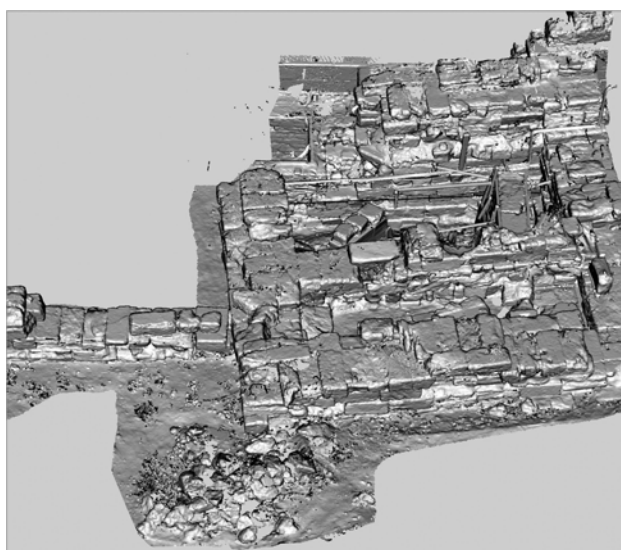
Figure 9. Arrephorion. Shaded surface model. By L. L. Grammatikopoulos, E. Kalisperakis, and V. Pagounis

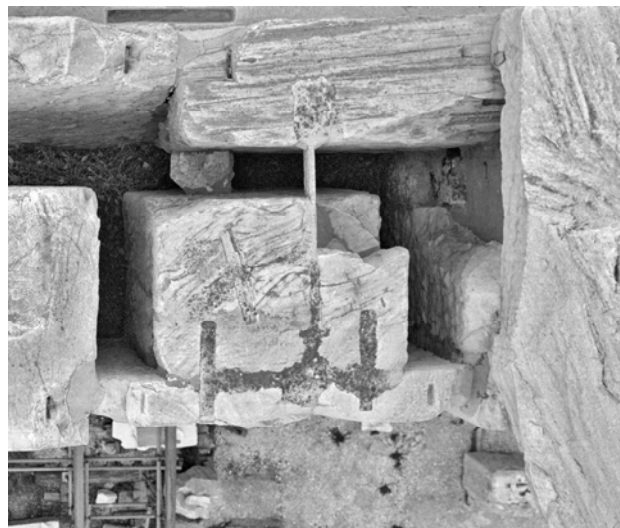
Figure 10. Parthenon. Part of the north side superstructure. Original photo of the plan view. By the D.T.Ph.L.R. (S. Gesafidis)

The same year the D.T.Ph.L.R. created the orthomosaic of the plan view of the west part of the superstructure of Parthenon's north side at a scale of 1:10 (by D. Mavromati). The original images were 20 at a scale of 1:80. The latter product, having achieved the expected accuracy (2-3 mm) and the needed visual quality, will be used for further restoration planning of the area (Figures 10, 11).

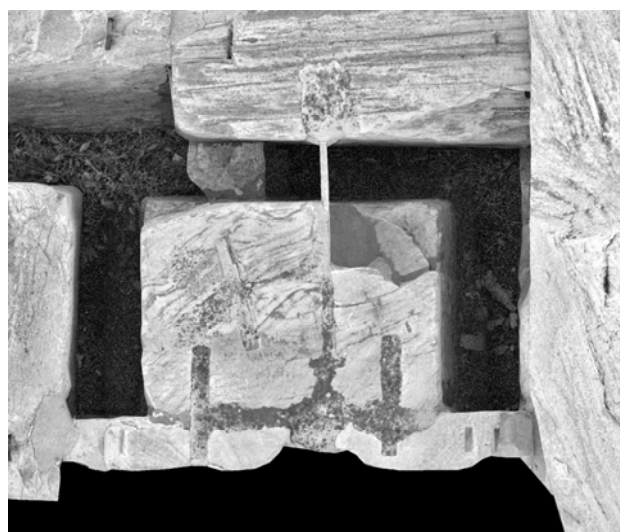
Figure 11. Parthenon. Part of the north side superstructure. Orthophotomosaic of the plan view. By the D.T.Ph.L.R. (D. Mavromati)

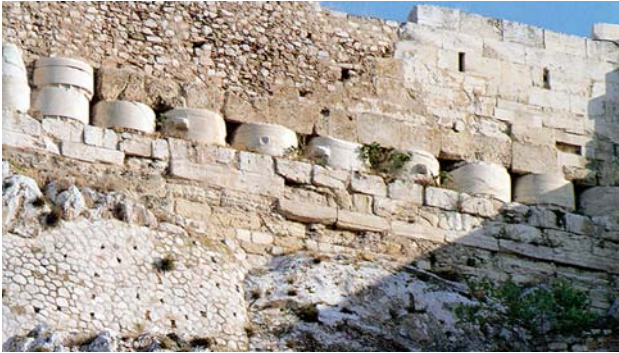
Figure 12. Acropolis north circuit wall. Detail.

One of the primary aims of the Acropolis Committee, since its inception, was the recording and documenting the Acropolis circuit walls. The walls are very valuable because of the great quantity of material from various Acropolis structures built into them; a fact that makes the lack both of adequate measurements and of plans all the more noticeable (Figure 12).

4. the object size and morphology,
5. the abrupt changes in relief, compared to the small recording distance
6. the obstructions caused by vegetation, scaffoldings, cranes, and scattered architectural members, pose severe problems to orthoimaging and laser-scanning (Figures 13, 14, 15, 16. See also Figure 12)

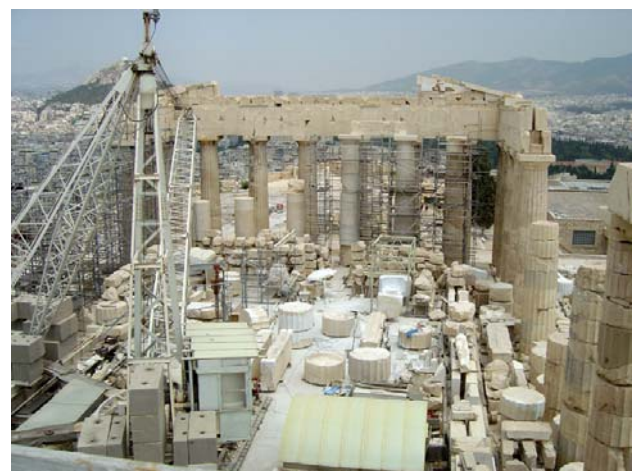
Figure 13. Parthenon. Inside view from the west. By S. Mavrommatis

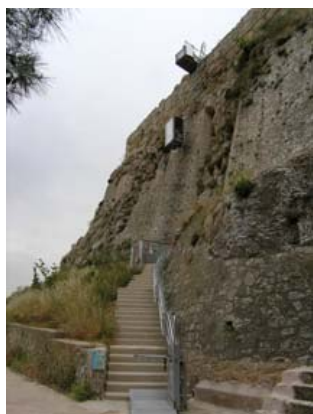
Figure 14. North circuit wall. By P. Konstantopoulos

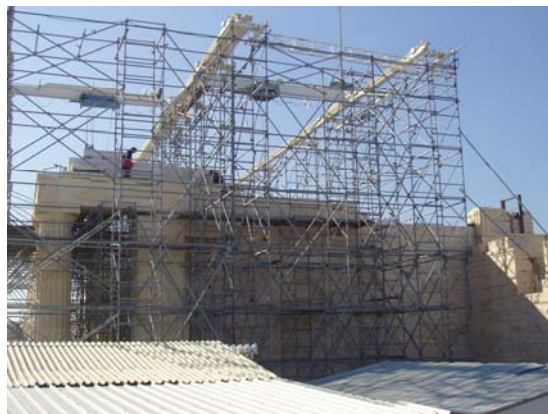
Figure 15. Propylaia and its worksite constructions. View from the north. By M. Ioannidou

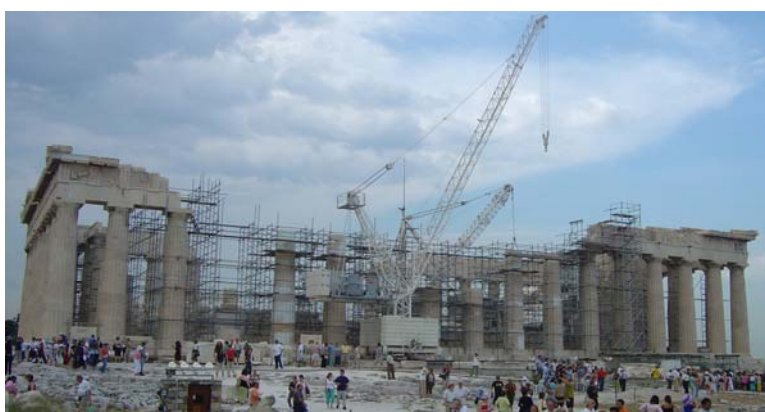
Figure 16. Parthenon. North colonnade. By L. Lamprinou
