EVALUATION OF STRUCTURAL DAMAGES FROM 3D LASER SCANS

The church of Santiago in Villamorón (Burgos, Spain) displays some structural problems related with the lack of necessary building adaptations for transition from Romanesque to the early Gothic style. Indeed, the central nave is too high for the lateral ones, some almost evident misalignments in columns along the head produce strong alterations in the structure with visible crashes in the tower. The performed work is focused towards the identification of deviations in regard to verticals for walls and misalignments for columns, their quantification and the analysis of crashes and structural defaults from the global 3d model.

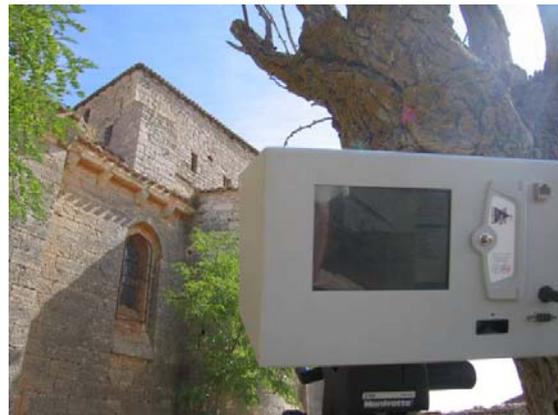
Fig.1: Laser scanning of Villamorón (Burgos, Spain)

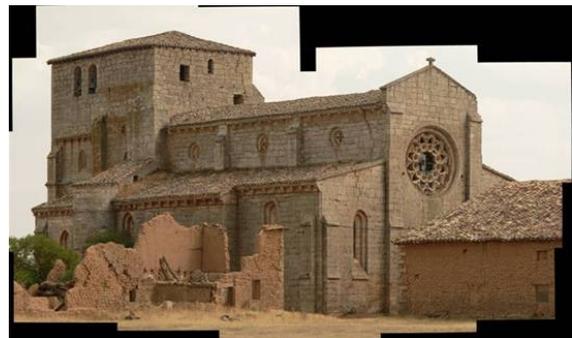
Fig.2: Panoramic View of the church of Villamorón (Burgos)

The western facade displays an important lack of verticality, which is in the issue of two large crashes going from the roof to the ground. In the head of temple, there appear serious crashes along windows which modify the continuity and the survival of structure. Inside, the vaults are apparently full of cracks and a meaningful number of stones located along arches are down-to-earth.

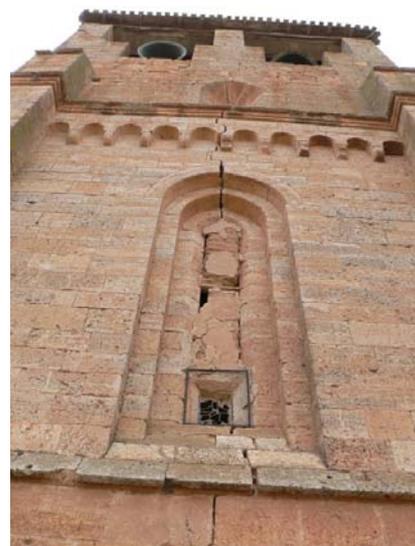
Fig3: Vertical crashes

Crashes are especially meaningful in the second part of the central nave, where lateral walls are literally detached from the roof. A large number of crashes appear also in the beginnings of arch nerves with walls.

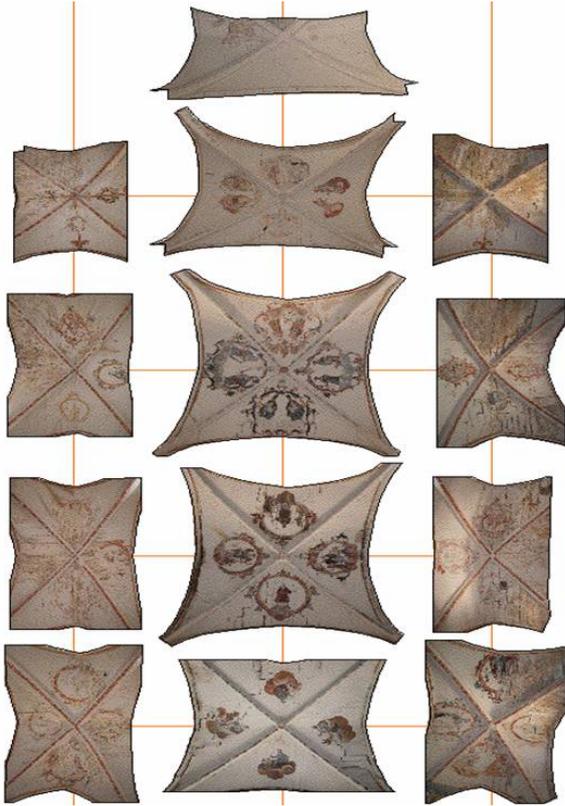
Fig.4: Visualization of the current state of the roof

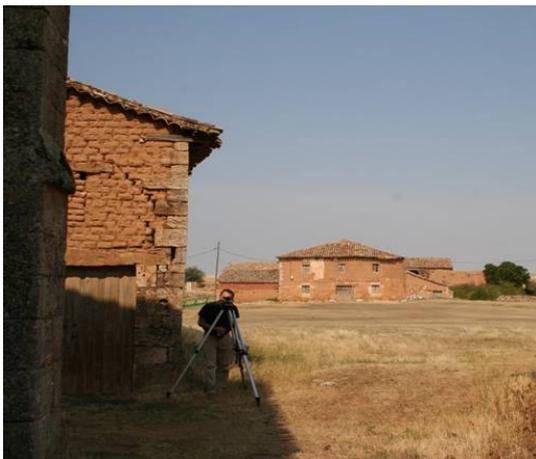
For granting a common general reference for the model, the clouds of points are referred to a superabundant mesh of reference points corresponding to the exterior and interior of the church. Levels have been verified with an automatic equi-heightmeter Pentax AL320.

Fig.5: Data capture in the outdoor for topographic network

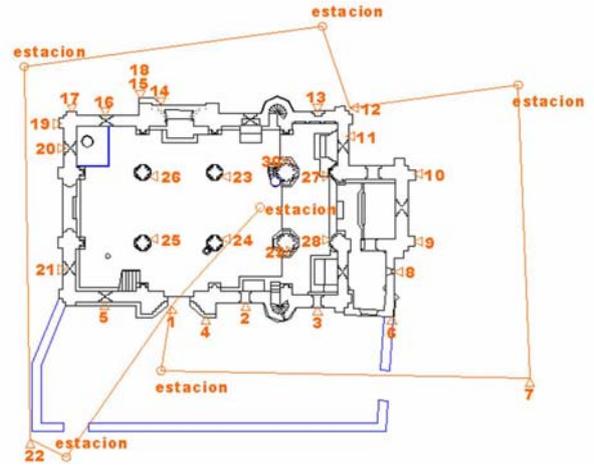
Fig.6: General representation of the topographic network

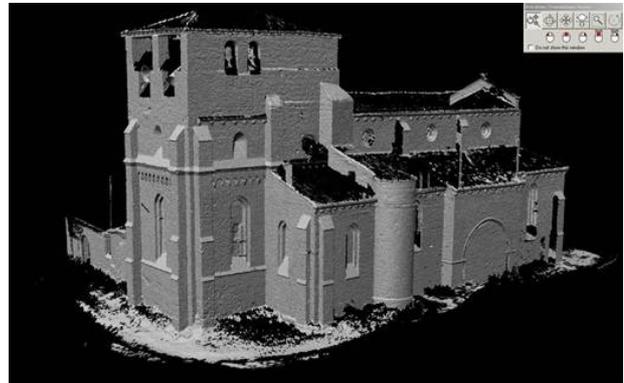
A dedicated software (Polyworks, Innovmetric) is used for registering, and match different scans in a global 3D model.

Fig.7: A general 3D representation of the outdoor

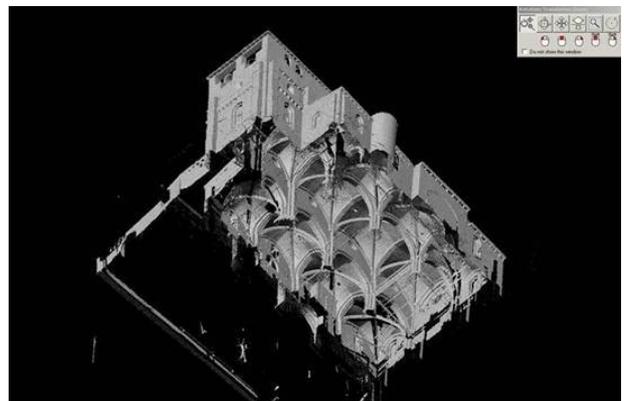
A more involved covering of scans of temple's interior provides a global model. By selecting a small number of common points, the interior 3D model is matched with the exterior model. In this way, a global model (including indoor and outdoor) is obtained:

Fig.8: An axonometric view of the global model

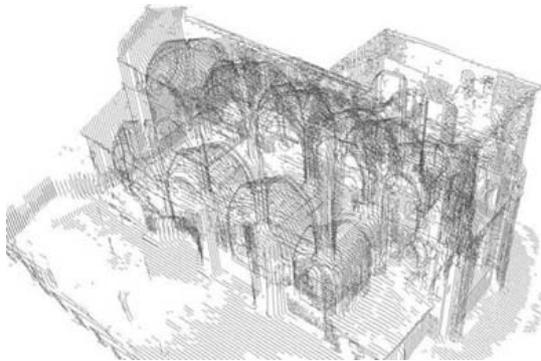
Fig 9: A map of sections along two families of equidistant vertical planes.

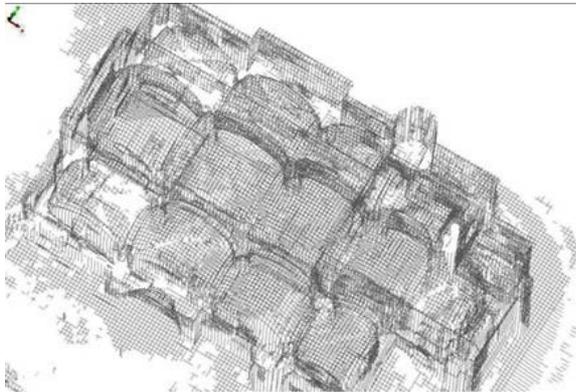
Fig 10: A map of sections along horizontal and vertical planes.

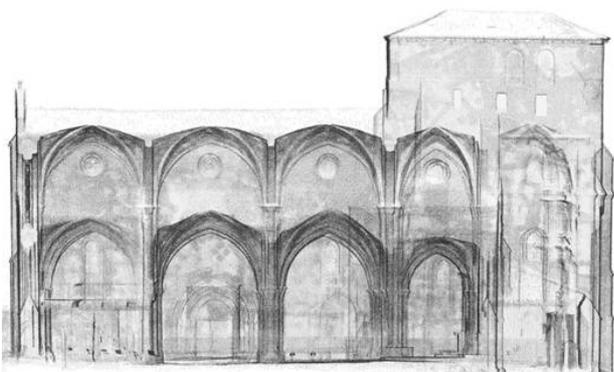
In particular, a collection of profiles is generated, and a parametrization following a rectangular mesh superimposed to the global 3d model. A visualization of the maps of superimposed longitudinal and transversal profiles corresponding to sections each 24 cm is showed in the next figures:

Fig 11: A map of longitudinal sections

The reprojection of sections on a common vertical plane of reference along the main longitudinal provides an information about meaningful deviations, mainly towards the West façade.

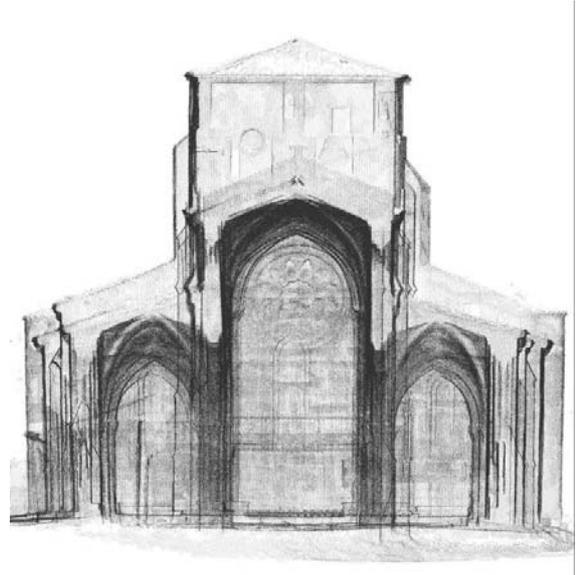
Fig 12: A map of transversal sections

In a similar way, the superposition of transversal sections on a common vertical plane allows to identify meaningful deviations of vertical walls towards the East façade.

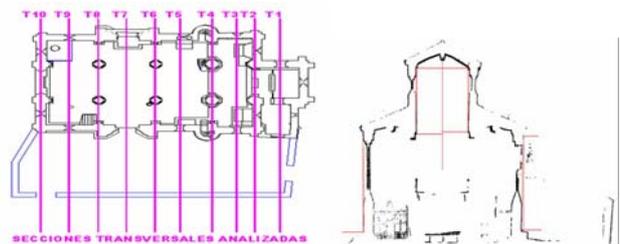
From the performed sampling of transversal sections, it is possible to verify that the main lack of verticality corresponds to the exterior south façade. It is comprised between 1.3 and 1.8 degrees.

Fig 13: A sampling of transversal sections for structural analysis

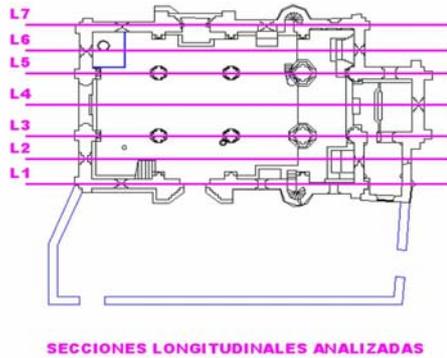
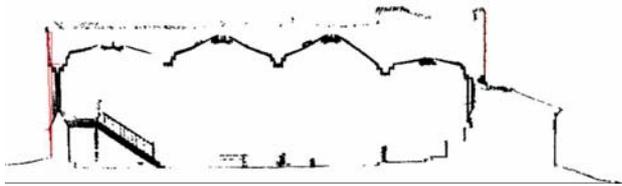
From the performed sampling of longitudinal sections, it is possible to verify that the main lack of verticality corresponds

to the exterior west facade. It is comprised between 0.5 and 2.8 degrees.

Figure 14. The map of analyzed longitudinal sections

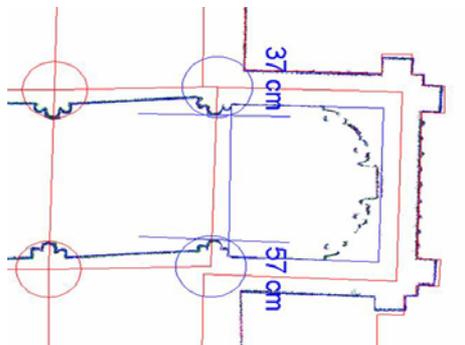
The axis of the south wall of the church head does present a discontinuity with respect to the axis of columns of the principal nave with a difference of 25 cm. The error is performed in the ampliation phase of the building construction from Romanesque to early Gothic style. In particular, supports are localized in different places and the axis of of the network of pillars and half-pillars are not located following an exactly orthogonal disposition, but with angles around 88°.

Furthermore, the angle defined by a) the longitudinal axis defined by pillars separating the major of the south naves, and b) the axis defined by half-pillars in the south wall, presents a displacement in intermediate zones which is comprised between 8 and 10 cm. In symmetric axis with respect to the longitudinal axis of the central nave the difference is comprised between 2 and 3 cm.

Fig.15: An identification of misalignments in plant

By taking an ideal slice below any column chapitel, it is visible the variation generated in the alignment of axis, and the displacements of walls with respect to alignments of axis. This

effect is remarkable in the head of temple, where evident discontinuities in alignments induces to think of two different phases in the construction.

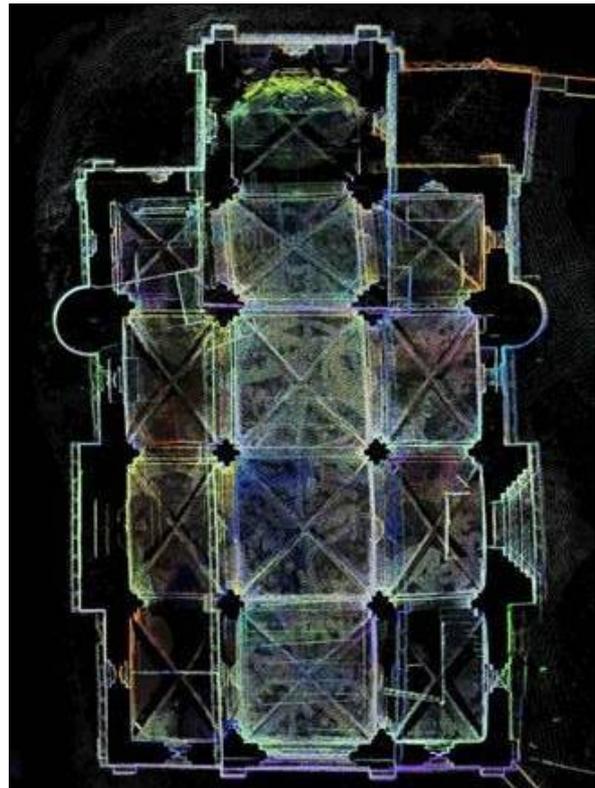
The worse lack of verticality involves to some zones of the south wall with 38 cm in 316 cm, giving a dangerous inclination of 6.72 degrees, where some vestiges of a Roman cisternae have been identified.

Fig.16: A general representation of the roof with appreciate structural defaults.

The structure is far from being stabilized. Indeed, recent corner stones falls and the crashing of the cementation (possibly due to water filtration, near to the Roman cisternae) induce to think a partial or total collapse of the building in the next future if there is no intervention. Luckily, after this work some consolidation interventions are in course of execution, currently.
