# RESEARCH ON THE REASONS FOR ANGULI LAKE'S SHRINKAGE AND DRYING UP USING SATELLITE REMOTE SENSING

Qiao Yanxiao\*, Hao Yuesheng, Lv Fengjun

Remote Sensing Centre of Hebei Province, Shijiazhuang, Hebei, China

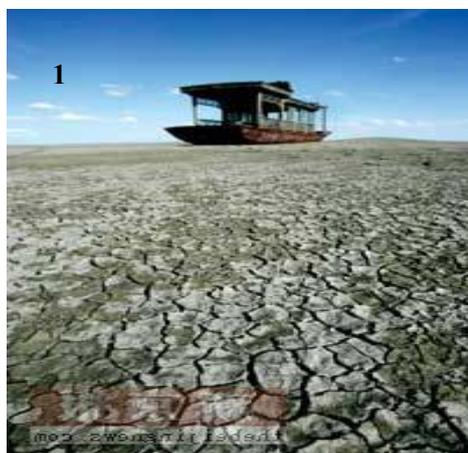
Fig.1 The Dried-up Anguli Lake(1 on-the-Spot Picture Took in Set, 2004  
2 Satellite Remote Sensing Image Acquired on Aug. 31, 2006)

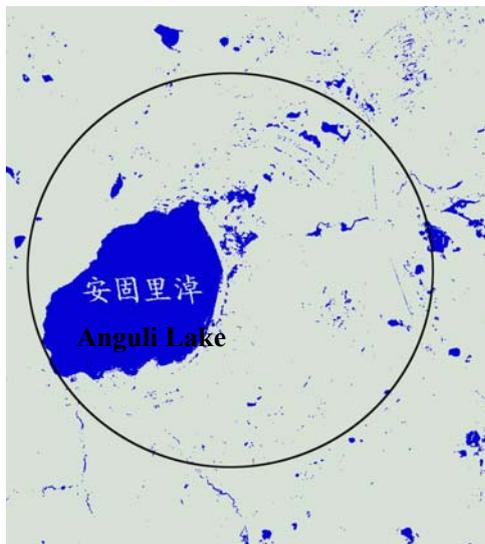
Fig.3 Water Information Extraction Around Anguli Lake

the original shrinking to the final drying up, the lake went through 8 cycles from one shrinkage to one steady state at least. The northeast is a favorable direction for the lake shrinkage; the second east and southeast, and the minor west and northwest. Anguli Lake experienced a long-term course from the initial shrinking to the final drying up in the past. So, all the reasons above mentioned for Anguli Lake's drying up are not correct. Besides, we can generally know the relative rate of Anguli Lake shrinkage from the satellite remote sensing image according to the density of the arc lines. Larger density area indicates that the rate is slower and lower density area means the rate is faster.
