EXPERIENCES ABOUT FUSIONING 3D DIGITALIZATION TECHNIQUES FOR CULTURAL HERITAGE DOCUMENTATION IN CÁCERES WALL (SPAIN)

In this paper we present an experience about combining 3D digitalization techniques for cultural heritage documentation. Cáceres Wall is a big and complex construction from the XII century. Cáceres was declared a World Heritage City by UNESCO in 1986 because of the city's blend of Roman, Islamic, Northern Gothic and Italian Renaissance styles and the wall contains rich elements of all those époques. The wall captured is close to 900 meters long and contains seven towers and other complex elements. An urgent conservation and restoration program was promoted in order to prevent further damage in the wall. A complete 3D graphical record was needed to support this intervention. The main objective was to keep control of the main structures and to detect deformations of the wall and the towers. This was the reason why laser scanner, photogrammetry and direct measurement methods were used. On the same side, the 3D documentation of the Cáceres wall was recorded also for virtual tourism. Thus, this 3D model was made by photo texturing. The fusion of laser scanner and photogr

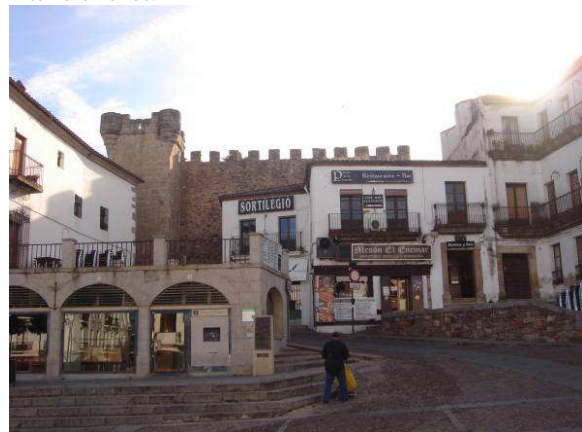
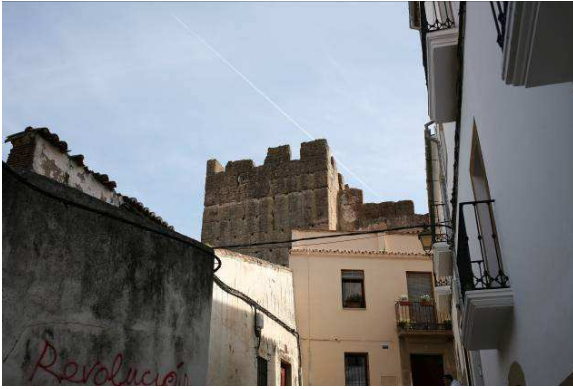
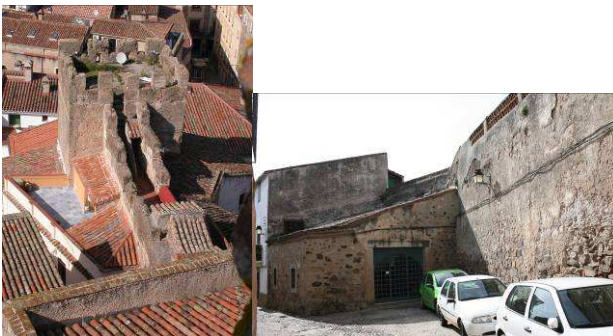
Figure 1. Cáceres wall and towers.

The wall captured is close to 900 meters long and it was documented within and without the wall. The morphology of the wall is very complex, overall without the wall because this area has lots of buildings leaning against the wall, making it impossible to see the wall in some segments. Within the wall, the battlements are really narrow in some areas, no more than 2 meters long and in the same sites, the wall is close to 5 meters high, thus the captured geometry of those areas is also very complex.

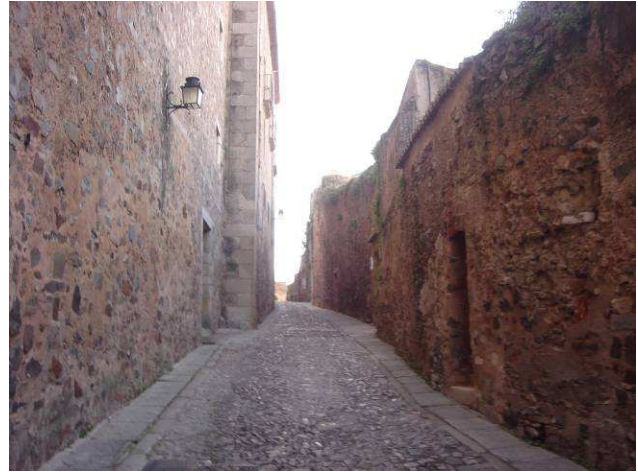
Figure 2. Narrow battlement of Cáceres wall.

Other fundamental aspect is the traffic: there are cars parked close to the wall hindering the full visibility of the wall and there are also some cars moving through the battlements making impossible the work in some narrow areas overall. But there is a capture obstacle also with it, because when there is traffic, the laser scanner captures it and do not capture the wall, having occult areas which can be important.

Respect of the natural colour of the wall in the documentation was one of the most important tasks in this work. For this reason, the sun-shadows projection in the wall was one of the most difficult problems to resolve. As was said before, the battlements were quite narrow and there were shadows in some parts of the wall during almost all the day. Just in one hour in the beginning and in the finish of the day the sun was occult and the wall colour was homogeneous. As it will be explained in the next point, we used laser scanner with the integrated camera, but it was not enough to obtain optimal colour results. That is one reason why we took several pictures with a hand held semi-metric camera in the hours when the sun was occult. Otherwise, the ortophotos would have parts with sun and shadows, being a problem to interpret the materials and its pathologies.

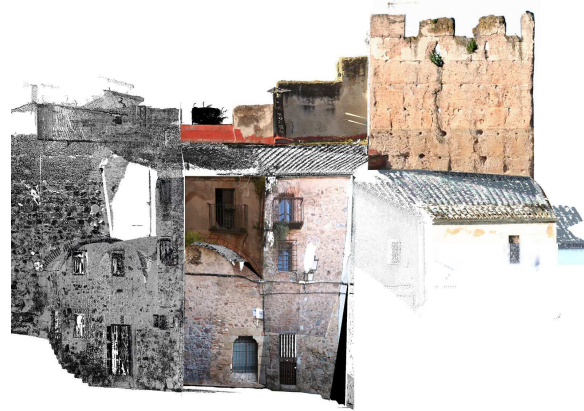
Figure 3. Ortophoto from LS and Photogrammetry.

We used digital photogrammetry to complete the range data. On one hand, we took photographs with a calibrated digital camera Canon EOS 400D to capture the colour of the wall in good light conditions. Then we referenced those pictures using as control points, common points between the points cloud of the laser scanner and the photogrammetry pictures. In this way we created a 3D model by images.

tried to reference them with range data, close to those places. We took some pictures of those zones from different perspectives to obtain enough angles for stereo matching process. Like in the anterior case, we create a geo-referenced 3D model using also images.

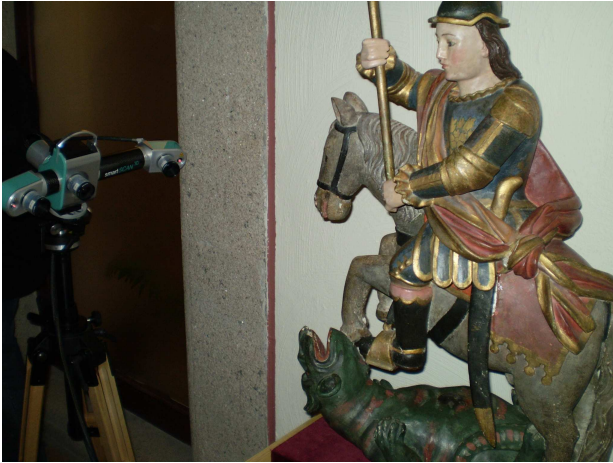
About the homemade laser scanner that we construct in the Research laboratory of *GAVLE: Documentación Gráfica del Patrimonio Company*, it has 0.5 millimetres of accuracy although it depends of the angle and the resolution is highly variable. The laser scanner consist of a line beam photodiode with 532 nm, 5mW and adjustable focus, a camera with Carl Zeiss optics, and a High detail video resolution of 960 x 720 pixels. The system contains also two tripods, one for the laser and another one for the camera, and a targets table to calibrate it before scanning. The calibration targets consist of two tables positioning with an angle of 90°. The camera captures this image and the user has to introduce the scale. This laser scanner has also photorealistic characteristics. The scanning process consists of positioning the object between the calibrated table and the camera and laser sensor. The camera cannot be moved; only the laser will be moved scanning the object slowly and without light. While the camera is recording all the process and computing the angle of the laser beam respect the calibration table, obtaining a points cloud with X, Y, Z. Then, with optimal light conditions, a camera will produce a snapshot to photo-projection on the 3D model.

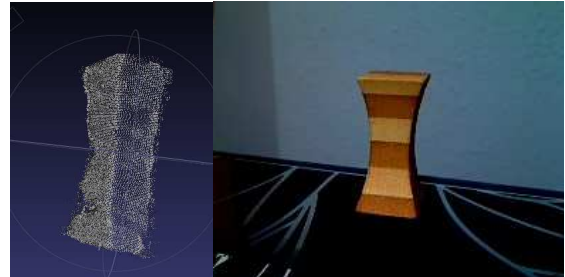
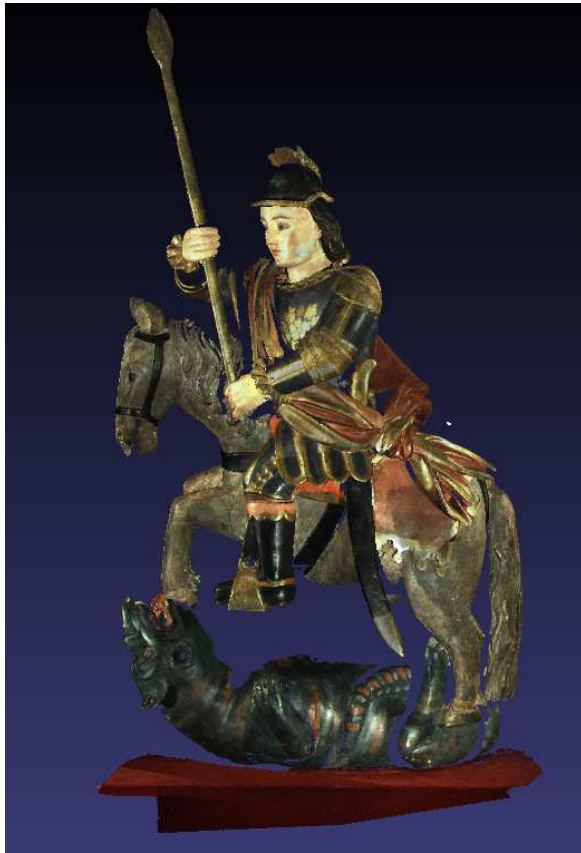
Figure 4. San Jorge Sculpture documented with SmartSCAN3d.

First we scanned some pieces related with the history of the wall and the old city with the smartSCAN3d of Breuckmann. This laser scanner has 700 mm of range and 2 µm of minimal resolution. The middle accuracy is 30 µm. Overall, this laser scanner has photorealistic characteristic. This laser has 100 W halogen of light source and two digital colour CCD cameras of 1384 x 1036 pixels each one. This laser scanner works recognizing light projection on the object, once the laser was calibrated using a targets table.

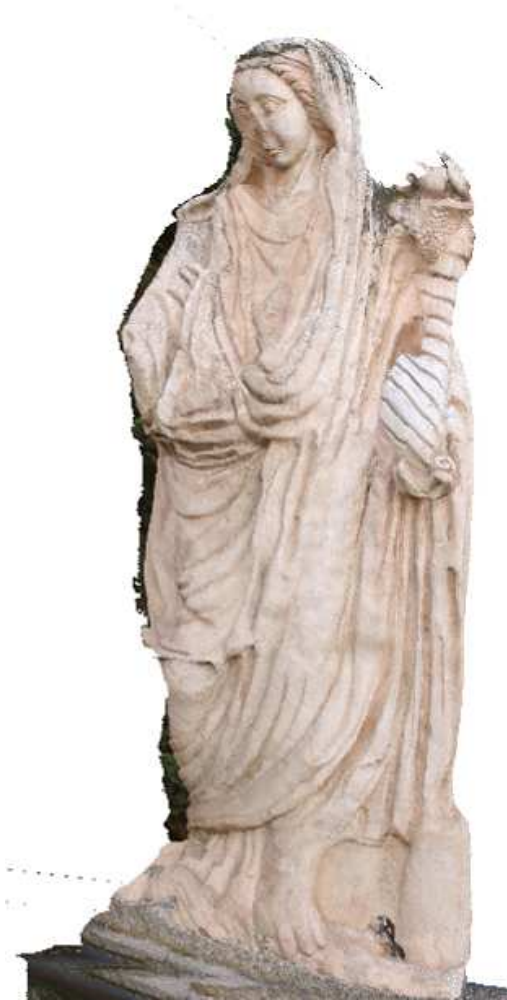
Figure 6. Ceres goodness 3d LS model.

used to scan a big sculpture of the Ceres' Goddess situated close to the exterior part of the wall.

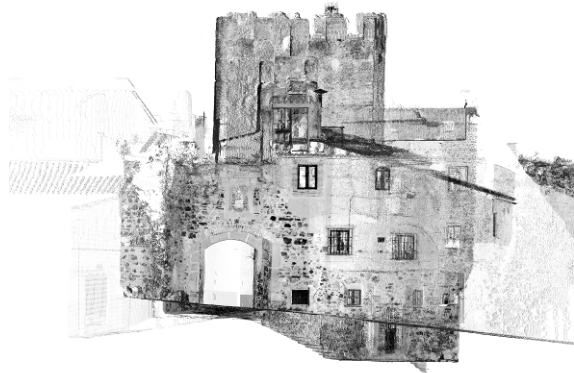
Figure 8. Ortoimage of the wall and Santa Ana tower obtained from range data.

The same plans from the ortophotos were used to capture the reflectance of the 3D model of the wall; creating the ortoimages.
