14th Congress ISP - Hamburg 1980 - Commission V - Presented paper

TECHNICAL-GEOLOGICAL INTERPRETATION OF THE PHENOMENA HAVING OCCURRED IN THE CASE OF A LAND SLIDING

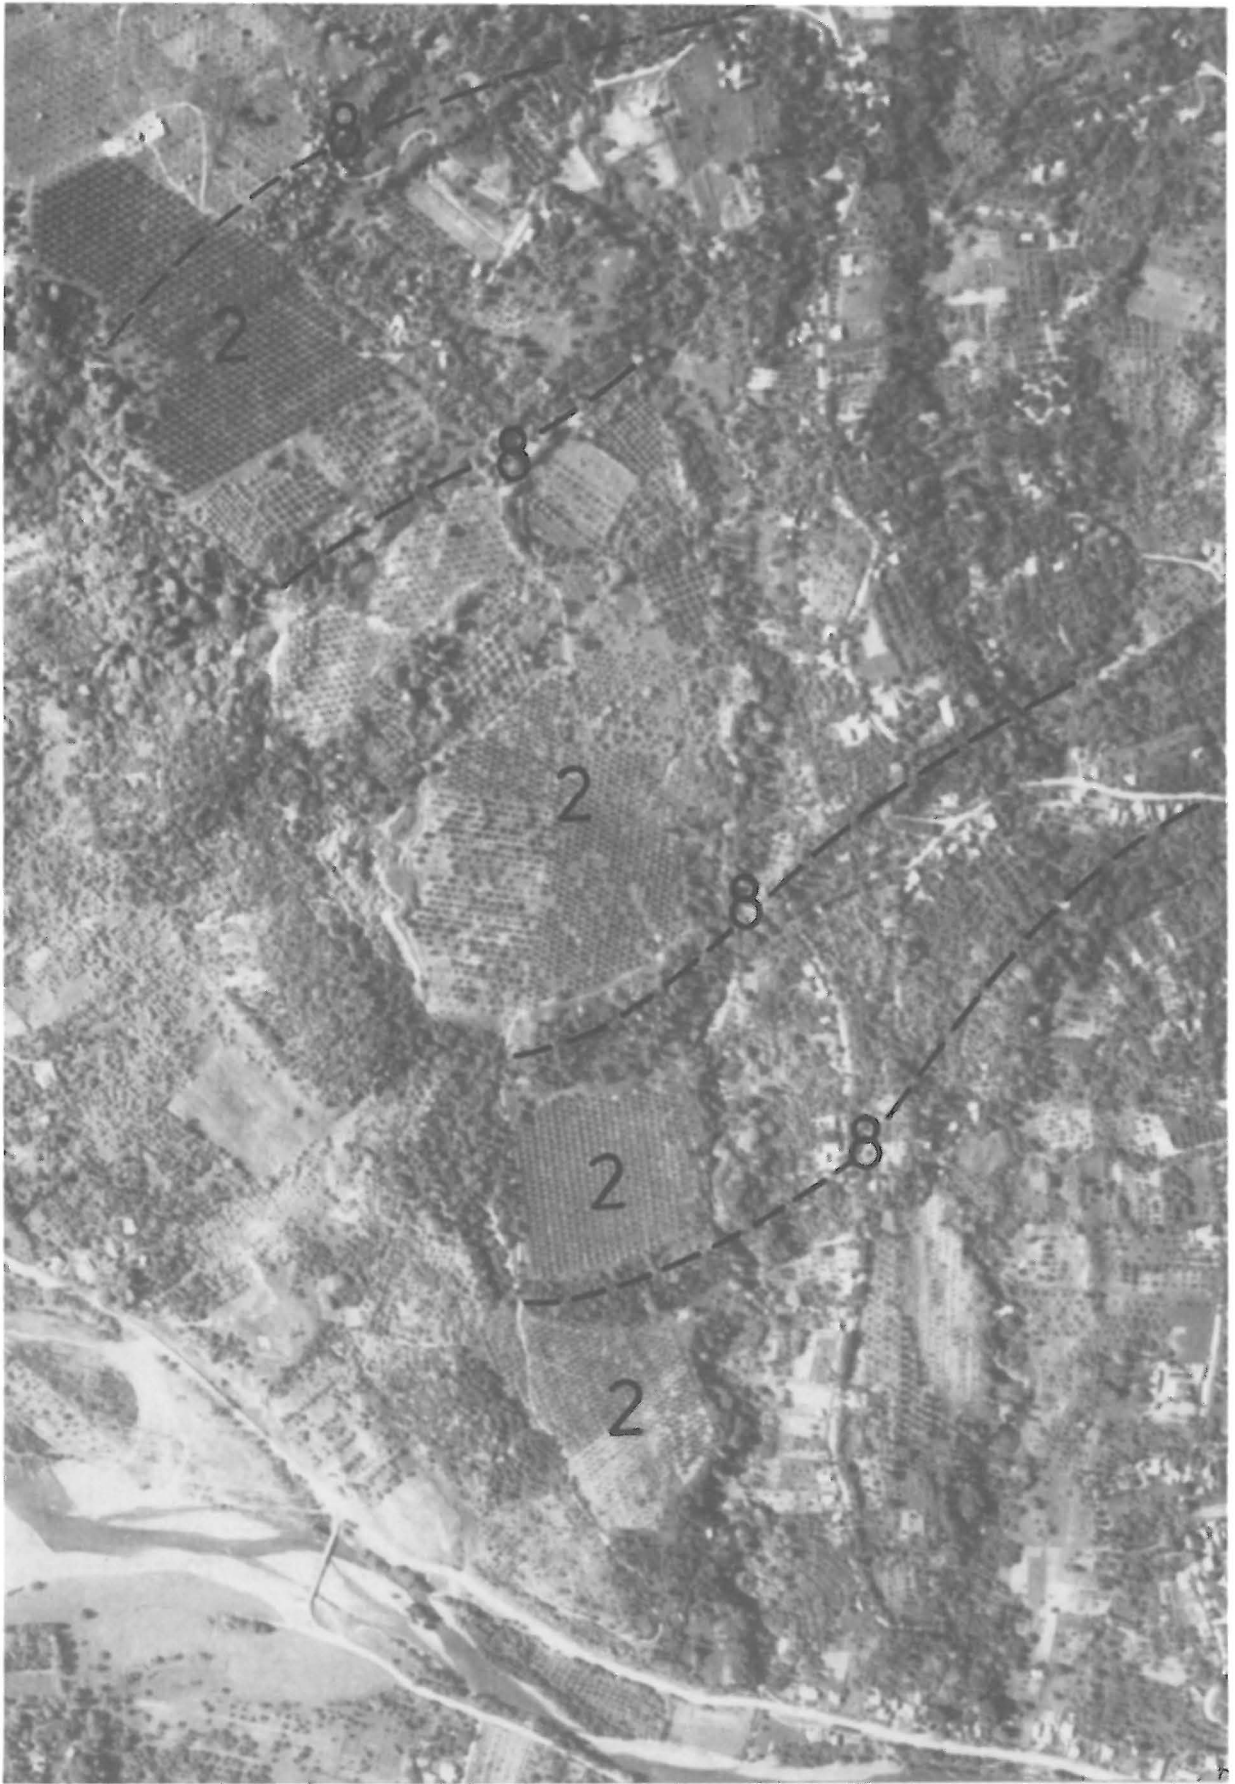
Fig.1 Aerial photograph showing the situation of the area in 1967 (before the sliding)

In figures 1-3 an example of the above is given , indicating the phenomenon or element shown by the photographic image or which can be determined by means of photographs.

A first estimate of the apparent size of earth mass movement in various sliding points was obtained by means of linear measurements made on orthophotographs derived from photograms taken after the land sliding. The measurements were made in the falling , upsetting and fragmentation zones , according to certain planimetric details ( fig.1-3 ).

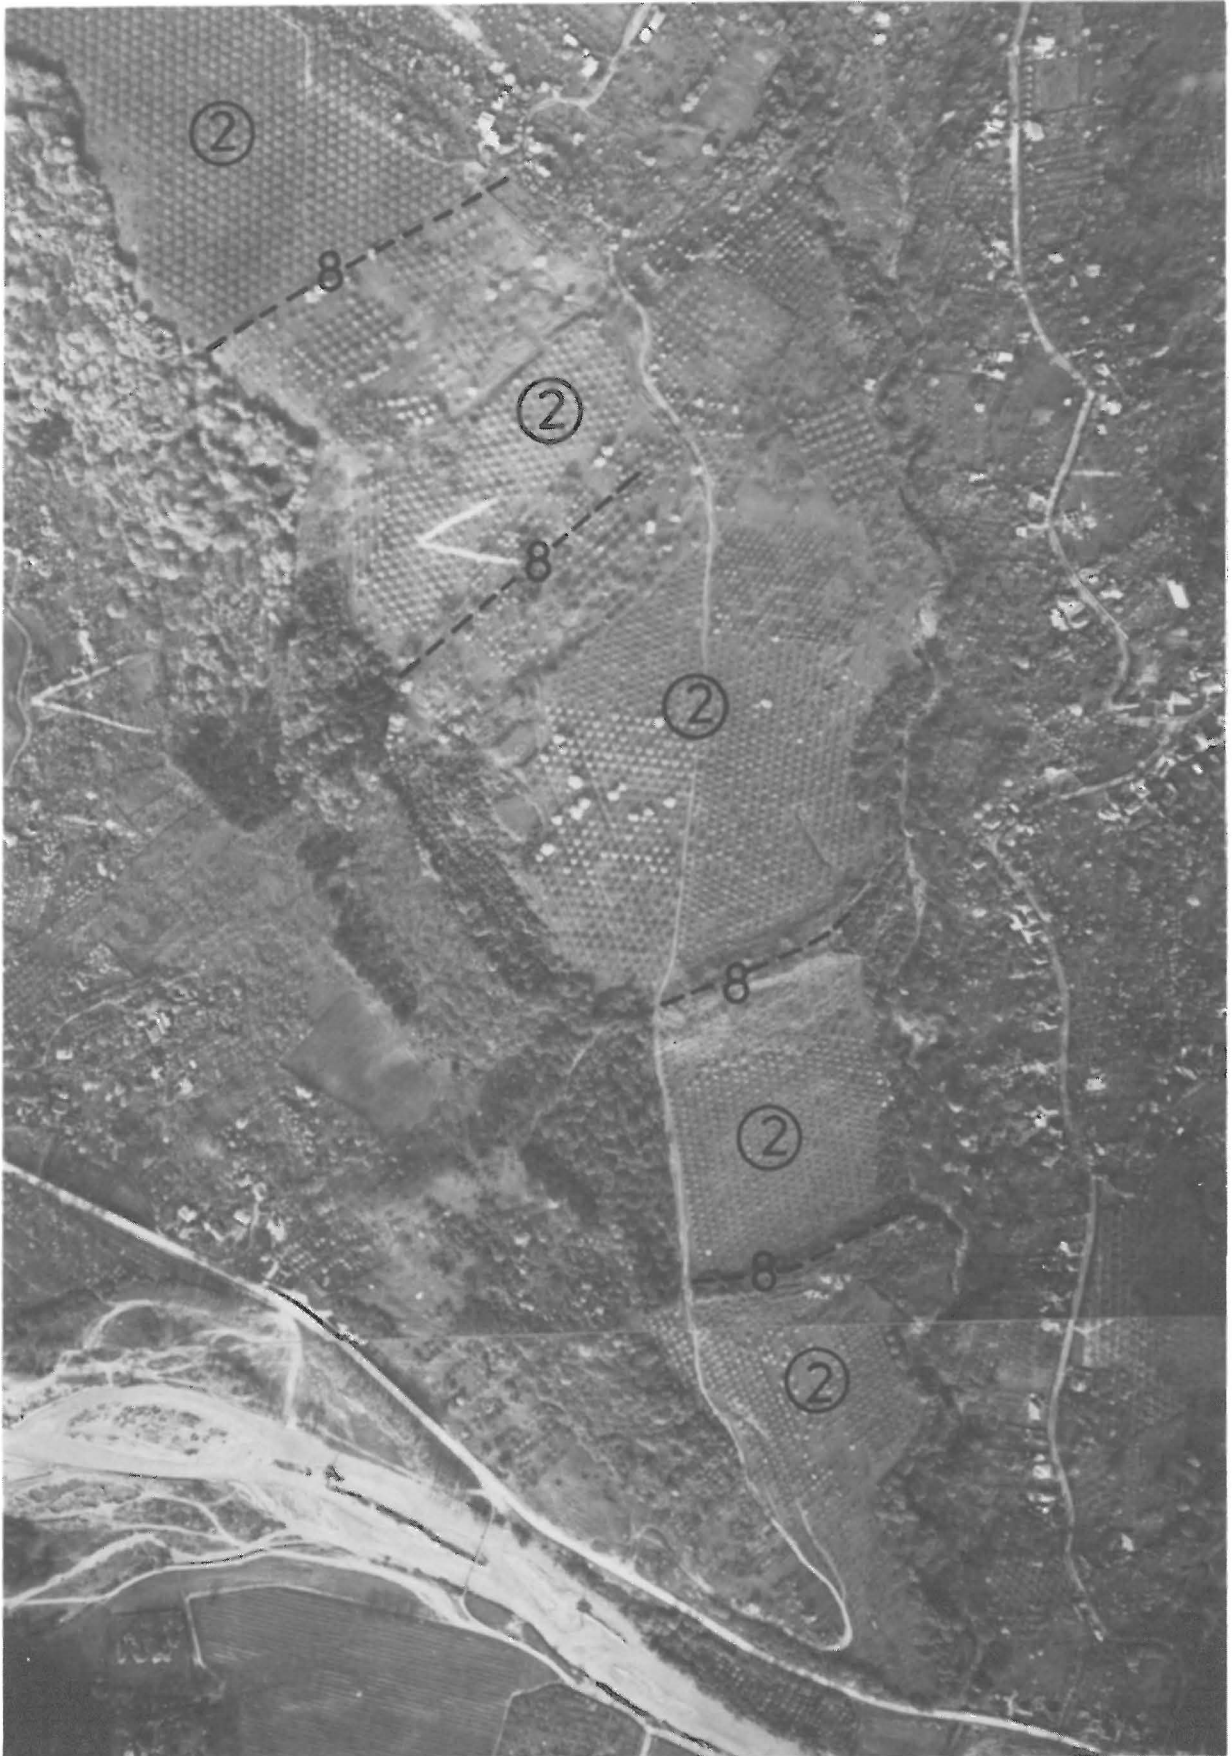
Fig.2 Aerial photograph showing the situation of the area in 1978 (before the sliding)

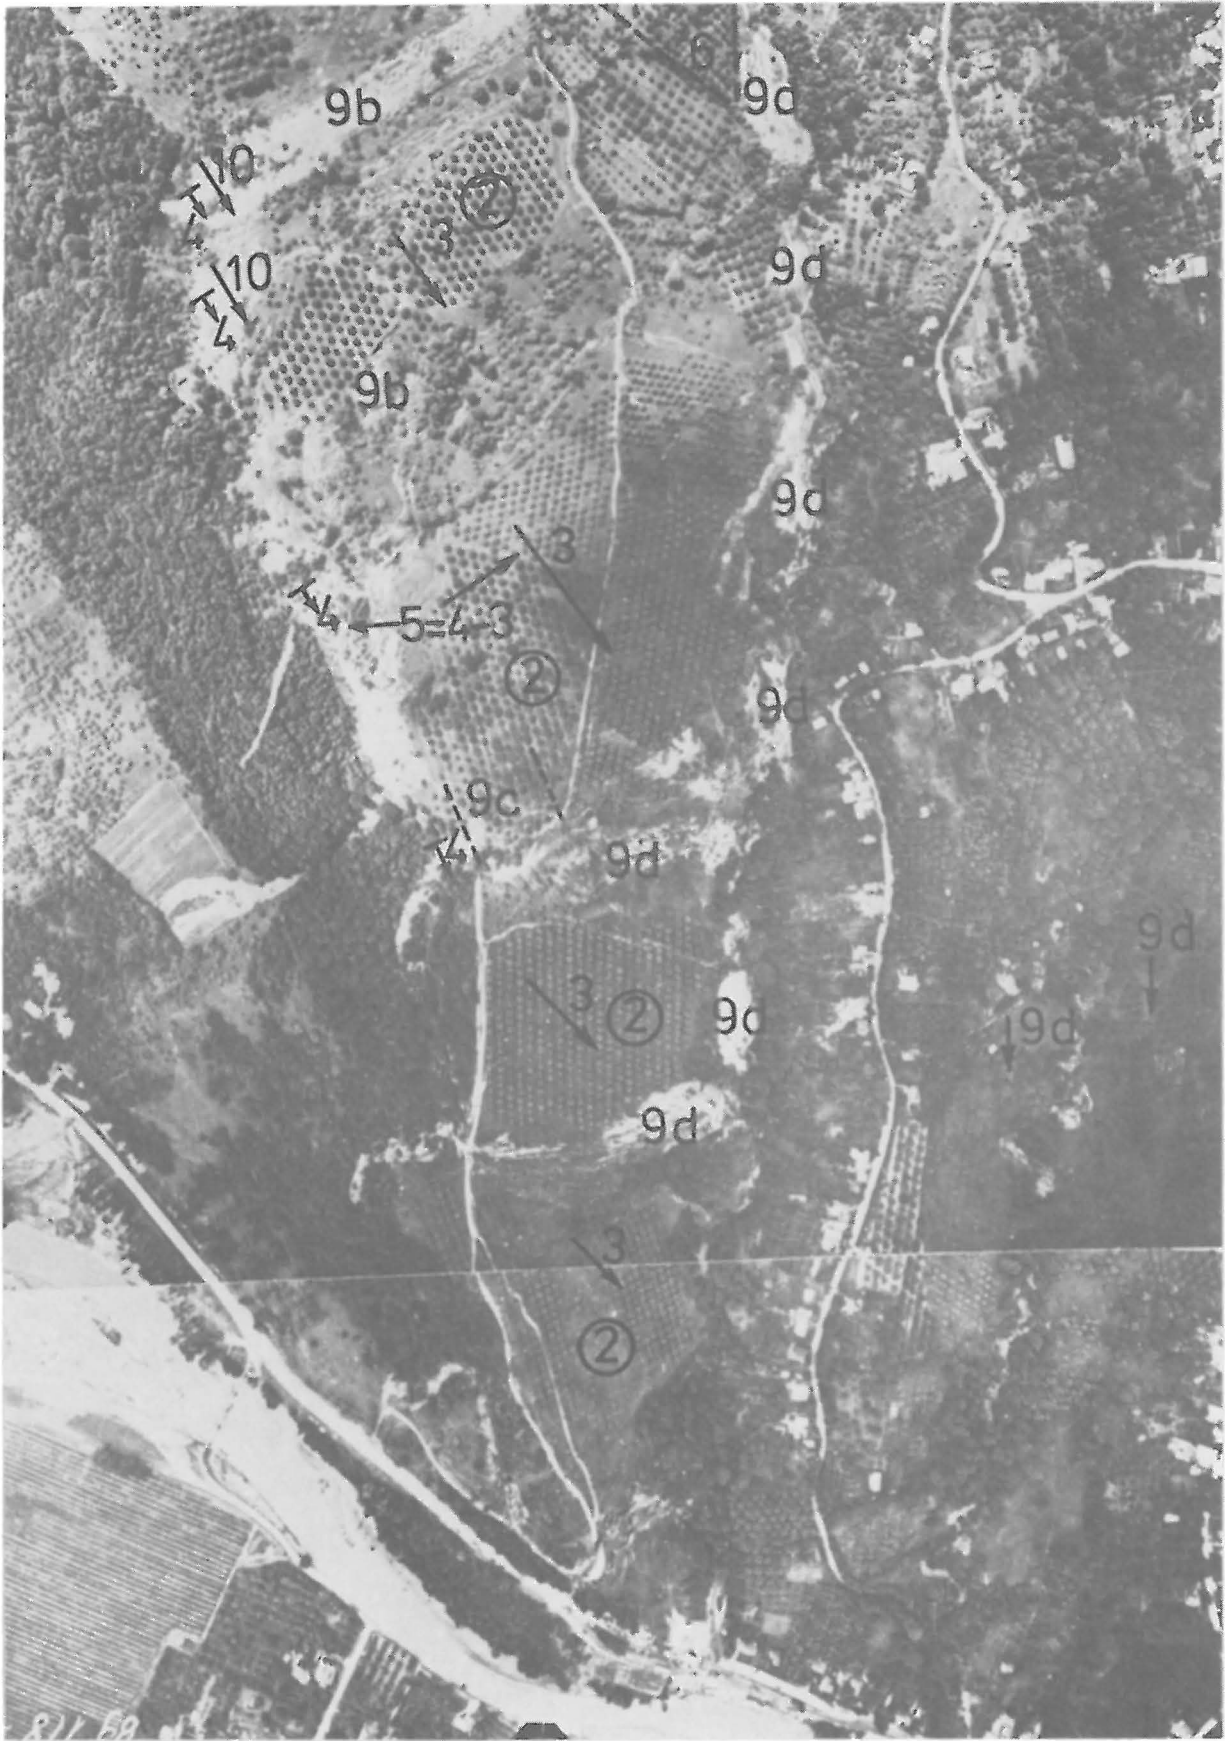
Fig.3 Aerial photograph showing the situation of the area in 1979 (after the sliding)

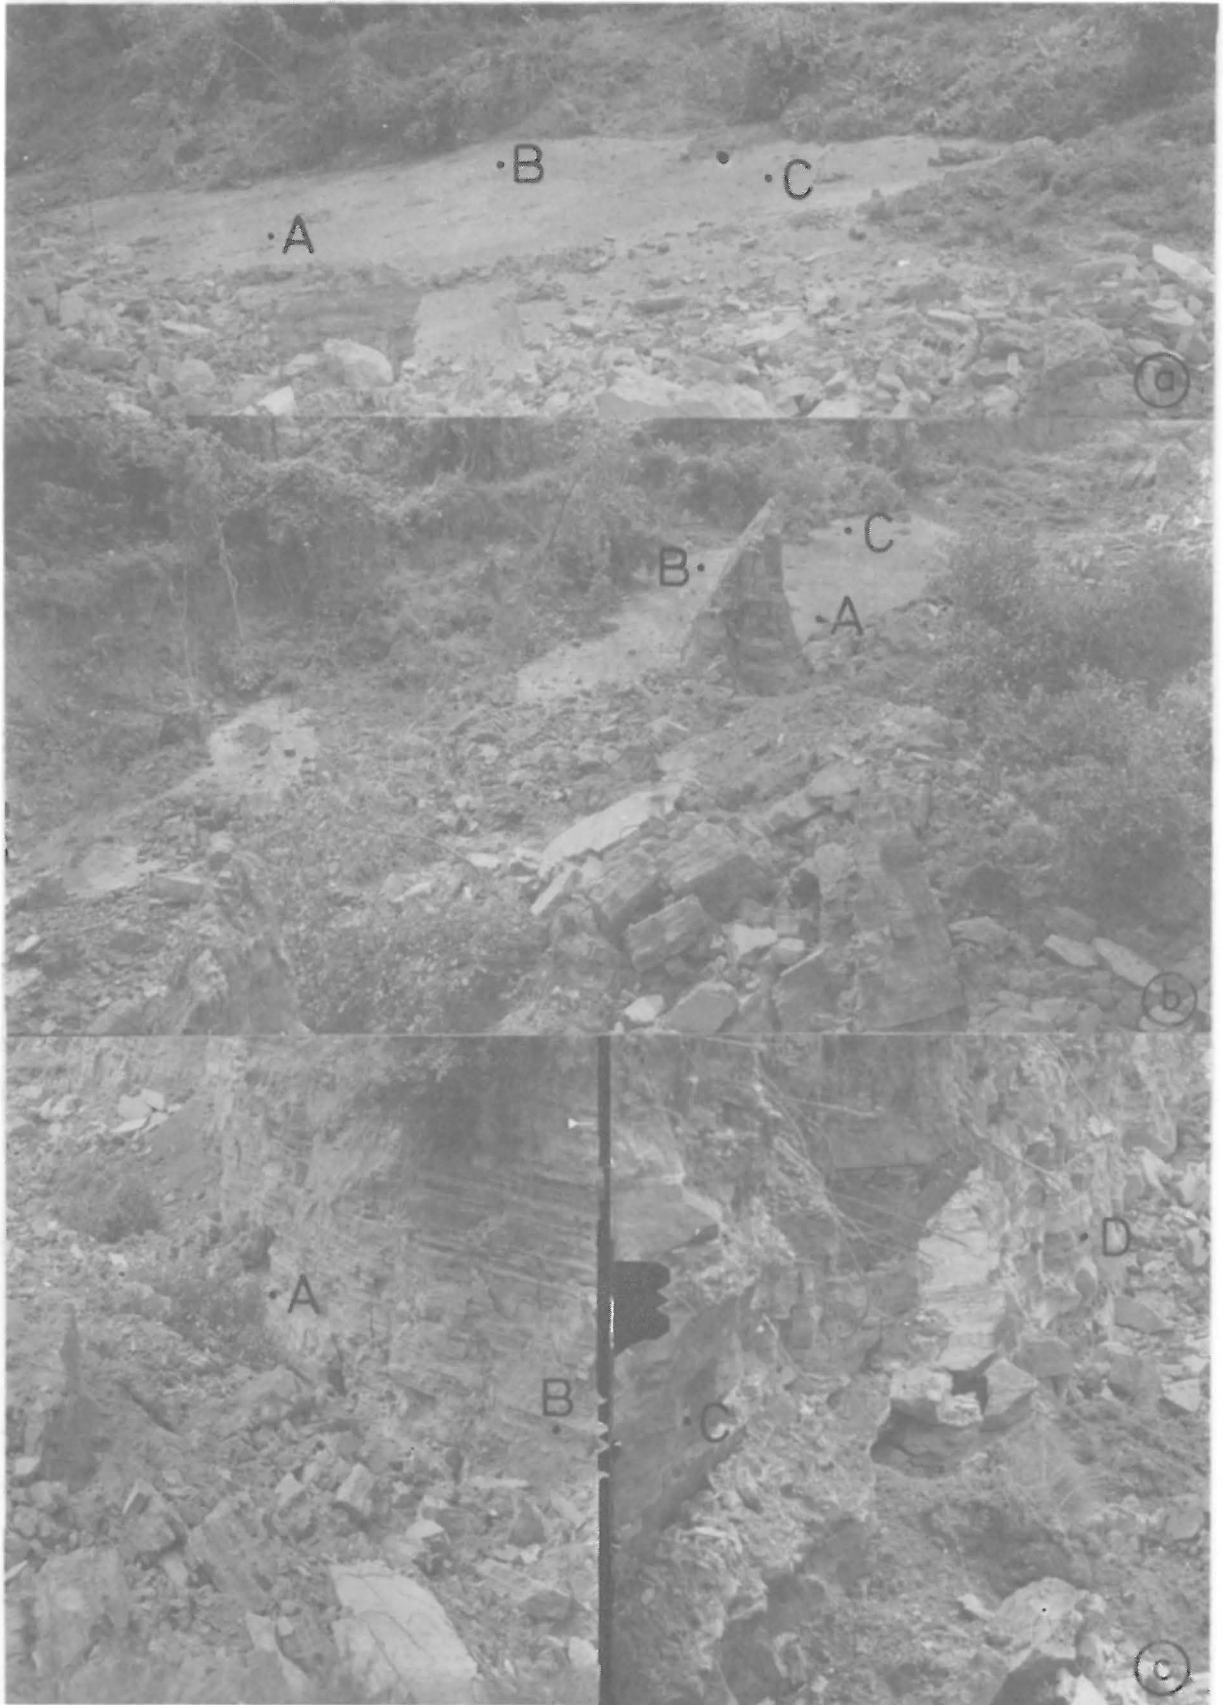
Fig.4 Terrestrial photograph showing the situation of the area (after the sliding)

a, b – the points selected for the determination of the position of the sliding plane ;  
c – the points selected for the determination of the position of the geologic structure.

The terrestrial photographs were employed for the places where the layer along which the sliding had taken place had remained discovered ( fig.4a and b ) .

When taking over the terrestrial photographs, we noticed portions where geological formations outcropped in two directions ( fig. 4 "c" ) in the separation zones, where the geological deposits were not affected by the sliding, and , by photogrammetric processing, the co-ordinates (  $x$  ,  $y$  ,  $z$  ) of points A, B , C , D were determined ; so , the layer direction and inclination were deduced in a way similar to the above mentioned one . It is preferable to make both direction measurements against reference horizons .

An orientative image of the earth mass thickness affected by sliding was obtained by comparing the position of the sliding plane with that of the land surface plane obtained by stereo plotting device , with levels in the falling zones and in the upsetting zones ( fig.1-4 ) ; these data serve to estimate the depths necessary for prospection works ( bore-holes, wells ) as well as in the stability calculations .
