14th Congress of the International Society of Photogrammetry  
Hamburg 1980  
Commission V  
Working Group 5  
Presented Paper

ANALYTICAL PHOTOGRAMMETRY APPLIED TO THE  
MEASUREMENT OF LARGE STRUCTURES

M.A.R.Cooper & M.R.Shortis  
Department of Civil Engineering  
The City University, London

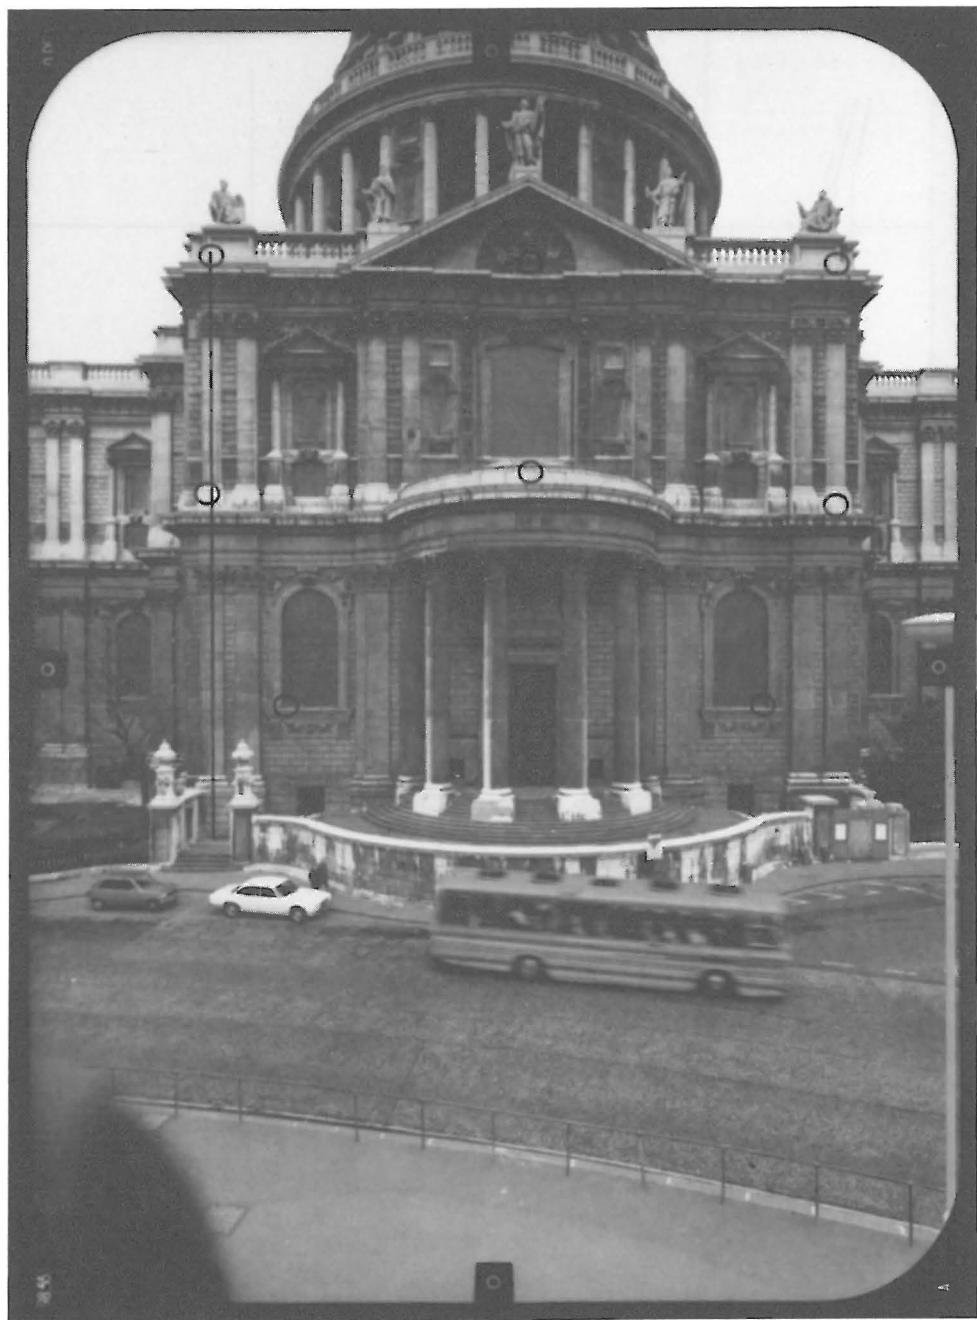
The control survey (1980). The same procedures as in 1978 were followed for the measurement and computation of the control on the facade. No significant change in the positions of the datum points was detected. There was a change in the disposition of the control on the facade. The three lower points in Figure 1 were replaced by four targetted points in 1980. The original three points were not particularly good for photogrammetric measurement and it was hoped to improve the accuracy by replacing them with targetted points. This did not entirely run counter to one of the main reasons for using photogrammetry because the targets were small, made of adhesive paper, were in position only for the few hours necessary for the survey and photography and could be placed and removed safely and easily. The results of the 1980 survey are summarised in Table 1 and are based on a variance factor  $\sigma_0 = 0.96$ .

terminal) it was possible to locate and measure points on it by running along the y-axis of the stereocomparator. The profiles were on the surfaces of smooth faced blocks of stone so that any small departure from the true profile in the XZ-plane would not introduce a significant error in the Y-direction. In any case, transformation of the stereocomparator measurements showed that the maximum departure from a true profile in the XZ-plane was 0.05m, over which distance there was no significant change in the facade in the Y-direction. This was confirmed by comparing the profiles from the stereocomparator measurements with those from a Zeiss (Jena) Stereometrograph F, the latter profiles being true profiles derived from the scaled stereomodel. Horizontal profiles were similarly recorded. In addition, an elevation of the facade at a scale of 1/50 was produced from the stereoplotter. This drawing was used to show the locations of the profiles and of the control. It also served (together with the photographs) as a useful reference for discussions between the photogrammetrists, the engineers and the Cathedral staff.

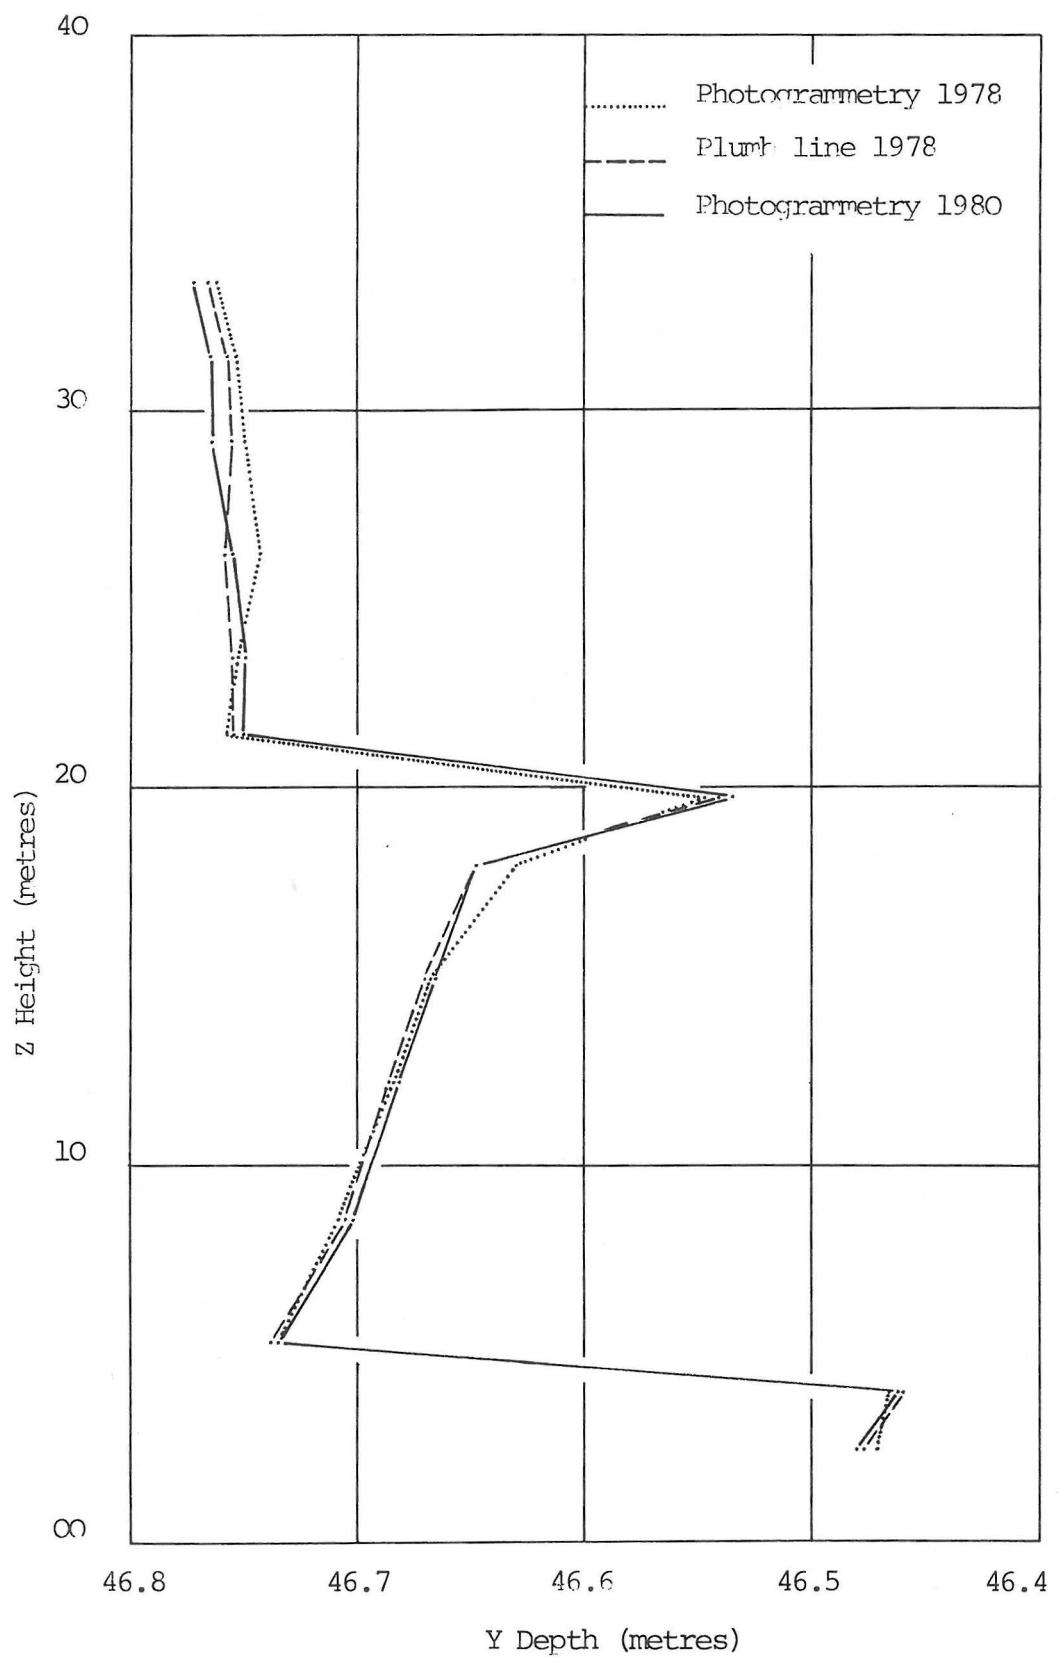
The photogrammetry (1980). Stereocomparator measurements were again the main source of photogrammetric information. Residuals at the 10 control points are shown in Table 2 and derivation of the (XYZ) co-ordinates of the profile points was by the same methods as in 1978 with stereocomparator readings as the basic data. These 1980 measurements for one of the profiles are illustrated in Figure 2.

As far as any deformation is concerned, Figure 2 illustrates a significant outward lean between Z-values of about 5m and 18m. The evidence is that this is not recent, and may even have taken place during construction; chains then emplaced at the 22m level may have been put in to tie back the masonry and restore verticality in the portion of the elevation above 22m. The agreement between the photogrammetric measurements and the plumb-line measurements is good. However at two points (Z-values 18m and 26m approximately) there are discrepancies of about 20mm between the plumb-wire measurements and the photogrammetry. Some of these discrepancies were caused by the points measured being either in shadow (for the lower) or on a bright part of the masonry (for the higher) and not ideal for photogrammetry. The evidence is that photogrammetry can be used successfully in the context described. Moreover, the stereopairs and control co-ordinates together constitute a unique source of quantitative and qualitative information that is impossible to obtain by any other means.

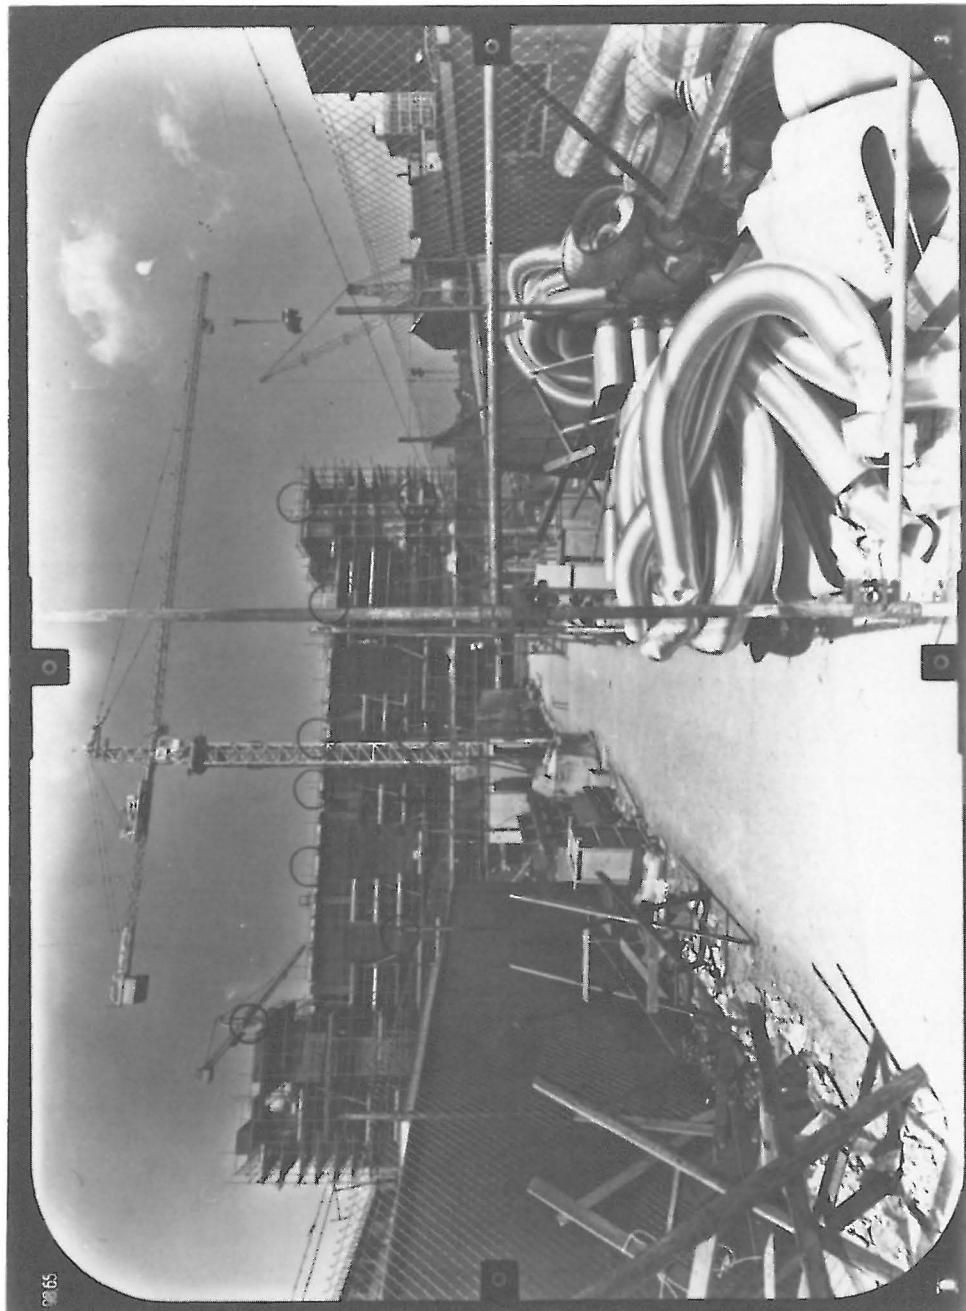
Figure 3

The geometrical and economic problems outlined above were overcome to some extent by using a crane that happened to be close to a tall building. Control points could be placed on the building and surveyed whilst the crane was working normally. In this way, the crane would be needed only for the period of the photography, and the area of the photograph format which could be used for measurement increased. However, the usual conglomeration of construction site materials and services placed a severe restriction on the geometrical configuration of the control survey and photogrammetry. This is illustrated perhaps too clearly in Figure 3.

Conclusions. The main source of error comes from the spatial separation of the control from the measured object. The figures quoted in Table 3 refer to the control and not necessarily to the crane, where there could be an undetected scale error. However, since deformations are required rather than absolute positions, this is of less importance. The deformations are predominantly in the XZ-plane and for each stereopair the rms residuals at the control were less than 20mm in this plane. Whether or not the same precision applies to measurements on the crane is uncertain; deformations

measured were apparently of the required precision. The accuracy could be improved by firstly having the crane closer to a back-ground where control can be better distributed and secondly, by positioning the cameras so that the geometrical configuration is stronger. Each of these conditions is often impossible to achieve in practice on a construction site, without taking the crane out of the normal work programme.

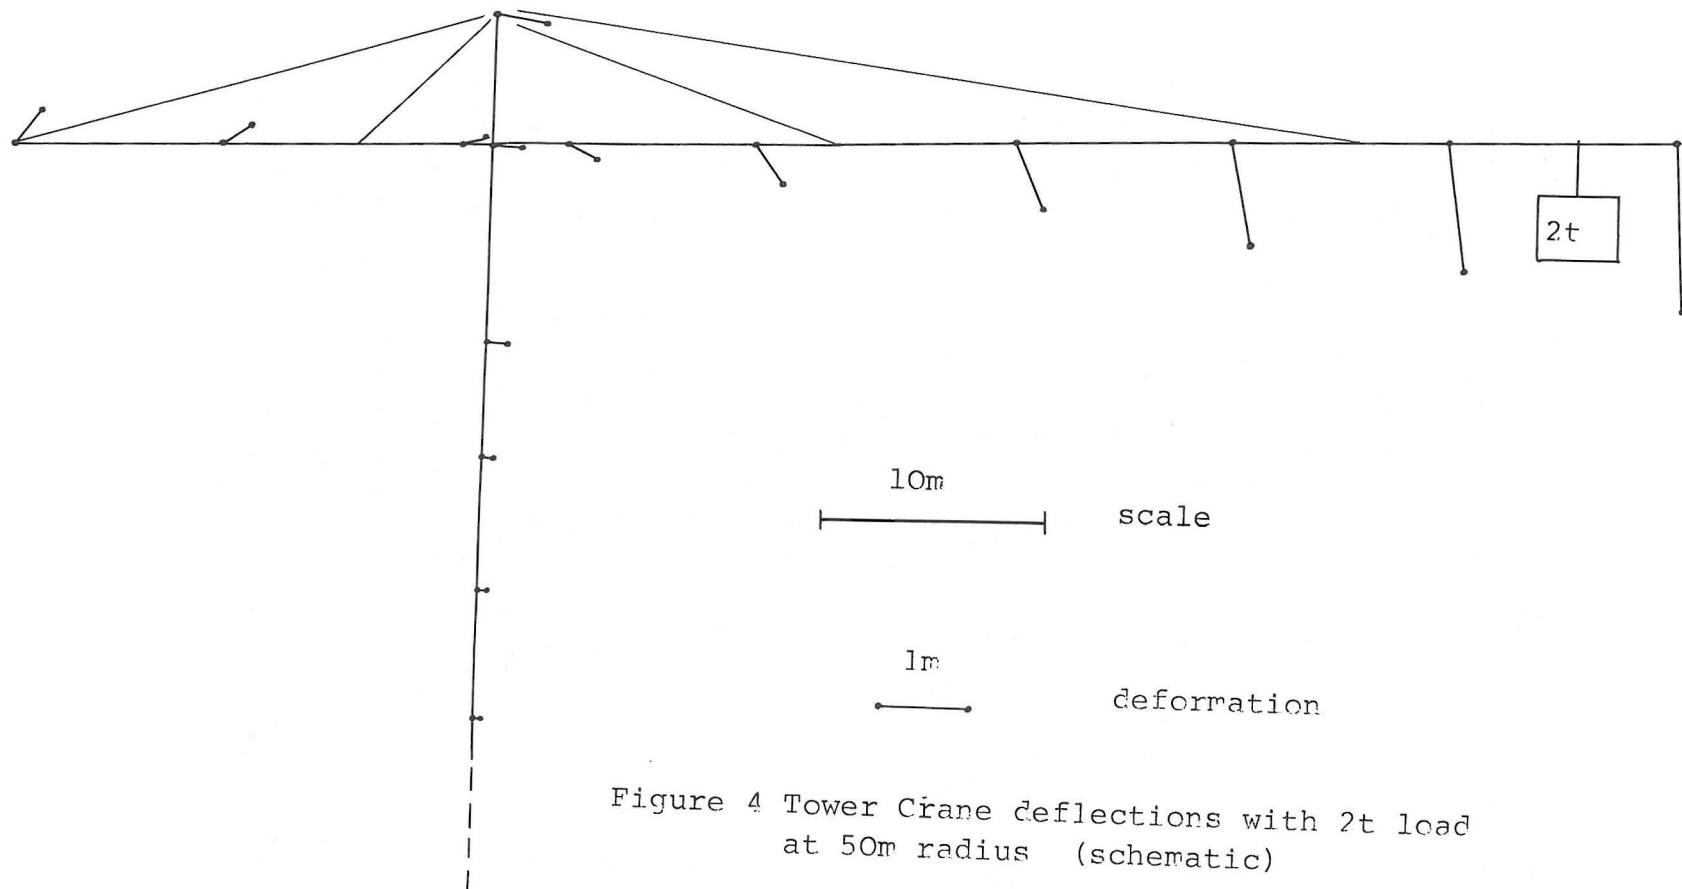
The results of the measurements with the load at 50m radius are shown schematically in Figure 4. The maximum and root-mean-square (rms) residuals at the control points are shown in Table 3. Nineteen points were selected on the crane at points of interest in the structural analysis. These points were not targetted, but were easily identifiable points in the stereomodels, such as the centre of a bolt.

Figure 4 Tower Crane deflections with 2t load  
at 50m radius (schematic)
