UTILITY OF PHOTOGRAMMETRY USING TIME-SERIES AERIAL PHOTO  
FOR LANDSLIDE INVESTIGATION IN JAPAN

Masatoshi NAGAOKA 1  
Kazunori TAKADA 2

1: Geographical Survey Institute  
Kitazato 1, Tsukuba-shi, Ibaraki pref., 305 Japan  
2: Aero Asahi Corporation  
3-1, Higashi Ikebukuro 3-b, Toshima-ku, Tokyo, 170 Japan

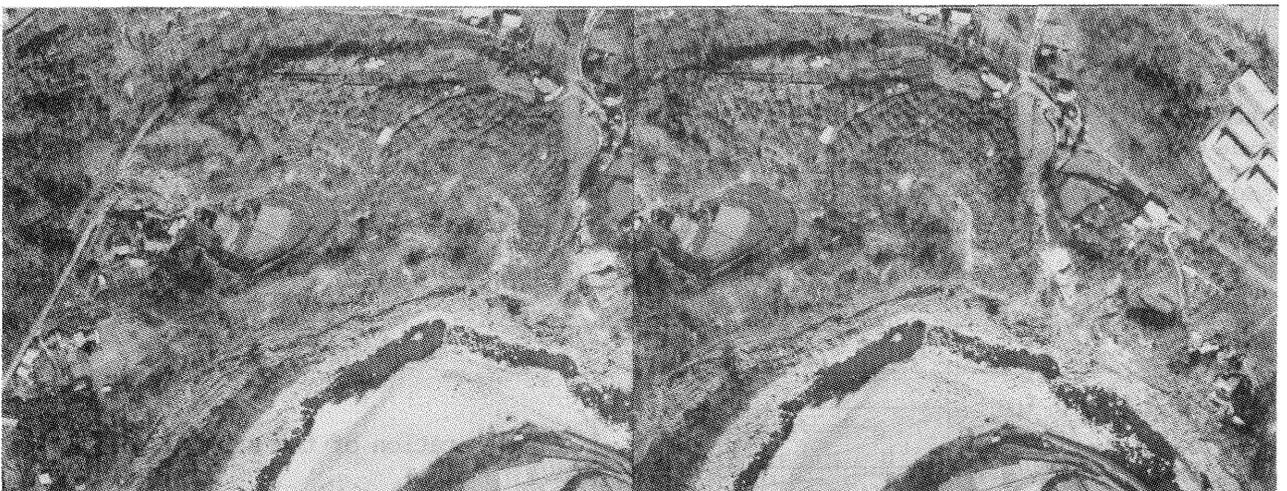
2-a 1946.6.14 ; Photo by US Army, M165-A-6, 106,106, 1:10,000. (×0.7)

2-b 1982.6.8 ; Photo by Komoro city, K4866, C8-6,7, 1:8,000. (×1.5)

2-c 1983.11.19 ; Photo by Kyodo-sokuryosha, C1-3528,3527, 1:4,000. (×0.66)

Photo 2 Landform change at the foot of Komoro landslide.; Changes of water channel and it height in riverbed should be notice ( Stereo view is possible for Photo 2-a,b and c, but the direction of each photo is different according to the flight course. )

Photo 2 are the aerial photographs of the landslide site in subject taken before and after the occurrence and one taken 40 years ago. A horizontal and vertical movement vector map are shown in Fig.4-a,b and c, as a study result. On the other hand, the authors introduced Fig.4 which depicting the change in the elevation of river-bed. The decreasing tendency of the level of the river-bed and changing of river-channel of Chikugo Gawa(River) is easily understood also by stereoscopic viewing of the above-mentioned aerial photographs.

\* According to the Photo 2-a,b and c., the low water channel of Chikuma Gawa around its curve changed its direction extremely to the north and gave rise to a severe decrease in the level of the river-bed. As a results, the

average depth of erosion reached 3 m. As the causes of occurrence of Komoro landslide, there occur two ; that is, an increase of groundwater level due to heavy rain and the decrease of the river-bed due to flood and exploitation of bed materials from there. The data acquired suggests that the latter is more important.

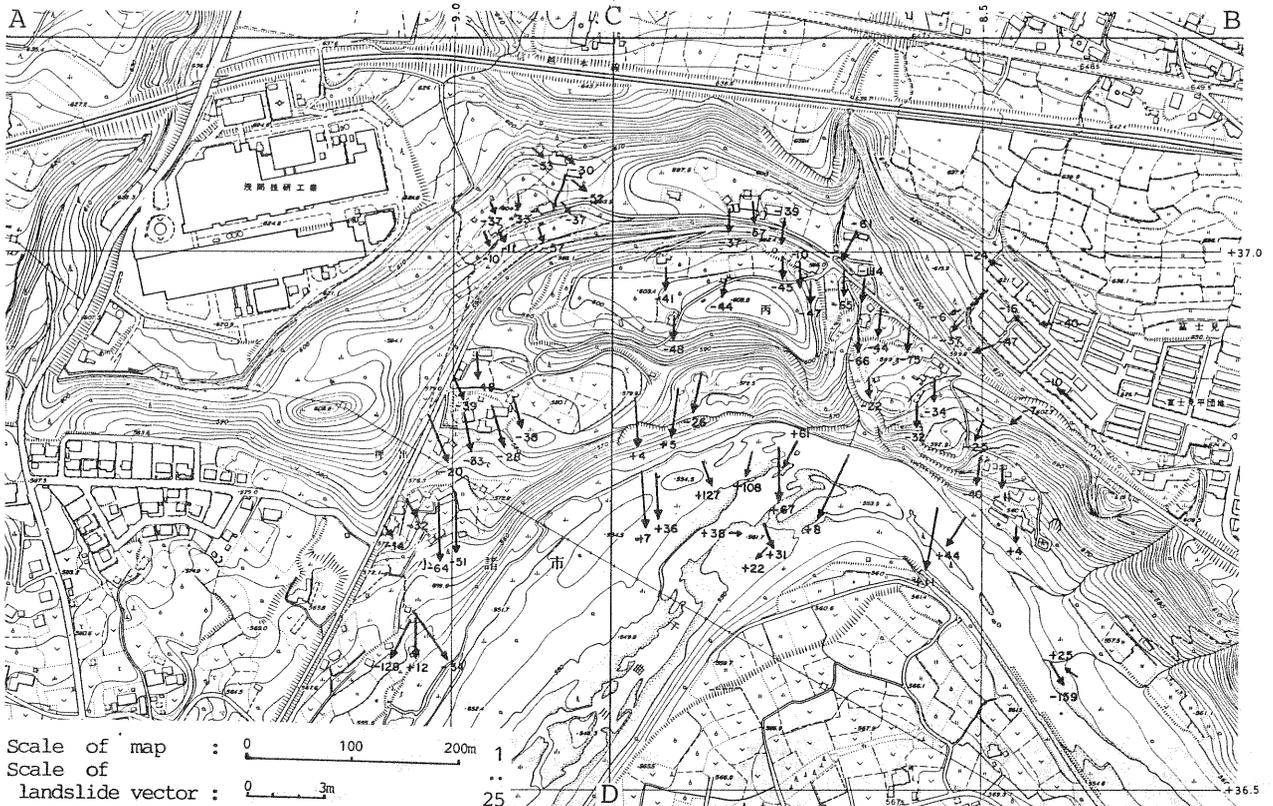
Scale of map : 0 100 200m  
 Scale of landslide vector : 0 3m

4-a Horizontal vector of landslide, from 1982.6.8 to 1983.11.19

Plotted data are selected points from 300 measured reliable points.  
 Figure of vector means elevation change in centimeter, figure on map grid is distance from datum point of Japanese Plane Orthogonal Coordinate System in kilometer.  
 Base map by GSI's 1:2,500 National Large Scale Map "VIII-ID77-42"(based on 1981 aerial photo), (x0.35)

\* Three-dimensional displacement was measured at 1125 tracking points over the the landslide-stricken area by the use of aerial photographs taken before and in the midst of the occurrence. As result, 300 points in the landslide area show their large displacements for comparing measurement.

\* In the Fig.4-a,b and c, survey points with measured displacement amount of 0.3 m or more are affirmed to be located within the area of the fast moving landslide.

\* On the basis of the pattern of displacement (direction ; the distribution of vertical element / horizontal element ), the area of the movement is roughly divided into ① the main block around the curve of the Chikuma Gawa water channel and ② Fujimi-daira block on the northeastern small area. This matches the zoning of landslide landform by means of aerial photograph interpretation (Fig.4-d).
