Photogrammetric documentation of the historical castle of Heidelberg and results of deformation measurements (1997 – 1999)

Michael Nutto, Konrad Ringle
 University of Karlsruhe, Germany
 Institute of Photogrammetry and Remote Sensing
nutto@ipf.uni-karlsruhe.de
ringle@ipf.uni-karlsruhe.de

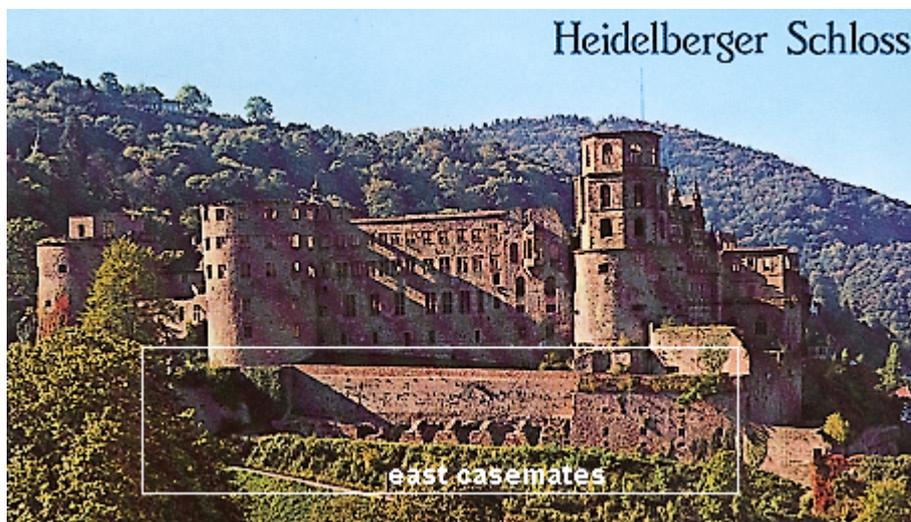
figure 1: castle of Heidelberg

Figure 1 shows the east view of the castle together with the east casemates.

The casemates which are partitioned in 13 parts are about 80 m long. Unfortunately 6 parts are heavily destroyed. In addition to the east casemates there is a 25 m long tapered casemate which is combined with the other casemates. But the position is across to them. The height of the east wall is 12 m. The stereo photograph contained the complete external walls and the casemates (internal and external). The cameras Pentax PAMS 645, UMK and SMK 40/120 (stereometric camera) were put at our disposal. Also the digital camera Polaroid PDC 2000 came into operation. Because of the close relations inside about 260 „stereomodels“ (model area in two photographs) were taken totally and about 1430 control points were surveyed (5-6 register marks each stereomodel). The necessary register marks were measured with geodetic equipment. The point determination is described in chapter 3. In addition the topography complicated the surveys because a scaffolding had to be put up.

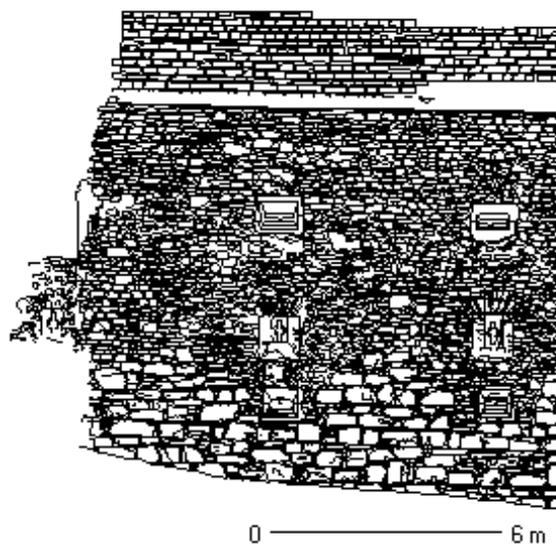
figure 2: north wall in detail

The accuracy of the evaluation is 1 cm (max. error of points). The results are to be fed in an informationsystem and made available for the users. The longitudinal section of the „north wall“ is described in figure 2.

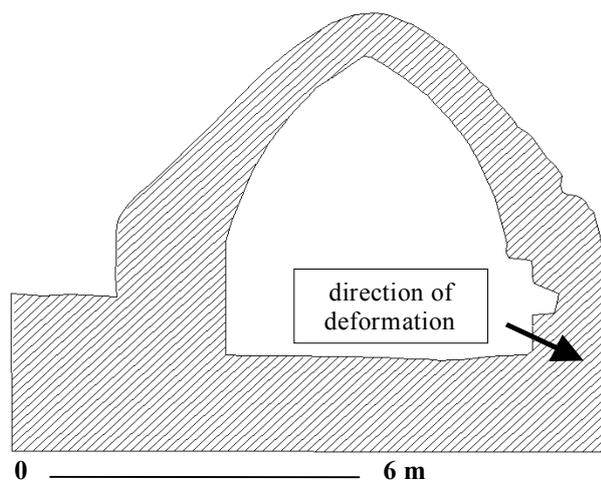
figure 3: cross section of the tapered casemate

Figure 3 represents a cross section of the tapered casemate. Here you can see the move direction which is represented by the arrow. The length of the velocity vectors is depending on the movement of the landslide of the underlying slope. This is an exact documentation of the supporting walls by means of photogrammetry.

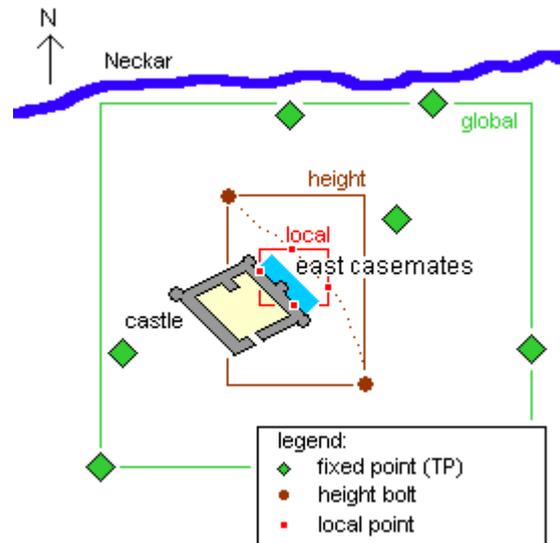
figure 4: survey map

The next task was to integrate the local network into the horizontal control network of Germany (National Triangulation System). But it wasn't possible to find any official fixed points around the castle. Therefore the decision was to start a GPS campaign to integrate the network in a global frame. The global network which is suffixed on the land system includes a total number of 10 stations (6 fixed points and 4 local points) which were occupied by using a set of 4 TRIMBLE 4000 SSE receivers.

Figure 4 shows an overview of the different networks around the castle.

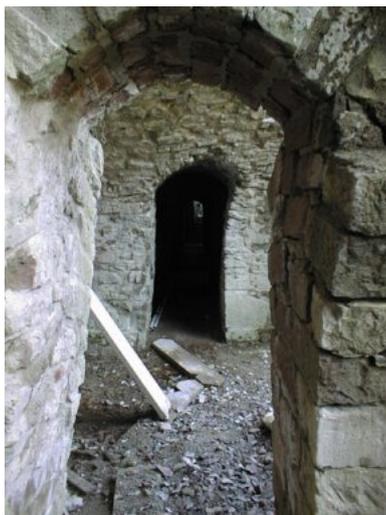
- the east casemates aren't built on the salient rock.
- the eastside wall is deformed.
- the east slope is sliding approximately 1-2 cm each year.
- the biggest cracks on the casemates arised from the frost.

figure 5: deformation of the entrance in the closed casemate 9

- Sealing of the casemates against the water. The complete wall and the casemates (internal and external) were treated with cement.
- Horizontal fixing of 13 anchors (with a length of 13 meters) which are attached to the foundation rock (see figure 9).

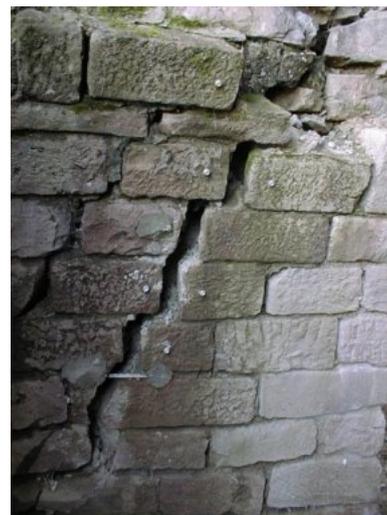
figure 6: crack in east casemate 7

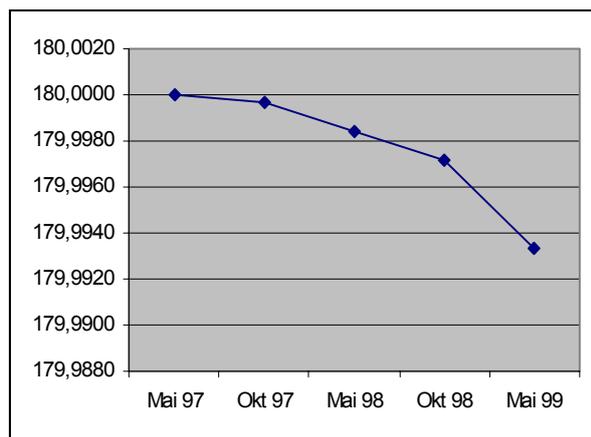
figure 7: precise levelling

„HEIDI 2.0“ (GIK). The average accuracy in this field is 0.3 mm (rms). The vertical settlement of the bottom was registered with the precise height network, too. Figure 7 shows the vertical average settlement of the casemates since 1997. The average height of the eastside foundation wall is 180 meters. The strong movement (4 mm) between Okt. 98 and May 99 can be assigned to the beginning of the construction work.

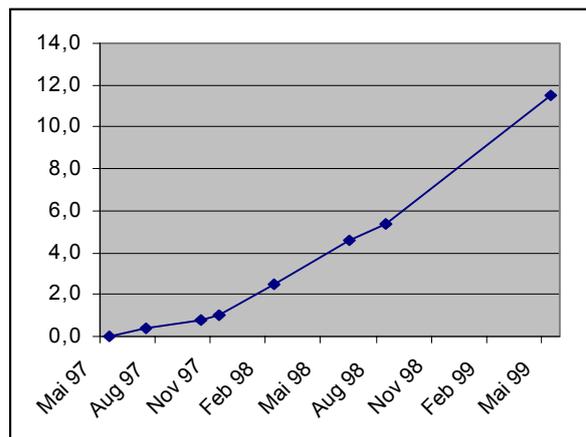
figure 8: crack movement

For the static calculation (exploration of external forces, shearing, consolidation and tilt) it was very important to get the values of the absolute deformations of the casemates which was realized with the technology of photogrammetry and the relative deformations on the cracks which were measured with geodetic instruments. Therefore the horizontal drift of the cracks was surveyed with a calliper rule. The advantage of this equipment is to have a high accuracy (0.1 mm). In order to compare the horizontal measurements several screws were fixed around the cracks. Figure 8 shows the horizontal average drift (mm) of the cracks (the values are added up).

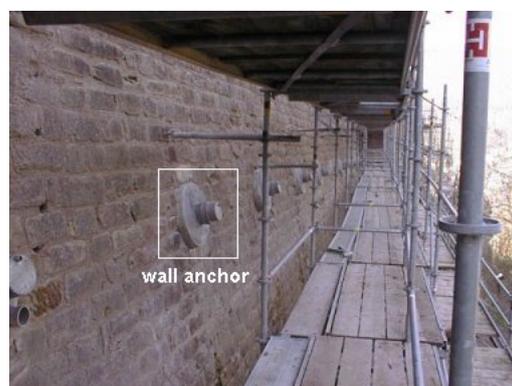
figure 9: construction work on the east wall

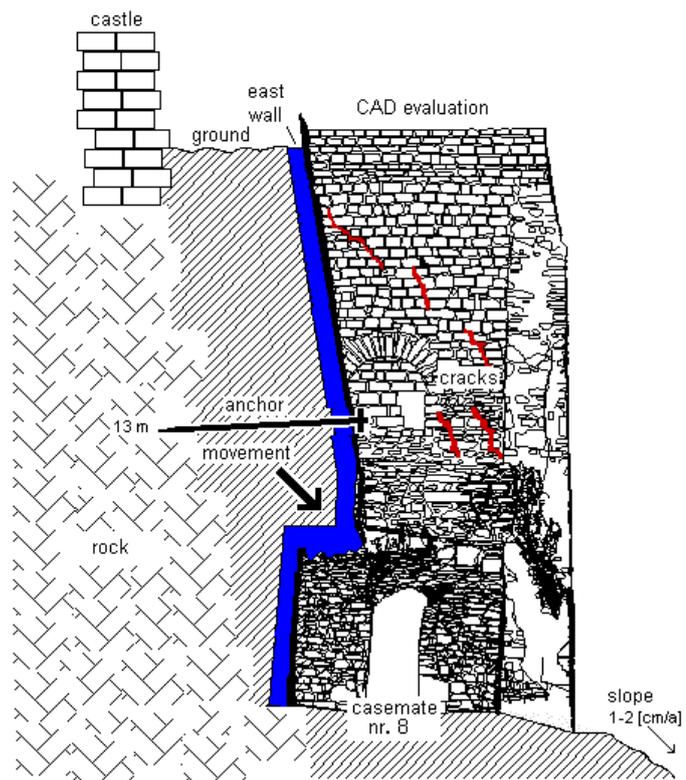
figure 10: combined evaluation – part of the casemates
