EROSION EVALUATION OF THE BAS RELIEVES OF S.MICHELE BASILICA IN PAVIA

Anna SPALLA, Riccardo GALETTO, Vittorio CASELLA
DIET - Dipartimento di Ingegneria Edile e del Territorio, Pavia, ITALY
spalla@unipv.it
galletto@unipv.it
casella@unipv.it

KEY WORDS: Close range Photogrammetry, Digital Surface Model, Historical Buildings

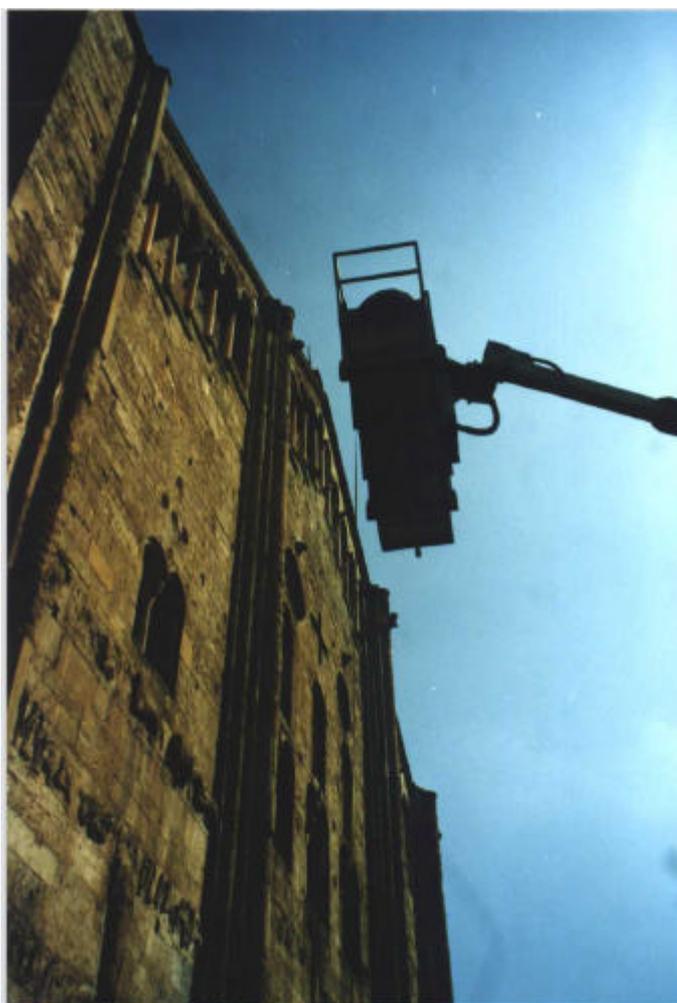
The whole facade was taken with 3 stripes of 7 photograms each, made at 5.75 m, 13.75 m, 21.75 m of elevation.

Topographic control survey ('99 datum) was realised, in order to achieve exterior orientation data of the stereomodels. The measurements was made by a Leica T460D and a Leica DISTO instruments.

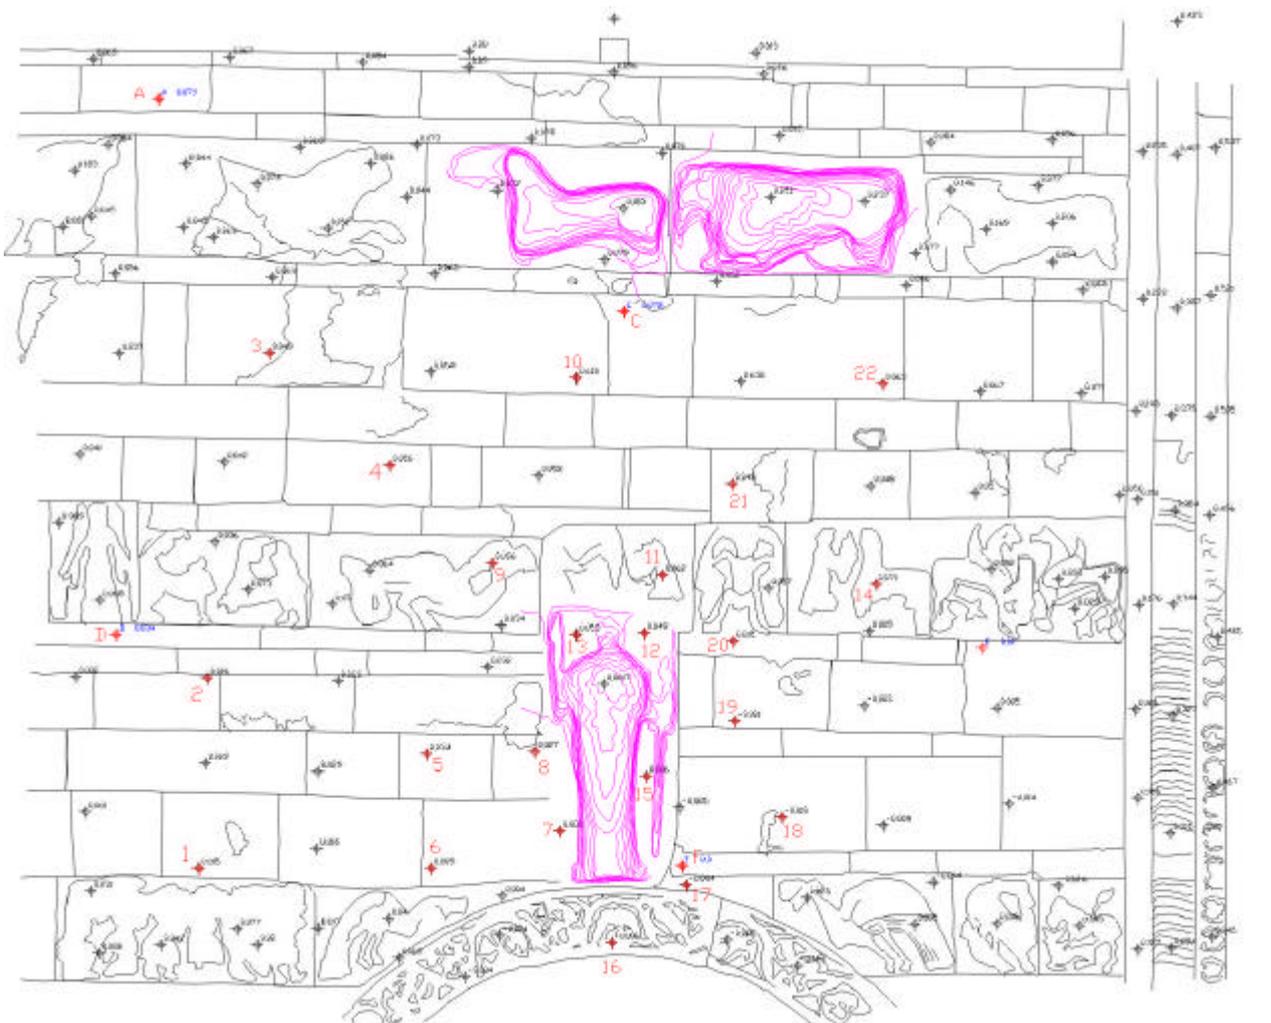
Figure 1

The original compilation (see figure 1) consists of : lineaments of the structure, many elevation points uniformly disseminated on the façade and contour line representation of three bas reliefs.

In figure 1 we can see '70 photogrammetric restitution, now digitised. We can also see the 5 original reference marks (A,B,..E) and 22 other points used like test, as we will explain in the following.

The first set of data was obtained by the transposition in digital form of the original on transparent sheet compilation. This has been done by manual digitising. The system co-ordinates in which the graphic drawing was transformed was determined by means of a co-ordinate transformation based on the planimetric co-ordinates of the 5 control points used for the original stereoplotting. The accuracy parameters of the co-ordinate transformation have been

- we chose 22 points taken in '70s photogrammetric restitution, like elevation points,
- the photograms couple of Figure 2 was oriented on the '70s datum: the 22 points chosen was taken by photogrammetric survey.

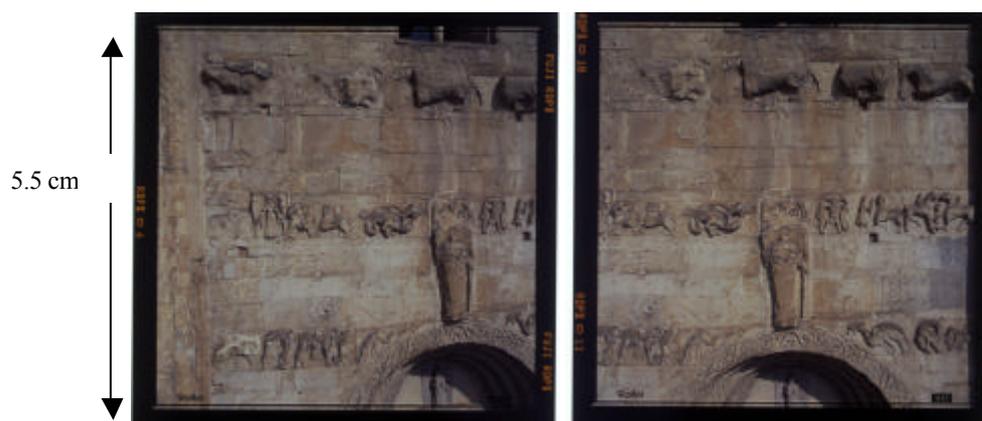
Figure 2

The second data set has been achieved by stereoplotting of a stereoscopic model composed of two pictures achieved by the '99 campaign; these are represented in figure 2.

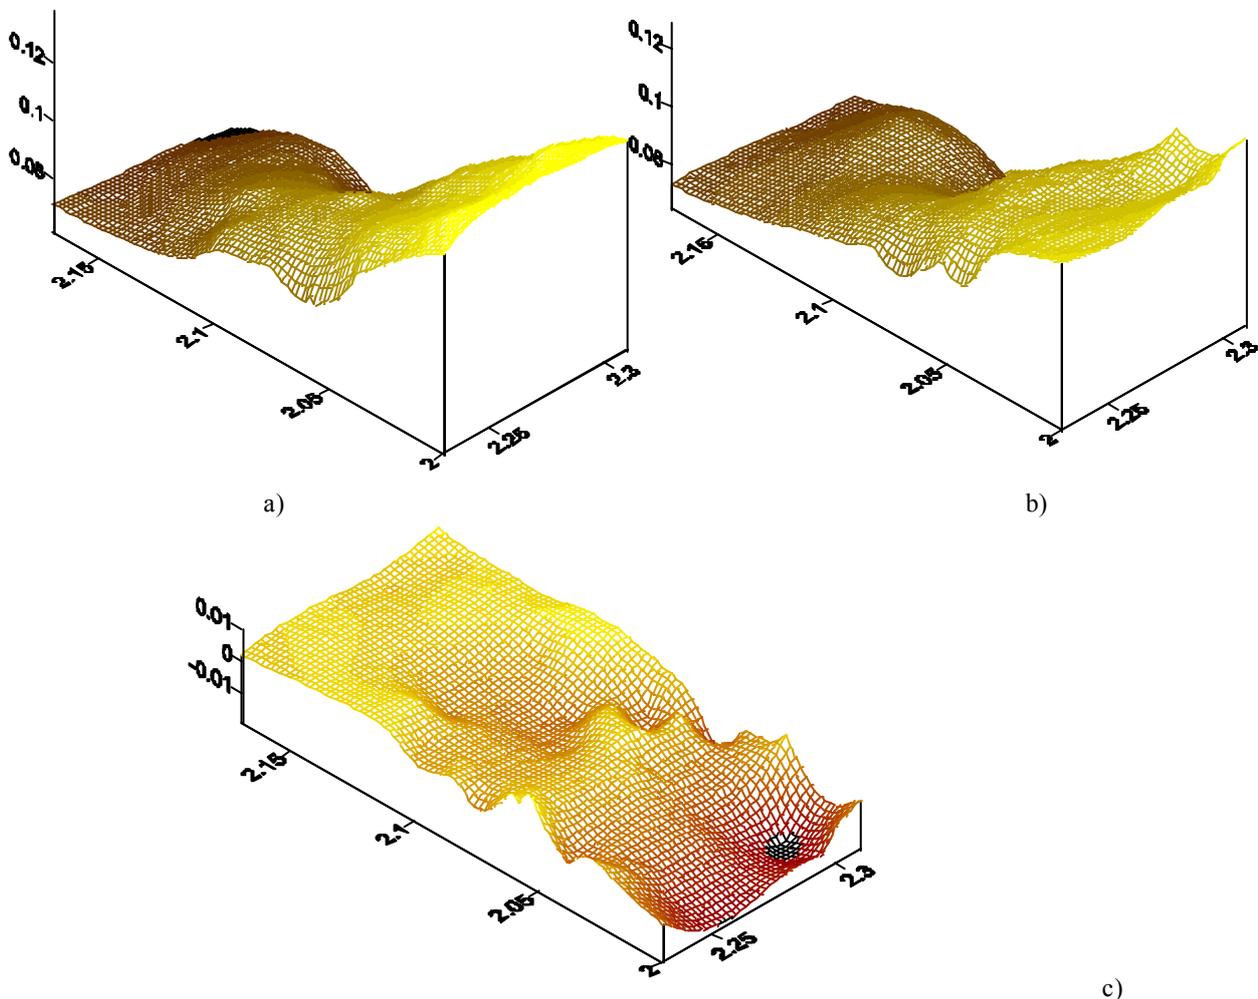
Figure 3 – S. Ennodio bishop head

In figure 3 we can see in a) the DSM made from '70s survey digitisation, in b) the DSM made from '99 restitution and in c) the DSM of differences between b) and a).

The entity of the differences checked is up to one cm.

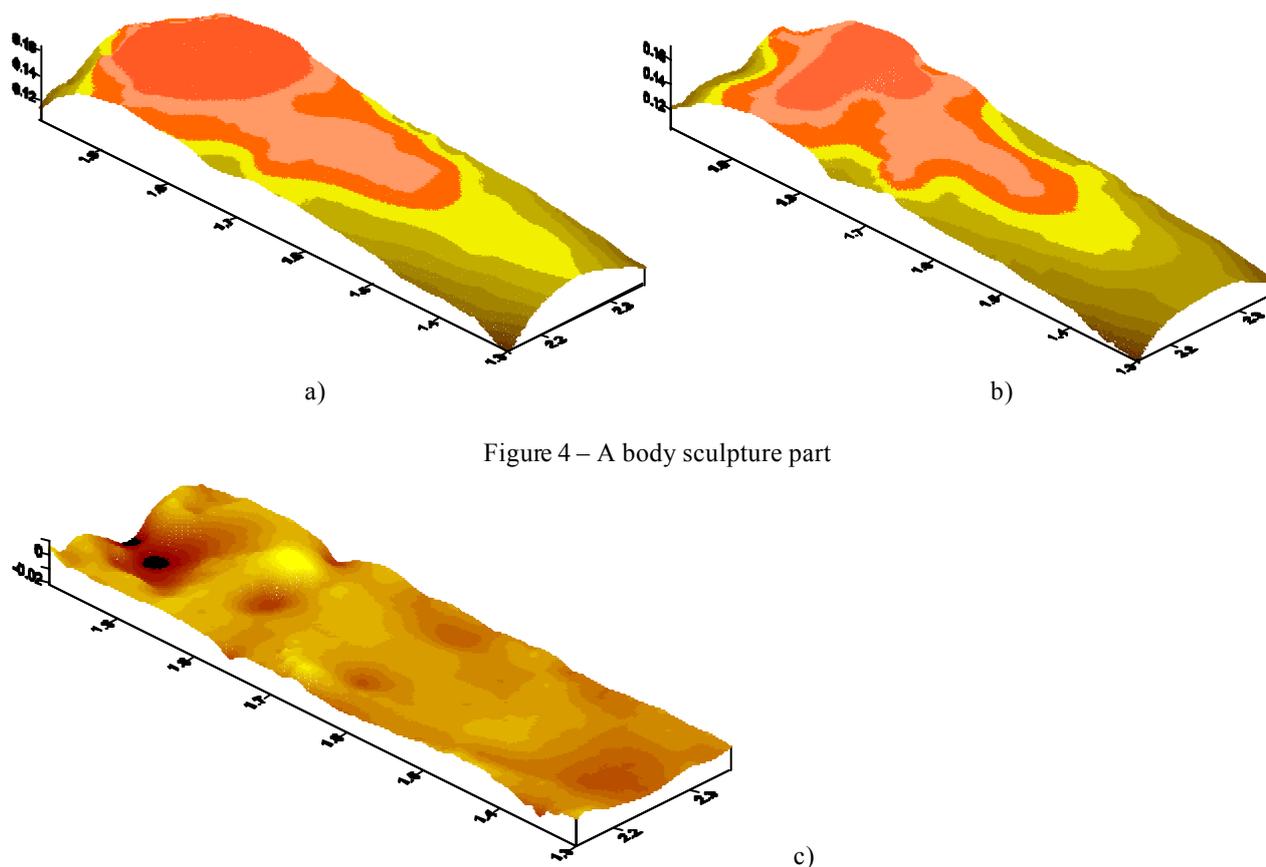
Figure 4 – A body sculpture part

Also in figure 4 we can see in a) the DSM made from '70s survey digitisation , in b) the DSM made from '99 restitution and in c) the DSM of differences between b) and a).

The maximum of the entity of the differences checked is up to 2 cm of erosion.
