MAPPING AND MONITORING INVASIVE AQUATIC PLANT OBSTRUCTIONS IN NAVIGABLE WATERWAYS USING SATELLITE MULTISPECTRAL IMAGERY

Mark E. Jakubauskas, Dana L. Peterson
Kansas Applied Remote Sensing Program
2335 Irving Hill Road
University of Kansas, Lawrence, Kansas 66045

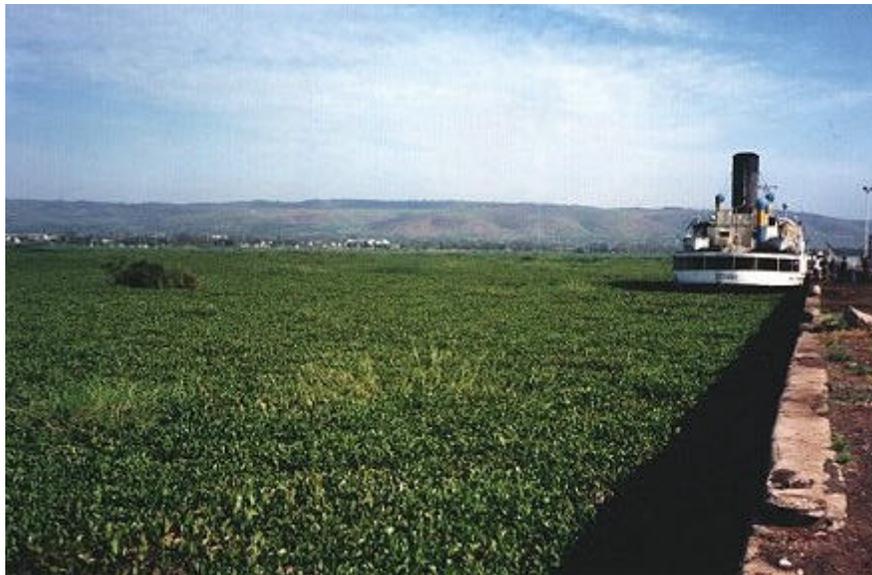
Figure 1. Water hyacinths blocking the port of Kisumu.

In the United States, aquatic plant invasion is a significant problem for southern and coastal states, predominantly Texas, Louisiana, Alabama, Mississippi, Georgia, and Florida, although nearly every state has some degree of infestation by one or more species. Transportation problems caused by aquatic plant cover are not limited to the US, however, and the effects of such infestations are particularly acute in tropical countries (Barrett, 1989). In South America, China, and parts of Africa, water-based transportation systems are often the only means of transporting people and freight, and consequently are particularly vulnerable to disruption by aquatic plant infestations. For example, in Kenya during the late 1990s and early 2000, extensive mats of water hyacinth growth in the Winam Gulf region of Lake Victoria were responsible for closing the port of the city of Kisumu, causing extensive commercial and economic disruption (Figure 1).

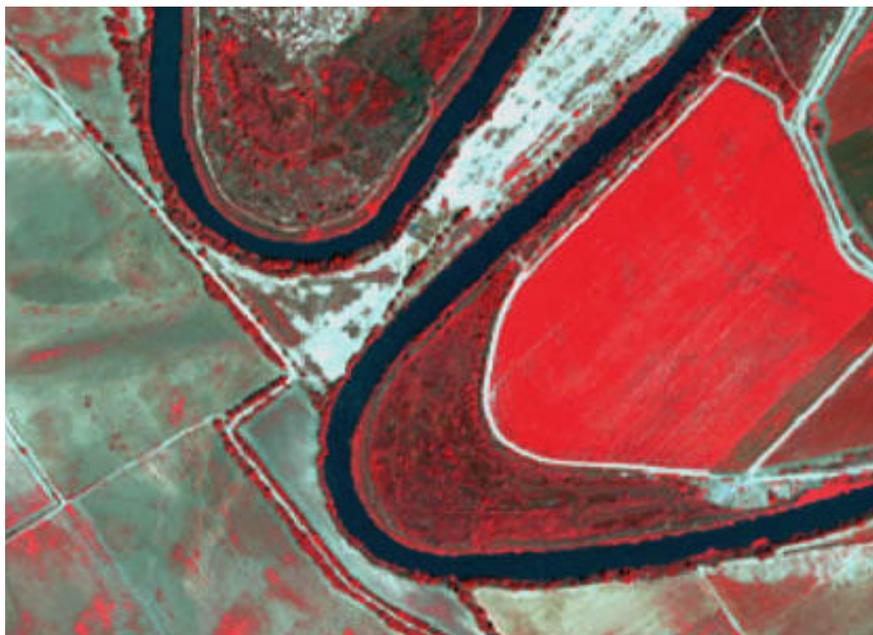
Figure 4. IKONOS image of same area 10 months later, June 16, 2002.

We originally planned to acquire the image six months following plant control efforts (carried out in August 2001), which would have indicated a second acquisition of imagery sometime in February 2002. Since this was early spring in southern Texas, and the plants were relatively dormant, we elected to postpone the acquisition until later spring when plant development would be more advanced and provide a truer indication of control efforts/plant survival. Space Imaging Corporation acquired a clear, usable image on June 16, 2002. The quality of the image is excellent (see Figures 3 and 4, images of a selected portion of the study are on the Rio Grande River).

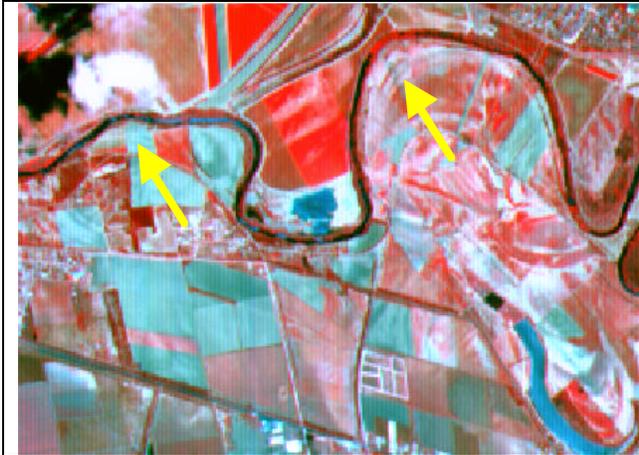
Figure 5a. January 21, 2001 ASTER imagery of Lloyd Bend area, upstream of the cities of Brownsville and Matamoros. Invasive aquatic plant cover is at a minimum on this date, appearing principally along the upper portion of the right-hand (downstream) bend).

The images varied considerably in cloud cover, from completely cloudfree to approximately 50% occluded. Images with significant cloud cover over the Rio Grande River were not acquired from the EROS Data Center. Invasive aquatic plant cover is at a minimum during winter months, as the growth rate slows and plants are “knocked back” by colder temperatures. Plant cover begins to increase in the spring, forming blockages visible on the false-color composite images as bright-red patches along the course of the river. Increased springtime growth of water hyacinth is also apparent along the banks in many places. By midsummer, significant blockages by water hyacinth and hydrilla are clearly apparent on the ASTER data. By the fall of 2001, as a result of control efforts and seasonal changes, aquatic plant cover has been reduced, although persistent blockages remain on parts of the river. Four samples of ASTER imagery from 2001 are provided in Figures 5a-5d.

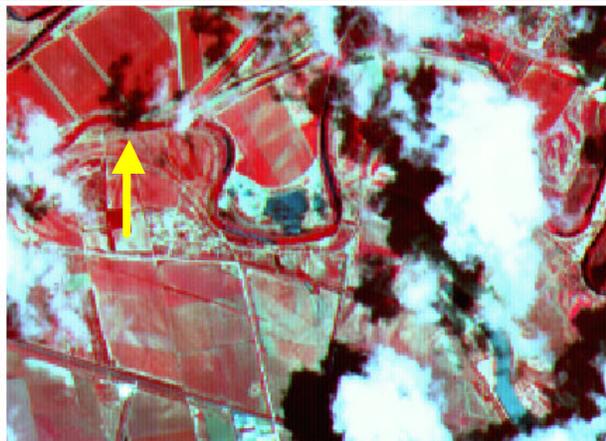
Figure 5c. June 4, 2001 ASTER imagery of Lloyd Bend area. Despite the cloud cover present over parts of the image, increases in plant cover are clearly visible. The left-hand (upstream) major river bend is now almost completely blocked by plants, significantly impeding water flow and boat movement along the river.

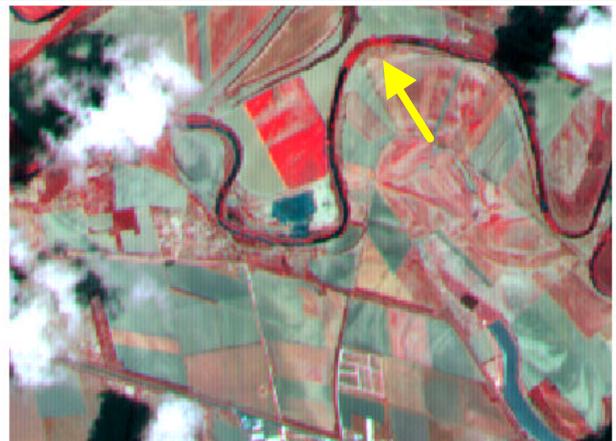
Figure 5d. December 14, 2001 ASTER imagery of Lloyd Bend area. As a result of control efforts and seasonal changes, aquatic plant cover is reduced on the image. This stretch of the river is nearly clear of water hyacinth, although a persistent blockage remains on the upper right river bend (Lloyd Bend).

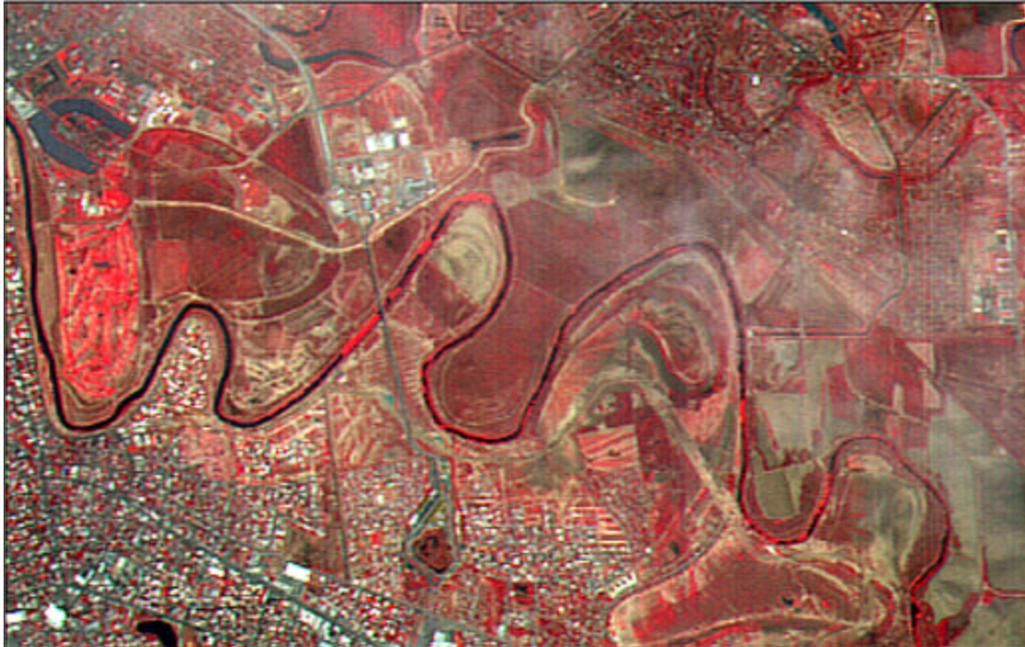
Figure 6a. ASTER imagery, Brownsville-Matemoros area, March 30, 2002. Most of the 7 kilometer reach of the river on this date is free of hyacinths (bright red areas along and within river).

ASTER imagery acquired during 2002: Three ASTER images were acquired for spring 2002: March 30, April 24, and May 9. Figures 6a and 6b show a section of the Rio Grande River separating Brownsville, Texas, from Matamoros, Mexico. The top image is from March 30, 2002; the bottom image from May 9, 2002. The Fort Brown Golf Course is at the left-central side of each image. In the images, the vegetation appears bright red, and water appears black. Total image width is about 4.7 miles (7.5 km). Significant increases in water hyacinth cover in the intervening six weeks are apparent on this image pair. A similar sequence of images for the same dates for an area several miles upstream has shown a 1.5+ mile accumulation of a hyacinth blockage during this six-week period, or approximately 200 linear feet of river per day.

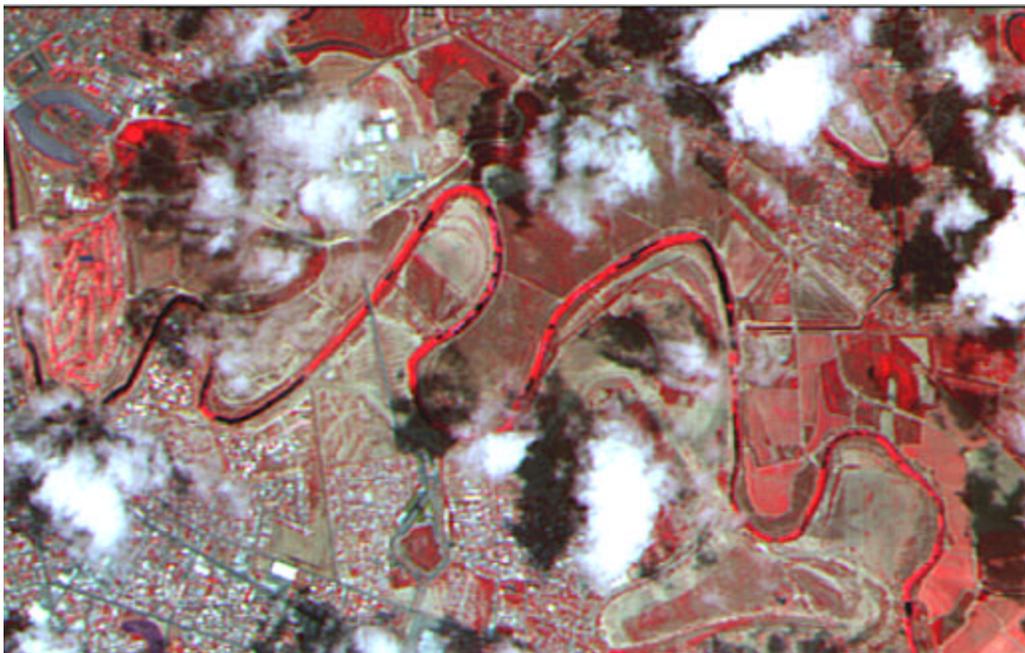
Figure 6b. ASTER imagery, Brownsville-Matemoros area, May 9, 2002. A significant proportion of the river has been overgrown by water hyacinths in the intervening six weeks (bright red areas along and within river).
