DIGITAL AND ANALYTICAL PHOTOGRAMMETRIC RECORDING APPLIED TO CULTURAL HERITAGE. A CASE STUDY: “St. DOMINGO DE SILOS’ CHURCH (XIVth CENTURY, ALCALA LA REAL, SPAIN)”

This paper is about a complete photogrammetric record of St. Domingo de Silos’ Church (XIVth century), in Alcala la Real (Jaen, Spain). It was declared National Monument in 1931. At present it is a ruin heavily damaged and near to collapse. So, local authorities have decided urgent actions for the reconstruction. Previous to the restoration works, different surveying and photogrammetric techniques were used for a reconstruction project and cataloguing of an important historical building, but at moderate costs with the extensive use of non metric and semi-metric instrumentation. A wide variety of photogrammetric methods and instruments has been applied: analytical and digital plotters; terrestrial metric, semi-metric (reseau plate) and non metric cameras (analogical and digital). Stereoscopic pairs, when possible, were taken with the help of a device which allowed for stereoscopic shots. Convergent photographs were also taken in order to reach a favourable geometry for bundle adjustment (selfcalibration) and control point

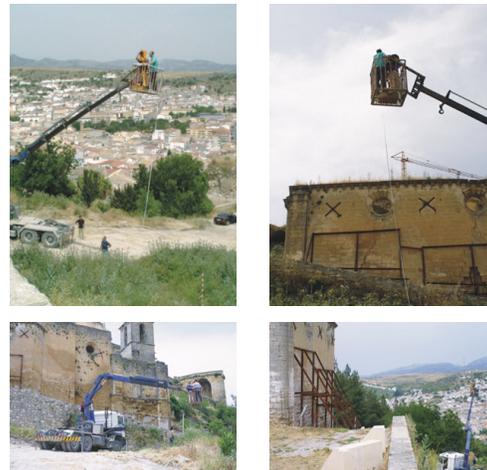
Figure 4. Stereopairs in the west walls were taken with the help of a mobile hoist.

Main eastern external walls and the façade were plotted using analytical stereophotogrammetry with UMK 1318/10 photographs. When necessary, shots were made from a mobile hoist (Figure 4). Stereoscopic base lines were situated with a total station and heights were measured with a tape from the platform.

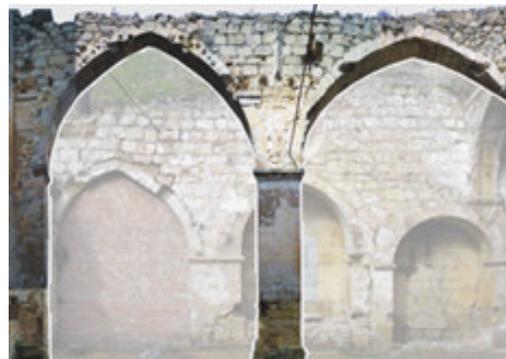
Figure 12. Images rectified mosaic of rear arches in the nave

Figure 11 shows a selection of highly oblique photographs employed in the bundle adjustment to solve the upper section of the rear arches. Workplace limitations made extremely complicate the measurement of control points due to excessively inclination of sight. So, most part of control points was by means of photogrammetric network densification. The rectified images mosaic of the rear arches is illustrated in Figure 12.

the right pillar was covered by convergent photographs. In the left part of the mosaic the deformation of walls and arch is noticeable. Thus this arch is leaning toward the chapel.

In both Figures 12 and 13 images of the nave walls have been added in the background only for visualization.

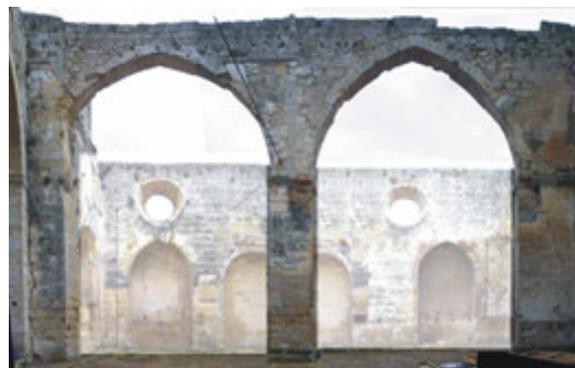
Figure 13. Images rectified mosaic of front arches in the nave

Figure 13 shows the front side of the arches. In this case stereopairs with the Canon D30 and 20 mm lens helped with the stereoscopic bar (Figure 5) were taken. Because limitations at the right side impeded the use of stereopairs,
