# IMAGE CHANGE DETECTION ON URBAN AREA: THE EARTHQUAKE CASE

**KEY WORDS:** Remote Sensing, Earthquakes, Change Detection, Disaster, Multitemporal

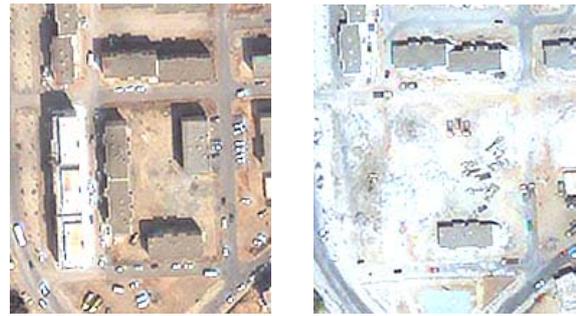
Figure 1. Boumerdes, change between 2002, April 22 and 2003, June 18.

Using Quickbird pre- and post-event images is possible to produce a map of damaged buildings, as required by EMS 98 macroseismic classification, at least for higher grade of damage. However, two Quickbird images need correction and registration to have a correspondence between single structural units on two different images (Fig. 1).

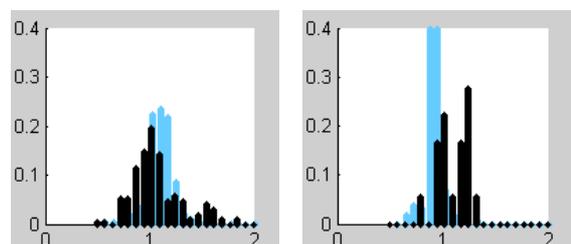
Figure 2. Left: ratio (post/pre event) in damaged buildings (black) and no damaged buildings (blue); Right: reflectance increasing in building and surroundings.

As can be observed in Figure 2 (left), it is quite impossible to define a threshold value to classify the damage using only roof reflectance. On the other hand, photo interpreters take into account surroundings of object/buildings to establish if a building is damaged or not: to simulate the surrounding of every building, a segmentation with an higher scale can be

performed, showing a significant increasing in reflectance on the damaged structures (Figure 2, right).

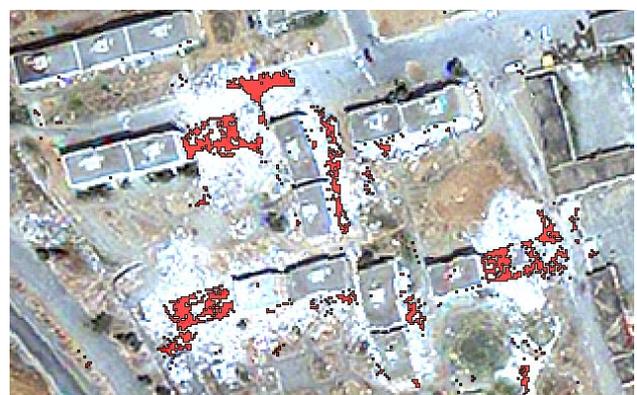
Figure 3. Boumerdes, change detection results by pixel-based classification.

The change detection module was applied between pre- and post-event QuickBird images. In order to remove false changes caused by presence of shadows, ISODATA classification of pre-event image was used: a class for shadows was identified and removed by its implementation in the decision tree. Other two variables were used in order to select the urban area: ISODATA classification of pre-event image and NDVI of pre- and post-event images.

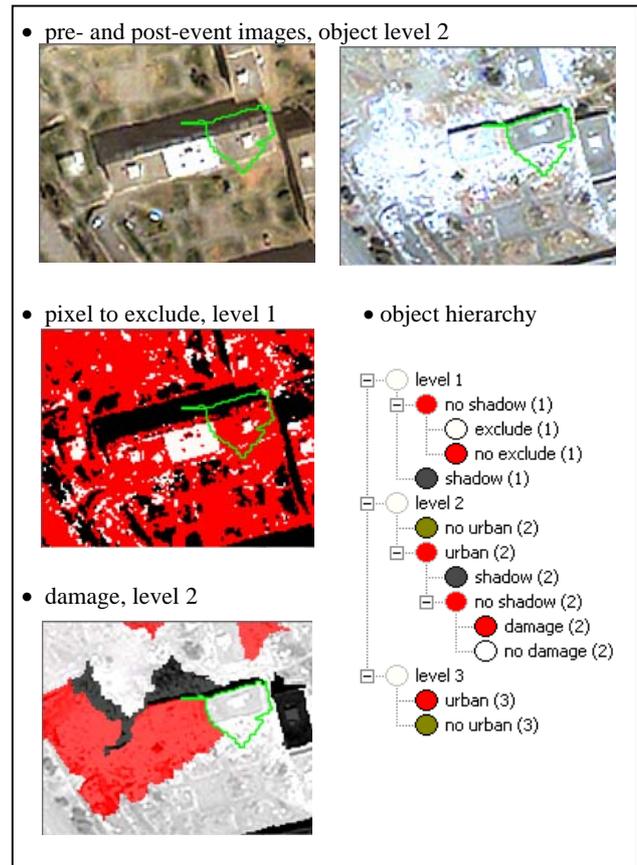
Figure 4. Object rules in eCognition, Quickbird image

Using scale it is possible to recognize different objects at different scales in the image. For instance, it is possible to separate urban areas using a texture value (for example object standard deviation) or vegetation using the NDVI index, or other index like in the case of ERDAS decision tree classifier. The level hierarchy is composed by two levels at least, the texture (level 3, scale 60-120) and the urban built (level 2, scale 15-30). In the urban level, it is necessary to define how an object is perceived as changed. Human eye is able to recognize reflectance changes without considering shadows; contrariwise, using image differencing techniques, an increasing in reflectance could happen when a building falls across a shadow in the other image. Thus, a sublevel of urban level (level 1) is created, to simulate the possibility of human eye to recognize reflectance in non-shadowed zones. The final level hierarchy structure is summarized below, in Figure 4 and in Table 5.

Level 1 represent a classified layer of shadow and saturated objects. In fact, Quickbird imagery presents some artifacts, or saturated zones, that should be removed to calculate damage index only on meaningful pixels.

Level 2 is the object of interest level: in this level a change index, such as maximum absolute difference on multispectral images or ratio post/pre event in panchromatic, is calculated. There is a hierarchical relation between this level and the level below: in fact, the index will be calculated only for meaningful pixels (not shadowed and no saturated).

In the Level 3, with the largest scale factor, vegetation and texture index could be used to separate region of interest, such as urban areas, and to avoid vegetated area from classification. Large damaged areas, such as flooded areas in the Marmara earthquake, can be well separated on this level.
