RAPID APPROACH OF INTEGRATED SURVEY FOR THE CONSERVATIVE ANALYSIS OF PICTURES.

The subject was the picture of Jesus Crucifixion, in the sanctuary of Cristo la Selva in Matera, on which were applied different types of data and non invasive integrated survey techniques.

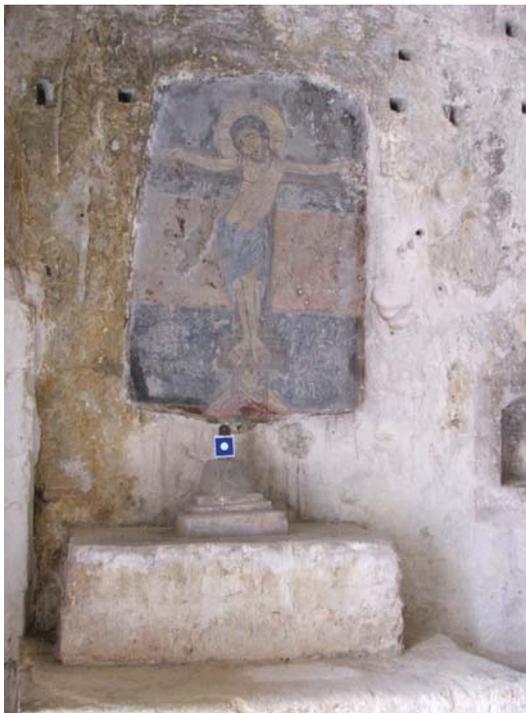
Figure 2. The painting of Cristo la Selva

The painting of Cristo la Selva has probably been made as a fresco on a thin plaster (of different thickness due to the irregular rock surface), composed by "tufina" and lime in direct contact with the tuffaceous rock into which crypts are carved [RCT03].

The style of the painting is Byzantine and its date is referable to 1600. In effects, also preserving the canons of Byzantine style, characterized by the two-dimensional look of the painting (without light and shade effects), the Christ does not present any more triumphant appearance, but closer to the rebirth of the western world that changes the figure from the erect representation with open eyes to that suffering and relaxed in the death with bent head and closed eyes. The same evolutions are also evident in the anatomical study of the body, still symbolized in two-dimensional way through precise signs of colour and moreover through the posture of the body that gets the idea of space between the Cross and Christ. In the painting there are also present the first Gothic aspects noticed through the elegance of the bust and the expressions of the face (fig. 2).

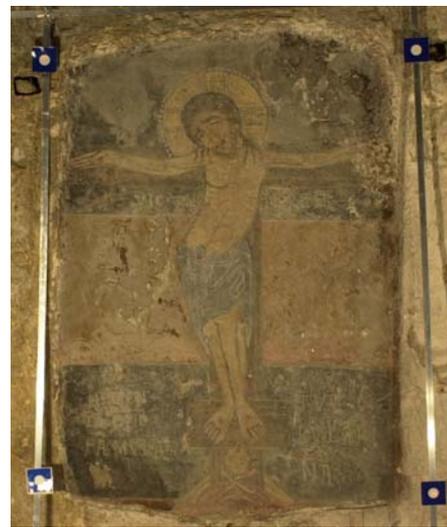
Figure 9. Photogrammetric Image

As visible in figure 9, there were materialized some points of support belonging to a metallic grate positioned on the painting. Through these points (recognizable in the photogrammetric image and in the laser scanner survey as well as in thermographic image), and other natural points, the processes of photogrammetric elaboration were run.

The photogrammetric data provided both the images necessary for a visual analysis of the object (to compare with other obtained results) and the metric restitution through the production of ortophotos.

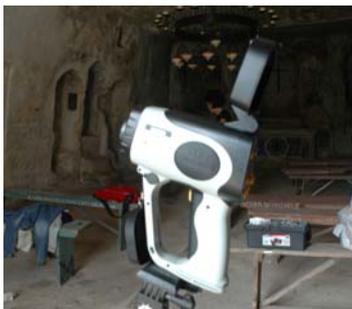
Figure 10. Thermal instrument

The thermal images were realized through Standard NECs version 7800 1.4A instrument (fig. 10) with sensor: 7100, dimension DX (0-319) DY (0-239).

The wall with the painting was heated through electric resistance reaching a temperature of around 50° Celsius. The characteristic parameters of the phases of survey were measured through Hygrothermometric sensory (Babuc M/A), necessary to acquisition, visualization, storage and elaboration of a big variety of physical and chemical attributes such as temperature, humidity, air speed, pressure, illuminance, gas, noise, etc. The thermal images allowed to analyse the external sub-surface structure through the comparison between the result before and after the heating, artificially provoked by thermo-convection, and to extract information corresponding to superficial differences and discontinuities, anomalies, defects and/or peculiarities invisible to the naked eye.

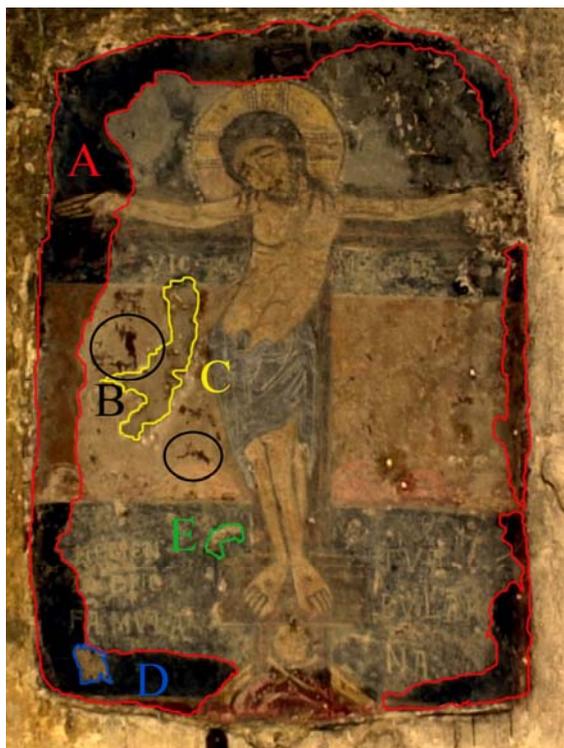
On the images the phenomena were named through the letters A) B) C) D) E) (fig. 13-14).

- A) Present in both the photographic image and in the laser one, it represents the grade of imbibition of the painting; in such points it was discovered the maximum gradient of humidity and temperature. It can also be observed that such phenomenon, also existing on the superior area of the painting, is not found by the classified laser datum, and it is more likely imputable to the imperfect perpendicularity of the laser ray with respect to the object.

- B) This phenomenon, also present in the laser image and RGB one, seems to be caused by the presence of mold e/o bacteria.
- C) It represents a supply element modified in the centuries, or an intervention of improvement, started after a phenomenon of detachment of a small area of painting, which was executed by using obsolete and handicraft procedures of restoration (fig. 15).

- D) This element, found in all the types of data, is imputable to the simple separation and loss of materials.
- E) More interesting is such phenomenon that represents an element of discontinuity in the rocky structure, actually, it is not influenced by the capillarity of the water (fig. 16).

Figure 13. Wet Image with underlined phenomena
