PRINCIPLES AND METHODOLOGY OF INTERVENTION FOR STRUCTURAL RESTORATION

M. Ioannidou

Greek Ministry of Culture, Acropolis Restoration Service, 10 Polygnotou str. 10555 Athens, Greece (mioannidou@culture.gr)

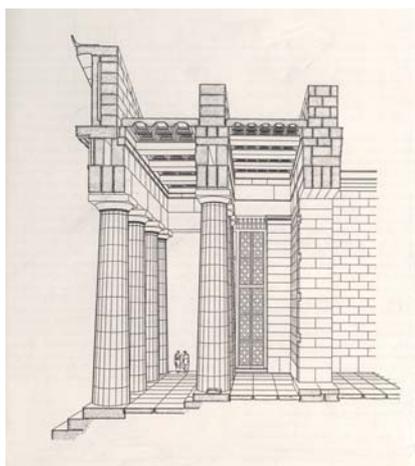
Figure 3. Section plan of the Parthenon. By M. Korres

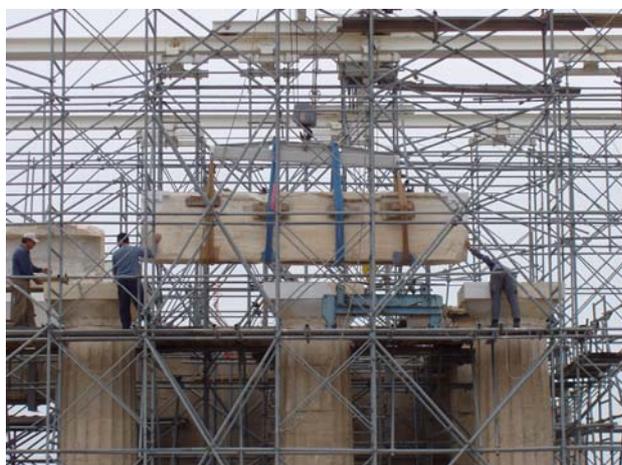
Figure 5. Resetting of a architrave after its structural restoration

When the architectural members have been repaired, they are set again in their original positions or in positions where they had been placed during the previous restoration. They are connected with titanium clamps and dowels which are secured in the ancient clamp and dowel cuttings and sockets with inorganic plaster. During the re-setting of members, geometrical deformations of the area that was dismantled are partially corrected to the extent allowed by the remaining distortions of the members that were not dismantled, in order to achieve as much as possible the original form.

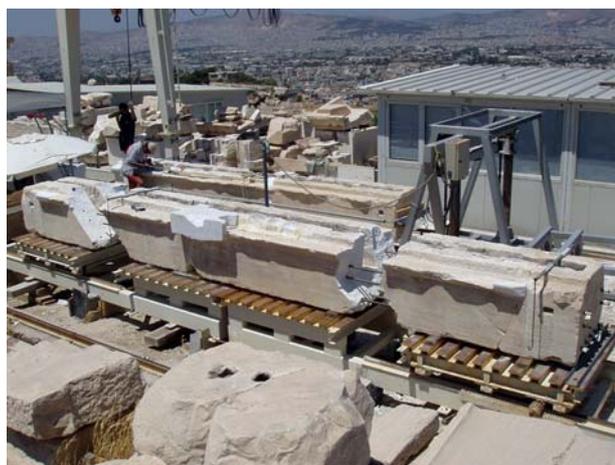
Figure 7. Joining of fragments of a beam by means of titanium bars, at the specially designed table. By T. Tanoulas.

During the joining of the beams fragments special care is taken so that the width of the join in the place where it is glued is as small as possible. The smallest possible amount of plaster is therefore applied. This is successful because the broken surface of the ancient piece is copied on the new marble (when an addition is made) and the fragments to be joined are strongly bound together during the process of joining and during the first stages of hardening of the plaster. Adhesion of the titanium to the plaster is improved by threading the rods.

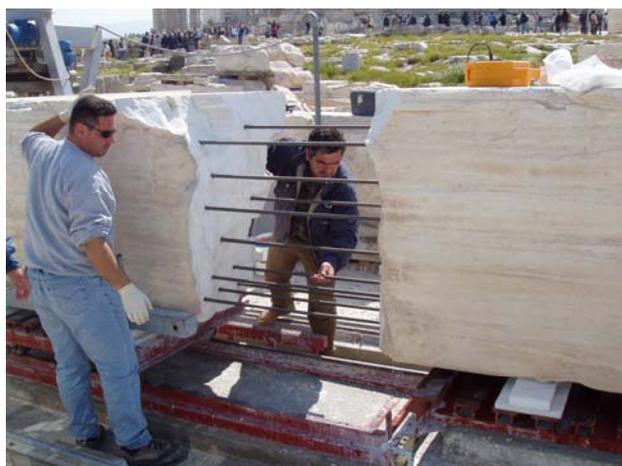
Figure 8. Preparation for the joining of the beam fragments

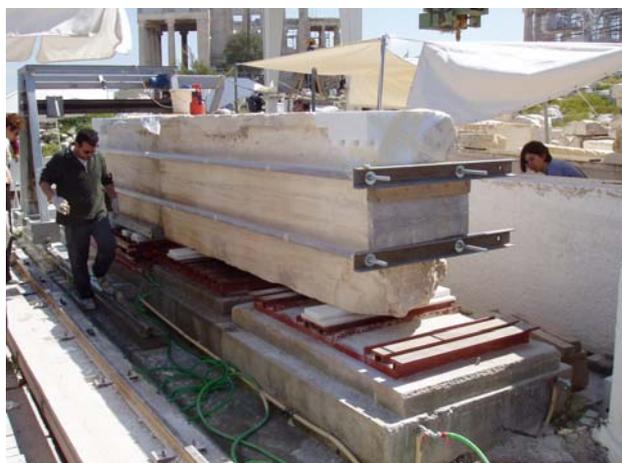
Figure 9. Binding of the beam fragments after the joining

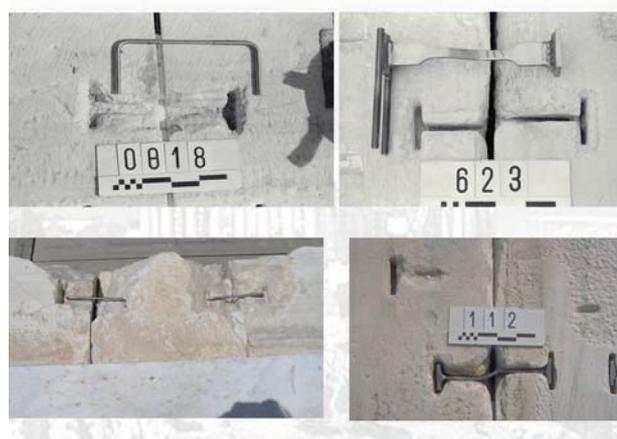
Figure 10. Different types of titanium clamps

If the original socket is preserved, the double-T clamp is designed so as to have the greatest possible strength and ductility. These are determined by the bearing capacity of the marble in the area of the socket. The new titanium clamps have the same form as the ancient ones with reinforced transverse legs, whereas the long leg forms a long neck so as to prevent the failure of its significant deformation and thus significant absorption of force. If the cavity (socket) has been damaged, the smallest intervention on the ancient marble is made secure by opening two drill holes in the position of the transverse legs and by using II-shaped clamps (letter II of the Greek Alphabet). The same principle is applied to the design of the dowels (rods). To increase deformability of the dowels/clamps in situations of shear force, a space of 1-2 cm. is left in the area between the dowel/clamp and the socket. This is left free of cement plaster so that transverse deformation of the clamp/dowel is possible.
