## NDT DETECTION OF DECAY AREAS AND EVALUATION OF THEIR ATTRIBUTES

P. Kapsalas<sup>a</sup>, M. Zervakis<sup>b</sup>, P. Maravelaki-Kalaitzaki<sup>c</sup>, E.T Delegou<sup>d</sup>, A. Moropoulou<sup>d</sup>

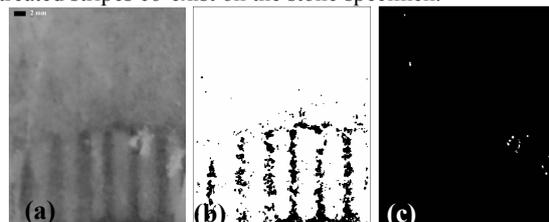
Figure 6: (a) Stone material (monitored by a digital camera) demonstrating cleaned and un-cleaned stripes, (b) Black particles detected, (c) white particles detected.

As it was stated previously, one of the objectives of this work was to assess the effectiveness of the implemented algorithms under different monitoring systems [11]. Figure 6(a) illustrates a stone surface depicted by the digital camera, while (b) and (c) shows the segmented black and white spots. Figures 7 (a) through (c) depict the same surface monitored under the reflectography in the visible spectral band and the black and white particles detected on it. As it can be seen, treated and untreated stripes co-exist on the stone specimen.

Optical inspection by the experts on Figures 6 and 7 verifies that the topology of the detected black particles, their spatial distribution as well as their shape and size closely resemble to their own judgment of sporadic particle presence. A more dissect inspection of Figures 6(c) and 7(c) though, reveals the detection of white decay spots even on treated regions. According to the experts' assessment, these spots are associated to regions of material loss. The above false positive induction illustrates the inability of the monitoring systems to distinguish between areas where gypsum prevails and other areas where material loss occurs. This limitation arises from its low magnification rate as it becomes difficult to view the inter particle area between adjacent black spots and thus to accurately locate areas of gypsum or CaCO<sub>3</sub> presence. A further explanation of the false positive detection is associated to the operation of the reflectography screening system and is discussed in more detail in [11].
