EVALUATION OF SHAPECAPTURE AS A HERITAGE DOCUMENTATION AND MONITORING TOOL.

KEY WORDS: Recording, Monitoring, Digital Photogrammetry, Stereo-matching

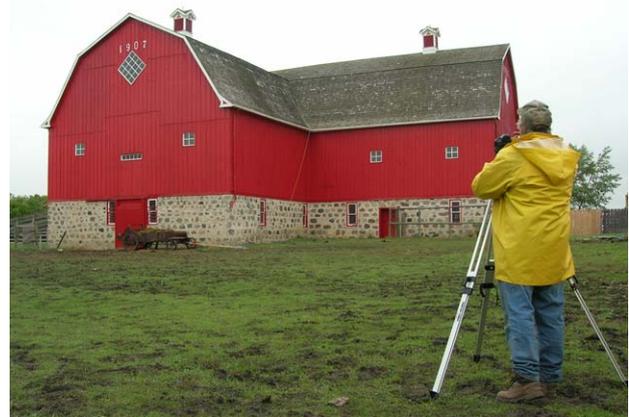
Figure 4. Site staff taking photos at Motherwell Homestead NHSC

A major challenge for this project was the client's limited budget, making it difficult to send a survey crew at the desired monitoring time interval. In 2005 a decision was made to produce an initial survey as a base for future comparisons. In order to achieve the desired measurement time interval of once a year, Shapecapture would be used to evaluate/capture overall movements. In lieu of a survey crew, a digital SLR camera was sent to the site (2,600 km from HCD's office in Ottawa) so that site personnel could take photographs at pre-determined stations. The camera and photographs were then returned to HCD's office for a comprehensive evaluation and comparison with previous models.

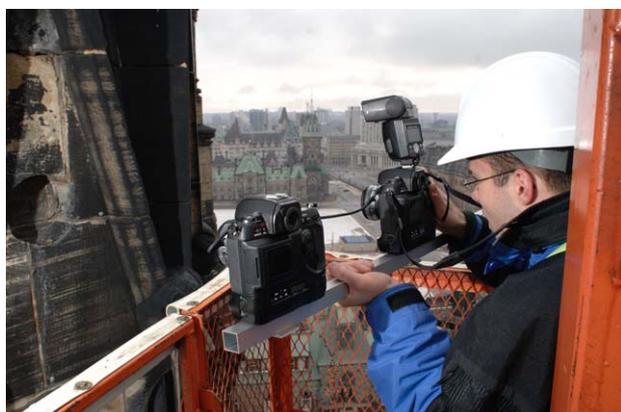
Figure 7. SLR Cameras to capture stereopair.

A photogrammetric pair using a digital SLR was captured of each panel from a crane. Some photogrammetric pairs were registered and sent to a consultant for assessment. This consultant has developed a method that matches pixels within the stereopair. This method is proving to work well on surfaces that have textured surfaces such as the sandstone on the Mackenzie Tower. The resulting point cloud approximates the density of data produced by a close range laser scanner. The intent is to compare the various scans of a specific panel and measure the differences in millimetres, and possibly microns, of the eroded areas. A benefit to this method is that it is quite similar to a traditional photogrammetric project in that these digital photos can be evaluated at a future date and for very specific areas.

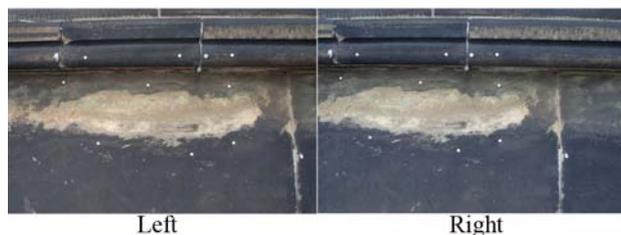
Figure 8. Stereopair.

Another benefit of this method was that there was little initial cost to take the photogrammetric pairs. These pairs were photographed at the same time as the visual record photos. Once the pairs were photographed, the team could then decide which panels to evaluate. Another similar advantage is that at the start of any monitoring program, it may be difficult to determine where the greatest movement/erosion occurs. This method allowed the team to capture many pairs or areas without sacrificing the project budget. This would allow many areas to be recorded for initial data to compare in the future. Once an area is deemed to have visual evidence of erosion, the initial pair could be evaluated against a later pair to quantify the amount of erosion.

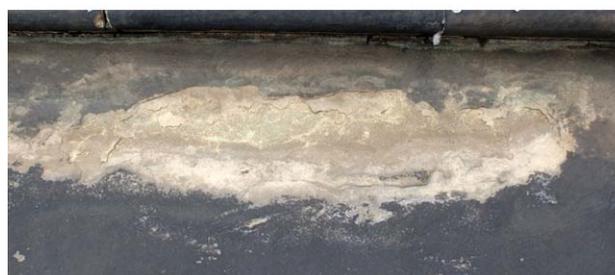
Model

Photo

Figure 9. Visual comparison of model and photo.

This method is continuing to be evaluated. The consultant used for the stereomatching service has done some successful testing by comparing data of a laser scan to the stereomatching pair. The next phase of the project will be to compare the data of multiple visits to see if the precision of the stereomatching models is sufficient to detect erosion.

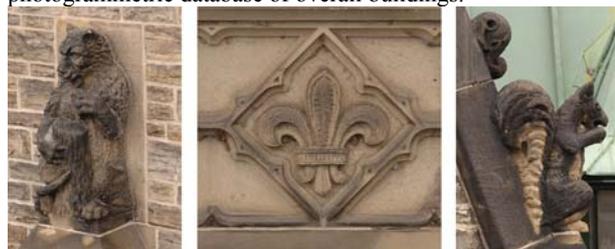
Figure 10. Carvings that could be modeled by stereomatching.

If successful, these monitoring projects may change how the Heritage Conservation Directorate undertakes documentation, such as capturing architectural elements like stone carvings. This tool could eventually be incorporated into HCD recording programs as a means of capturing large amounts of accurate 3D coordinate information for architectural details to be reconstructed at a later date, similar to the HCD's existing photogrammetric database of overall buildings.
