THE SURFACE CONSERVATION PROJECT OF THE ACROPOLIS MONUMENTS: STUDIES AND INTERVENTIONS

E. Papakonstantinou*, A. Panou, K. Franzikinaki, Anthi Tsimereki, G. Frantzi

Ministry of Culture, Service for the Restoration of the Acropolis Monuments,
Polygnotou Str. 10, Athens 10555, Greece. epapak@yahoo.com

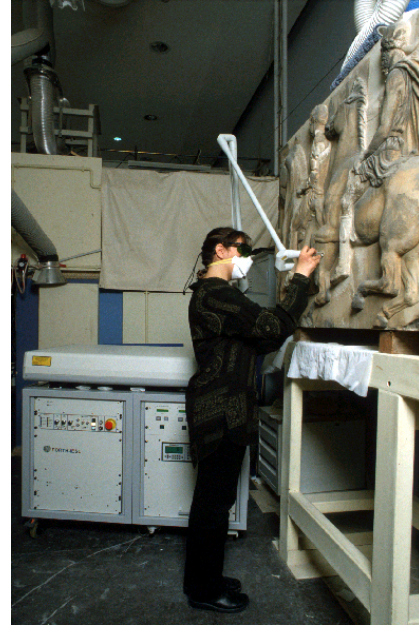
After experiments to all the possible substrates and encrustations present on the surface of the Acropolis monuments, the IESL-FORTH research team suggested combining the action of the two discrete laser ablation mechanisms. This was accomplished by the simultaneous use of two laser beams of different wavelengths, whose pulses were temporally and spatially overlapped. According to this scheme, a prototype hybrid laser system was developed by the IESL-FORTH (EP1340556A2) which in its initial state was tested successfully on the Acropolis site (Figure 6). The laser system developed was a Q-switched Nd:YAG system emitting at the fundamental (1064 nm) and the third harmonic (355nm), with

the option of using the two laser beams individually or in combination and in various ratios of energy densities. This made possible to combine different cleaning methodologies to adjacent areas of the surface to be cleaned with no profound colour or structural differences.

Figure 6. The laser system

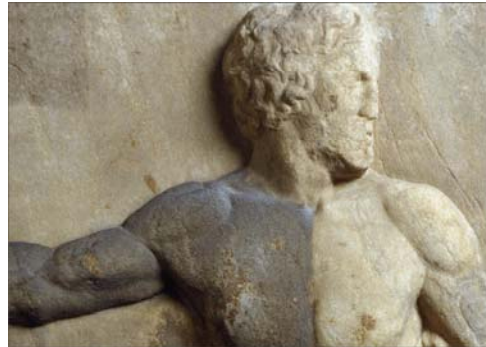
The combination of the infrared and ultraviolet radiation at relatively low energy fluences ($F_{IR} = 0.3 - 0.5 \text{ J/cm}^2$ and $F_{UV} = 0.08 - 0.2 \text{ J/cm}^2$) on loose deposits was successful without any discoloration to the underlying marble surface (Figure 7). However, in some cases, where the substrate is non-homogeneous due to deterioration, loose deposits remain among the marble crystals. In these cases, infrared radiation alone at higher densities about $0.6\text{-}1 \text{ J/cm}^2$ was applied selectively on the non-cleaned areas.

Figure 7. Detail during the laser cleaning

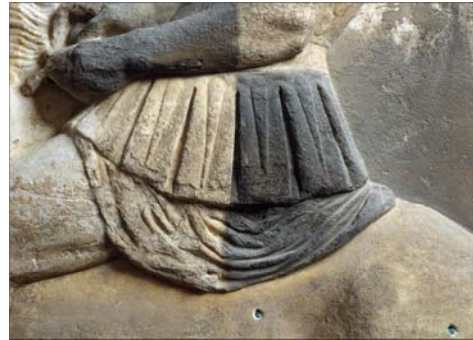
Figure 8. Detail during the laser cleaning

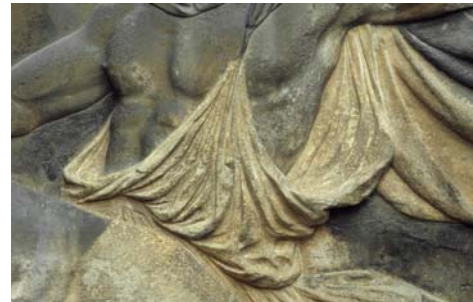
Figure 9. Detail during the laser cleaning

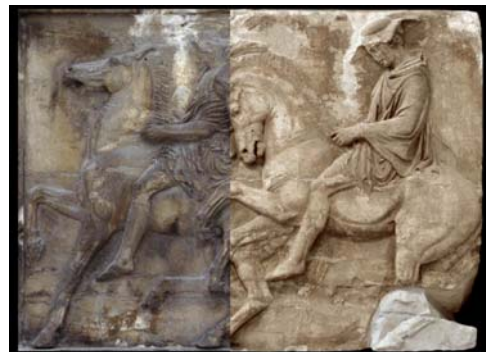
Figure 10. During the laser cleaning

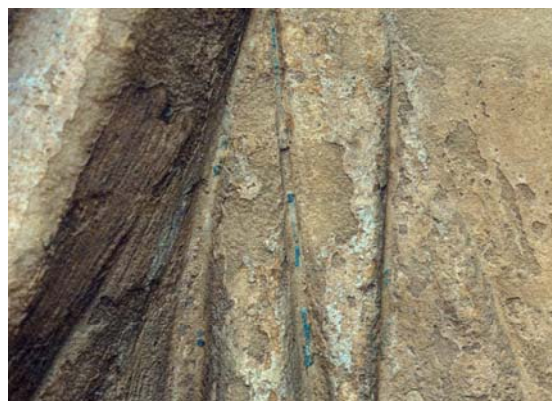
Figure 11. Ancient colour traces

The cleaning process revealed the precious details of the sculptures and traces of ancient tools and colours (Figure 11,12).
