PHOTOGRAMMETRIC DOCUMENTATION OF THE VAULTS OF HISTORICAL MONUMENTS

M.Potůčková, E.Štefanová, S. Grill

Charles University in Prague, Faculty of Science, Albertov 6, 12843 Prague, Czech Republic
stefano1@natur.cuni.cz

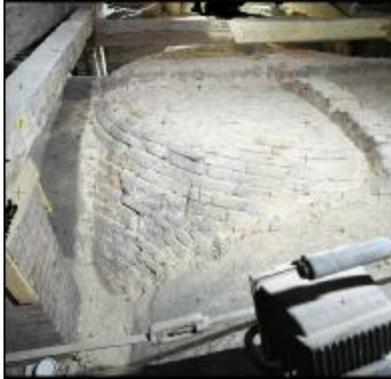
Figure 2. A vault from above

The vaults were first cleaned from malt so that all brick and joints were visible (Figure 2). A set of about twenty photos per a vault were collected. The positions of the camera were chosen with respect to the further processing in the software package PhotoModeler.

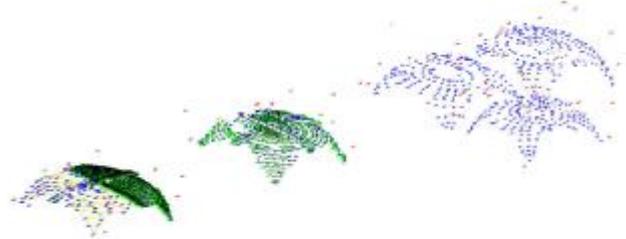
Figure 8. The final result: a 3D model of all vaults in one reference coordinate system after importing to AutoCAD. The measured points are displayed in blue colour, outlines of the bricks are in green colour and red points show control points used for the final 3D model.

A single spatial model was created for each vault in PhotoModeler. Examples of outputs in different stages of processing and visualization are presented in Figures 5 - 7. All models were exported as dxf files and connected in AutoCAD at the end as shown in Figure 8.
