IN SICILIAN ANCIENT THEATRES THREE INTERVENTIONS OF RESTORATIONS IN SICILY

V.L. Ruggirello

KEY WORDS: restoration, morphology, building technique, preservation

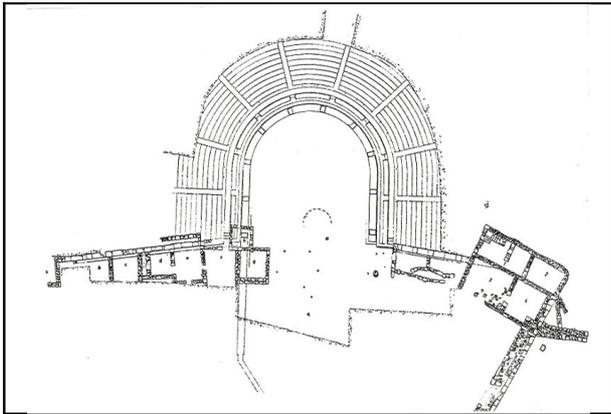
Figure 2. The plan of theatre Eraclea Minoa (De Miro, 1966)

The Theatre is settled on the natural declivity of the hill, whose geology is not unitary: the inferior part is of marly nature, the superior one is composed from sandstone of astian type, that is sparsely cemented. The *koilon* (auditorium), with diameter m 33,25, is oriented to the South with the view on the sea. The semi-circumference of the cavea is extended through two parallel lines that form a very stressed horseshoe, figure 2. The *koilon* is divided radially in nine *kerkides* (wedge-shaped) from eight *klímakes* (stairways). Horizontally it was divided in ten orders of seats, of stone of marly tufa. It presents a *prohedria* (seat of honor around the orchestra) and a *diazóma* (horizontal walkway), for which the *koilon* is subdivided horizontally in three fields: the *ima-cavea* composed by ten seats and the *epithéatron* (seating in theatron above the diazoma), where spectators sit directly on the slope; at last, a *prohedria*, composed by nine benches in correspondance of the pertinent wedges, everyone of which is constituted by more blocks. The tiers of the *koilon* are constructed with blocks of limestone-plaster arenite, very tender and friable, that has lost nearly totally the compactness and the cohesion of the stone because of the progressive washing away. The frontal

Two various levels of the *orchestra* (dancing place), with horse iron shape which diameter measures m 14,20, has been recognized, that are correspondent to two various ages of realization: in the earlier stage it is composed from marly beaten, while subsequently the *orchestra* is covered with a turn of tans in the inferior limit of the *kóilon*. The *eúripós* appears like a channel, which allowed the passage of the spectators, interrupting itself in correspondence of the *kerkides* through ten rectangular openings for the flow of water. The access to the *kóilon* was directly from the *orchestra*, through *párodoi* (passageways). There are not traces of constructions of the scenic building. They have found holes for poles that let to suppose that they had to serve in order to support a mobile ligneous proscenium. In 1955, the Central Institute of Restoration of Palermo carried out some interventions of consolidation on the entire theatral building, because the stony material was strongly degraded and had lost its original solidity. The executed intervention consisted in consolidation, by means of the application of chemical products as a spray and of a plastic-protecting solution, which created a removable film. Unfortunately, such film, rather than protecting the building, has prevented the humidity, present in the stony material, to come out, accelerating the degradation process.

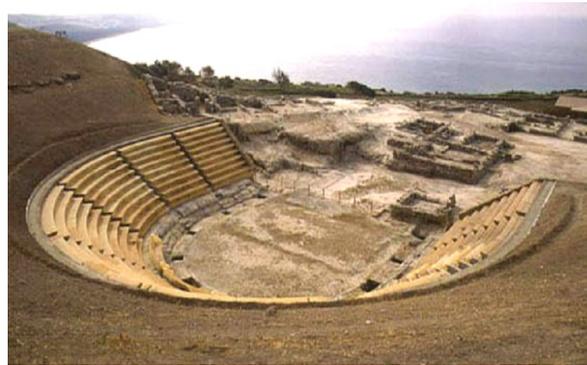
Figure 3. Theatre of Eraclea Minoa with the Minissi's cover

A new intervention of restoration was necessary in 1960: the assignment of planning a cover was given to the Arch. Franco Minissi, which began the works in 1963. The realized plan was based on precise indications, as the transparency that lets to show the monument, the possibility to shape and to model the several parts, allowing an easy reading and understanding of the monument. The created inner tube would have made possible, moreover, a thermal isolation with the task to defend stones from cold. For the execution of such cover, it was necessary to use a shape in Perspex, that would have guaranteed requirement of transparency, figure 3. Contrarily to the plan of Minissi, that previewed some vertical septa realized in perspex, anchored through implantations in aluminium, more than seventy T bars fixed on the tiers trough so many holes, of approximately millimetre 400, walled with grout. An irreversible damage to the entire monument has been created. Moreover some walls in reinforced concrete were executed side by side with the seven *klimakes*, and a system of water-drainage, realized up stream to *kóilon*, with the creation of a channel in concrete. The two lateral heads of the walls of

analémmata were reintegrated with walls of new brick built above them.

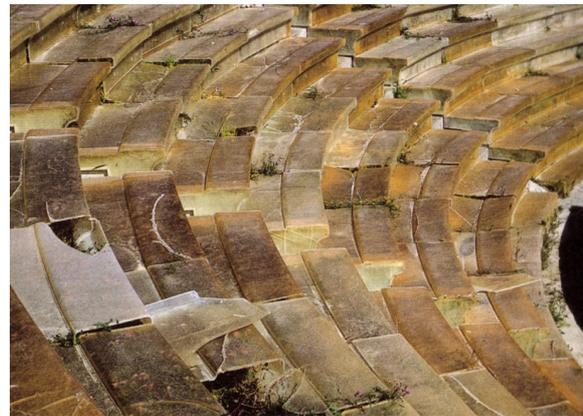
Figure 4. The cover become yellow and under it there was a spontaneous vegetation

The purpose to protect theatral building was soon neglected, accelerating remarkably the degradation processes which are: erosion, pulverizations and disintegration, scaling, gaps, exfoliation, separation, biological patina, efflorescence. The entity and the causes of degradations are various: in the exposed part degradations were caused from chemical and physical effect of the eolian and meteoric action; in the covered part they were caused both by the oxidation and corrosion of the metallic structure, with the consequent fissure of the stone, and by the infesting vegetation that is favoured by the greenhouse effect. It is clear in which state the Theatre appeared when in 1995 the Superintendence of Cultural and Ambient Heritage of Agrigento started an extended campaign of studies finalized to the acquaintance of the causes of degradation and to the corrected execution of the restoration works: the cover had lost its transparency and had become yellow, figure 4; many elements were broken; the supports in iron, originally white painted, were oxidized, folded or broken; under the cover there was a spontaneous vegetation that reproduced the shape of the steps.

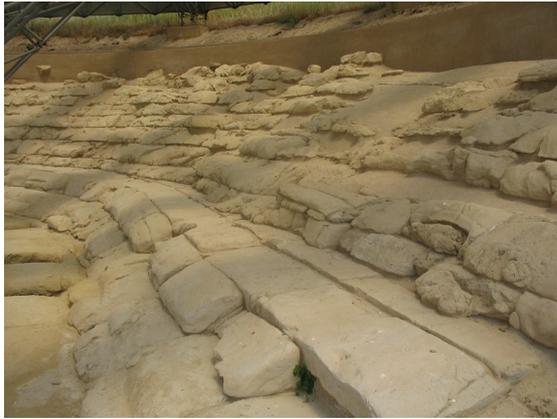
Figure 5. The Koilon of theatre of Eraclea Minoa after the restoration

restoration¹. The successive operation has previewed the disassembly of the old protecting structure, the removal of vegetation and accumulation of ground on the stone, and to the application to spray of ethyl silicate, as general preconsolidating. The operations have interested the removal of iron bars, the removal of the stuccature and cement integrations. The fragments which were, fragile and pulverulent fragments have been dusted and glued with mortar; those ones of greater dimensions have been fixed always with mortar and with some micro-hinges in glass-reinforced plastic, figure 5. Today the Theatre is protected temporarily by a cover that is not incident on the monument and thought in the respect of ambient figure 6.

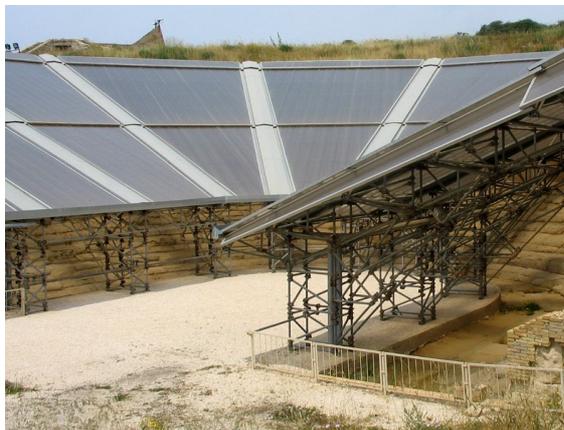
Figure 6. Today the Theatre is protected temporarily by a cover

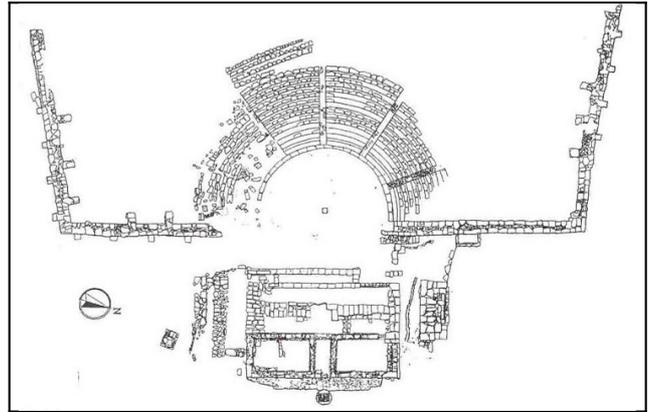
Figure 7. The plan of theatre of Morgantina (Sposito, 2003)

310 b.C., the Agatocle period, and a second one between the IV century and the beginning of the III century b.C. The *kóilon* that is built with local limestone blocks, with horse shoe shape, has a frontal diameter that measure m 57,70, and is subdivided horizontally in two sections: the *ima-cavea*, composed from sixteen orders of seats, and the *epithéatron*, in struck earth, had no places to seat. Seven *klímakes* subdivided radially the *ima-cavea* in six *kérkides*, of which two constructed under the *analémmata*, figure 7. Such subdivision that is with equal number of *klímakes* is no diffused in theatres of Greek origin, since in the center of the *kóilon* there is one *klímax* in axis to the Theatre, rather than one *kérkis*^{*}.

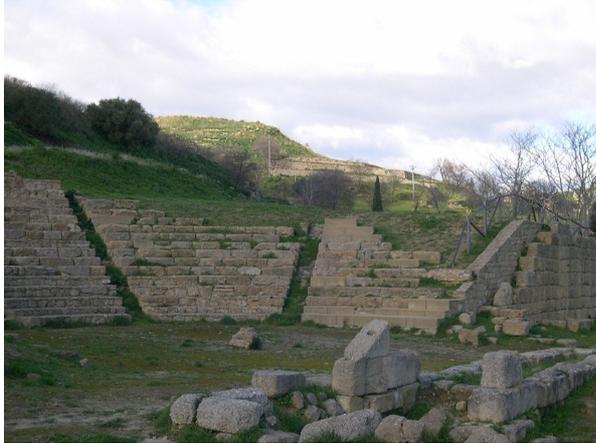
Figure 8. The Koilon of Morgantina's theatre before the last restoration

The *kóilon* is settled, for a quarter, on a open space in light slope of the rocky ridge, on which, in order to emphasize the inclination, filling material composed by rubble granulate, sand and ground, was put with beating and previous wetting. On such foundation a floor of variable thickness, was probably spread with the aim to settle the slope, at last on it stairs were mounted which, for their little compact nature, had to be joined with filling mortar. Thick walls, supported by inner counterforts, the *analémmata*, contained this material. The *analémmata*, constituted by a part which is perfectly orthogonal to the axis of the Theatre and from an other inclined one, like a upside down trapeze, is composed by building double curtain surfaces: the external one has pseudoisodoma waving, while the inner one is irregular, filled up by “box wall” and broken material. A row of limestone blocks marked the shape of the orchestra, an extended semicircle, which has the plan constituted by impermeable sand and clay, figure 8.

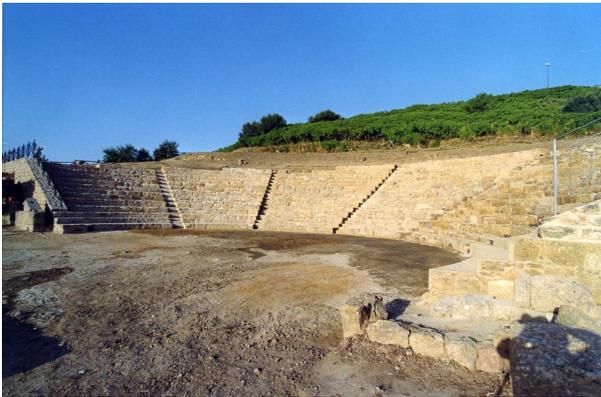
Figure 9. Morgantina's theatre after restoration

The last intervention of restoration of the Theatre was executed between the November of 2003 and September of 2005. The works, financed by the Regional Province of Enna and supervised by the Superintendence of Enna, assigned to Archh. Alberto Sposito and Francesco Franchina, have assumed the purpose: to re-establish physical and structural integrity of the manufacture; to restore the works executed in Sixty years; to give back to the theatre its original shape, in respect of historical evidence; to take part with suitable works aimed to the conservation of the monument and to reduce the costs of

extraordinary maintenance; to get material and constructive procedures that are reversible; to assure the benefit of the monument in its physical functional and historical globality, to value the monument and its context, figure 9.

Some trials on filling material executed behind the right frontal *analémma*, that had serious structural failure, and they have recorded an argillaceous ground water saturated, which provoked an excessive thrust on the structures of the *analémmata*. The intervention constituted in dismounting partially the wall, replacing with barren material in the lower surface; a tube for the water-drainage has been placed at the base of the digging, and the walls have been waterproofed with reinforced geomembrane, coupled to geocomposite in order to facilitate the water-drainage of infiltration waters. The blocks of the wall of frontal *analémma*, which are been already collapsed, have been catalogued and reused. The blocks of the superior rows, that had excessive failure, have been dismount, catalogued, and replaced. The stony surfaces of the vestments have been cleaned up and dealt to the aim to conserve, to consolidate the present state of stone, and to avoid a successive degradation. At last, some new *klimakes* in grey local stone have been realized between the fields of the *koilon* in order to avoid the improper use of the sitting and in order to concur a sure reutilization of the Theatre.

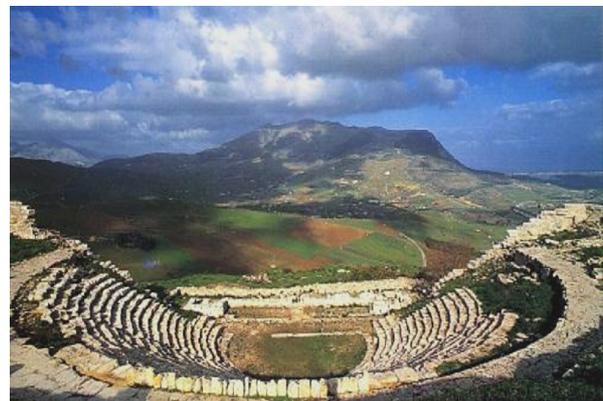
Figure 10. Theatre of Segesta

The *koilon*, that surrounds the *orchestra*, with horse iron shape, has a diameter of m 64. Contrarily to the other theatres of the Sicily, excluding Syracuse whose *koilon* has been dug in the rock, the Theatre of Segesta is not found above the mount but it has been built with an ingenious system. The *koilon* is subdivided by two *diazóma* in three fields, the *ima-cavea*, the average cavea and the *summa-cavea*, of which the inferior it turns out subdivided by six *klimakes* in seven *kérkides*, composed by twenty sitting orders. Under the western zone, a cove is found, whose the functions are not still completely know*. The access to the *koilon* for public was through the *parodoi*, which are situated along the frontal *análemmata*, through two entrances in *summa-cavea* opened in the perimetral wall, figure 10.

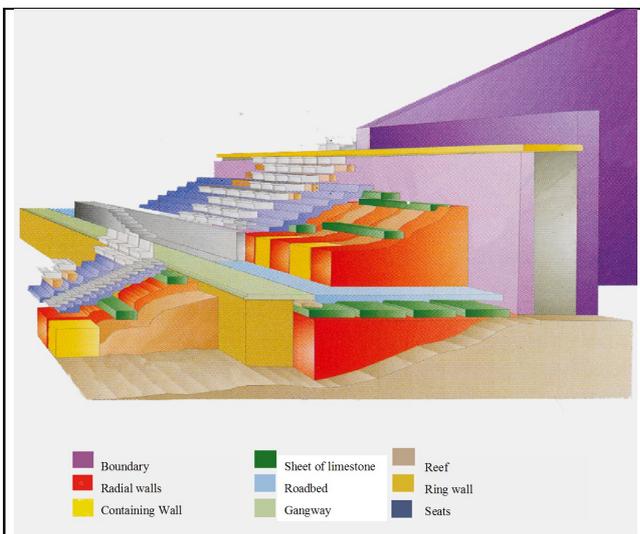
Figure 11. The constructive technique (Camerata Scovazzo, 1996)

disposition covered by a big stone slab. It constituted a crawl space in which the cavity served to lighten the push of the ground of filling against the wall of *análemma* that covered all structure, figure 12. Unlike the other Greek theatres, that they are usual to lean itself on the hill, the entire building seem rested on the empty one, thanks to this ingenious sac technique, that let it to be leaned on an artificial ground filling. This constructive technique seems to precede the systems of vaulted substruction that, instead, are peculiar of the roman theatres. The *orchéstra*, with horse-shoe shape, of m 13,8 of diameter, is composed by ground earth striking marked by a row of calcareous rock blocks. Like the greater part of the theatres in Sicily, it does not present the *euripos* (channel of drain of waters), but a square basin on the western side. Like for the greater part of the classical theatres, of the scenic building remain only the traces on the ground that allow us to identify it like a building to *paraskénia*. The scenic building, built with calcareous rock blocks, is with closed proscenium, flanked by two lateral bodies, *paraskénia*, whose facades degrade towards the inside of the scene, creating perspective effect.

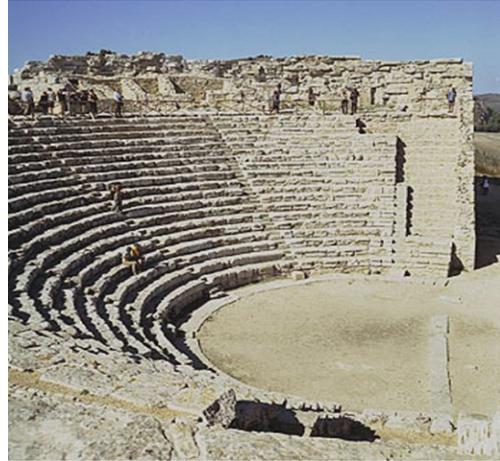
Figure 12. The Koilon of the Segesta's theatre after the restoration

Recently it has been undertaken a new plan of surveying and restoration, terminated in 2001, realized from the Supervising of the BB.CC of Trapani. The plan has not been limited to the surveying of the Theatre, but, on the base of the acquired data, it has allowed to reshape the media-cavea with works of consolidation and completion of the radial septa. The *ima-cavea* has been integrated, in structural gaps, with walls of substruction of the seats, making necessary also the completion of the rectilinear features of the wall of *análemma*. In addition, the superior entrances have been interested by the intervention of restoration, that has restored the paving to the original altitude, figure 12.
