## **THREE-DIMENSIONAL RISK MAPPING FOR ANTI-DISASTER RECORDING OF HISTORIC BUILDINGS**

M. Santana Quintero . B. Van Genechten

### **ICOMOS CIPA Symposium**

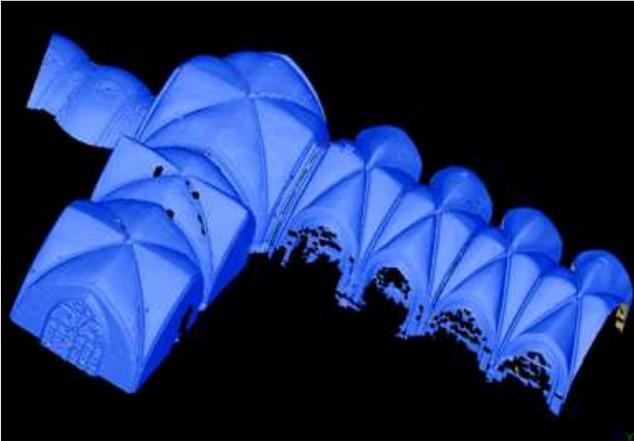
Figure 3: Meshed point cloud from interior, PCA and author.

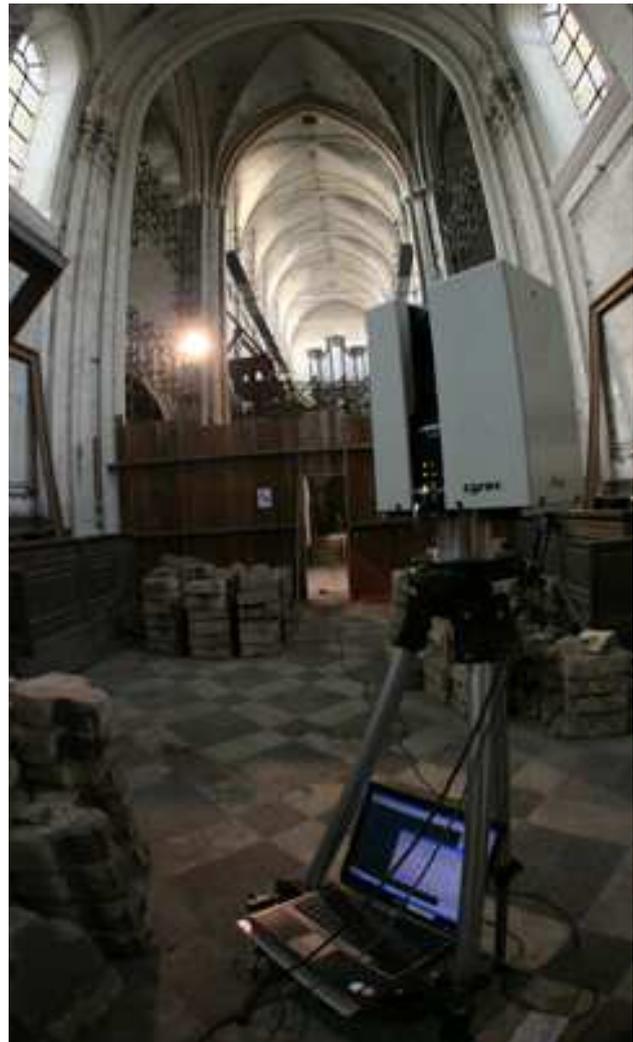
Figure 4: inside St.-James church in Leuven, scanning using a phased-base scanner provided by Plowman Craven and Associates, author.

In this case study we focus on the problem of connecting inside scans to the outside scans. This means that we will need some kind of a reference system that connects the inside and the outside measurements. For this purpose we suggest using a total station to setup a closed polygonal reference system that allows us to reduce errors by traverse network adjustment. From each of the total station setup points, we also measure a number of target points (natural or artificial) on the building itself, which will provide the necessary means to connect all the measurements.

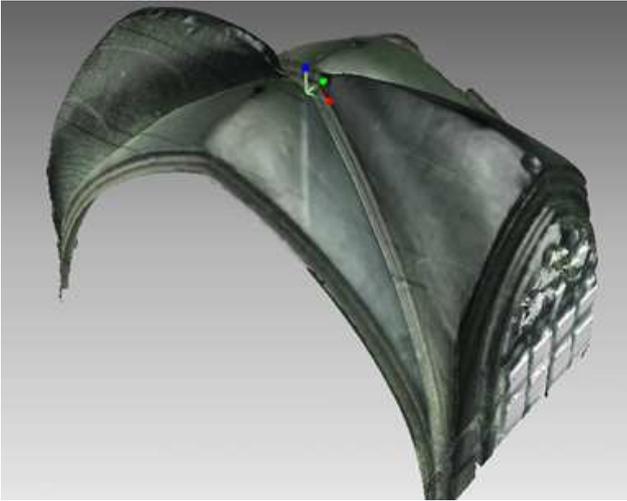
Figure 5: Example of a meshed point cloud from one of the inner vaults, PCA and author.

By scanning the structure more than once over a certain time frame, conclusions can be made about the structural safety without having to perform destructive testing. The benefit of this type of monitoring is also that not only stresses or deformations in sparse points can be measured, but the deformation of the structure as a whole will be assessed.
