# THE COMPLETION OF THE CONSERVATION PLAN FOR THE M. KOGĂLNICEANU STREET REFORMED CHURCH, CLUJ NAPOCA, ROMANIA

Description the Arhitectural surveye and data acquisition using a Riegl terrestrial Laser Scanner and hand measurements and presenting the final results after the documentation. For the details we used a Leica Laser Scanner.

Presenting the conservation plan and the structural modeling of the building

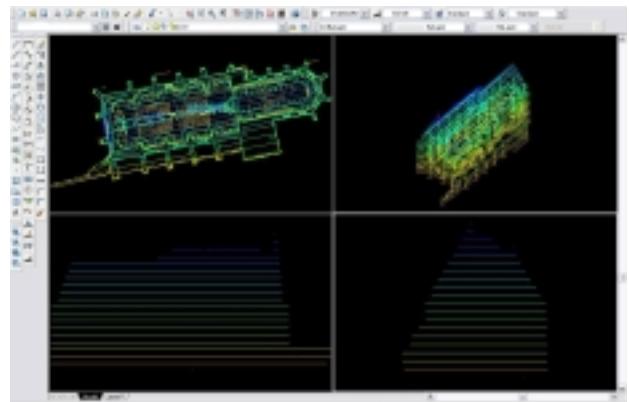
Figure 6. The slices made cutting the point cloud

Using the point cloud we made sections in each 2 m in transversal, longitudinal directions and parallel with the ground plan. Using this sections combined with the topographic measurements we prepared the plans in 2D Cad drawing format.

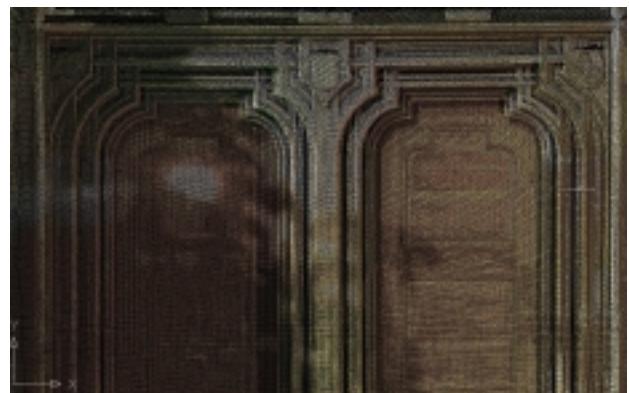
Figure 7. Colored point cloud of the main entrance

To complete this work we contacted the University of Iasi and we rented a LEICA 3D laser scanner to do a very accurate scanning for the important architectural details. For the main entrance we realized 3 scans from different scan positions with a 5 mm distance between the scanned points.

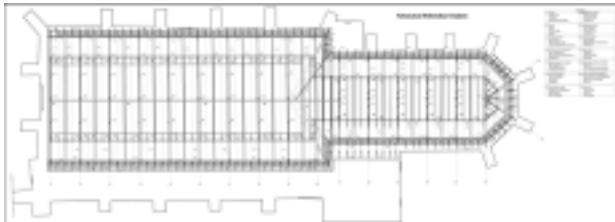
Figure 9. The plan of the roof structure

As all the roof surveys have to have the layout of the building as a starting point, in parallel the topographical / geodesic survey was carried out, and the outer line of the building was constructed in the same CAD format; The survey is necessary in order to identify all the elements, details and sub-assemblies to be able to study the mechanical behavior of the roof itself. As the results of the measured survey we can present the layout of the roof structure, all the characteristic cross sections, meaning main and secondary trusses, as well as the longitudinal bracing system and the joint details.

In order to carry out the measured survey of the baroque roof structure first a set of hand drawings were done, and later these drawings were transferred to a dwg format.

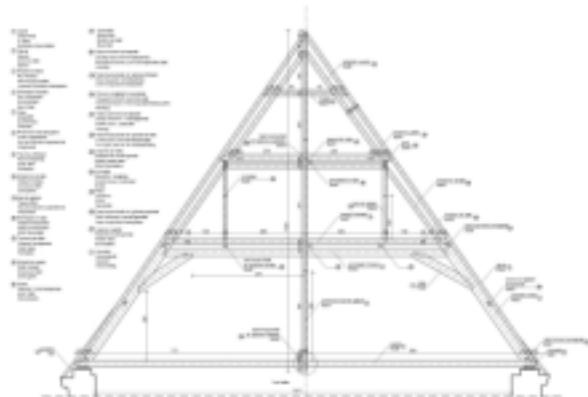
Figure 10. The main truss of the nave

The roof structure is part of a hall-type gothic church, with one of the largest span in Central-Eastern Europe: 15,30m (an early gothic choir, late gothic vault of the nave); The roof was rebuilt – probably – after the fire in 1798; with a 55,6° angle, or 3/2 ratio (approximately); in case of the nave; and even 59,7°, or 12/7 ratio for the choir – characteristic angles to the medieval roof structures. On the other hand the structural concept is of a late baroque structure – the intermediate period to eclectic – the superior levels have clearly eclectic structural solutions.

Calculus was done with the program: AXIS VM7 / 8 and was carried out for the following units: – 3 main trusses (and secondary trusses in between) for the nave; – 3 main trusses (and secondary trusses in between) for the nave; – Complex overall model.

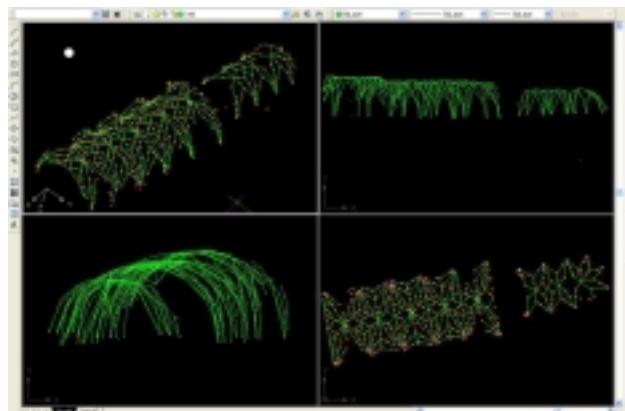
Figure 12. The wire model of the star vaults

The ceilings are the original star vaults, dating back to the second half of the 17<sup>th</sup> century, both on the octagonal choir and above the nave. The western gallery and southern arcade has a cross vaulting ceiling. The vaults are mainly well preserved though essential cracks can be seen longitudinally between the walls and vaults, especially in the nave, as well as perpendicular on the walls. Cracks can be seen both from inside the church and from the roof structure. A huge overload was accumulated as pigeon guano at the vaults' springs. The overload was removed during the project. The cracks on the upper side was checked and an overall structural analysis was carried out in order to identify the most important causes of the damage. The upper part of the vault has to be repointed, the rib stones have to be checked and the ones that moved have to be fixed.
