THE RESTORATION OF THE SUPERSTRUCTURE OF THE PROPYLAIA CENTRAL BUILDING*

T. Tanoulas, , Ministry of Culture, Service for the Restoration of the Acropolis Monuments, Polygnotou Str. 10, Athens 10555, Greece - atano@tee.gr - tasos.tanoulas@ysma.culture.gr

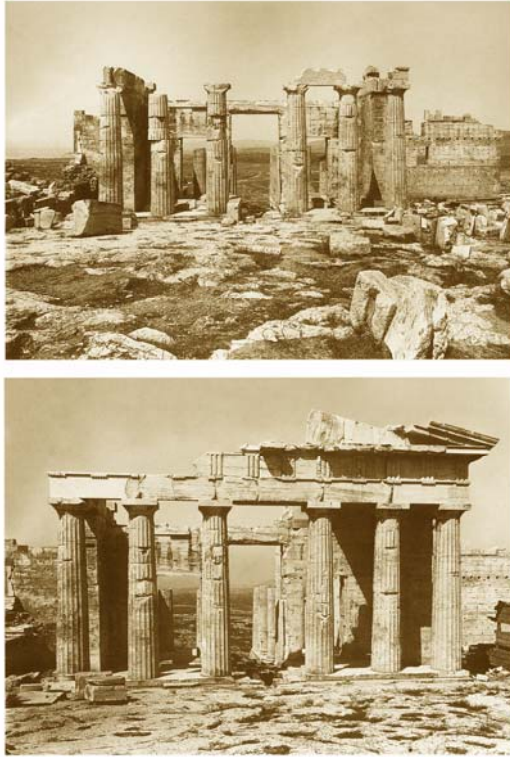
Figure 1. The east front of the Propylaea before and after the restoration by Balanos.

The first restoration of the Propylaia was conducted by Nikolaos Balanos between 1909-1917 (Balanos. Tanoulas, 1994a, pp. 37-52, drawings 18-43, photos 3-16). In the eastern portico, Balanos restored the architrave, more than half of the frieze and of the cornice, less than half of the pediment, as well as the northern end of the ceiling. In the western hall, he reassembled the extreme eastern column of the northern Ionic colonnade on which, successively, the northeast part of the ceiling was restored.

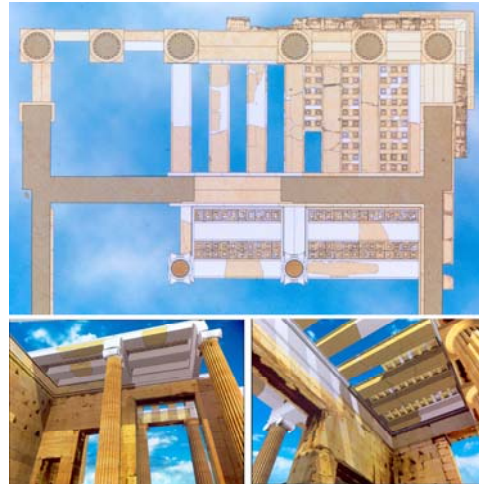
Figure 1. Proposed restoration of the ceilings. View from below (above), in the west hall (below left) and in the east portico (below right).

adjoining authentic fragments (Tanoulas-Ioannidou, pp. 66-76.). The large number of newly identified authentic fragments for the beams and the coffer slabs allowed the formation of concrete proposals for a new restoration of the superstructure, which envisaged the use of this identified material in order to display the ceilings, which have always been the most admired feature of the architecture of the Propylaea, to best effect. The great number of coffer slabs provided the possibility of extending the restored ceilings above the central passageway, allowing the visitors to enjoy the feeling of an interior space.

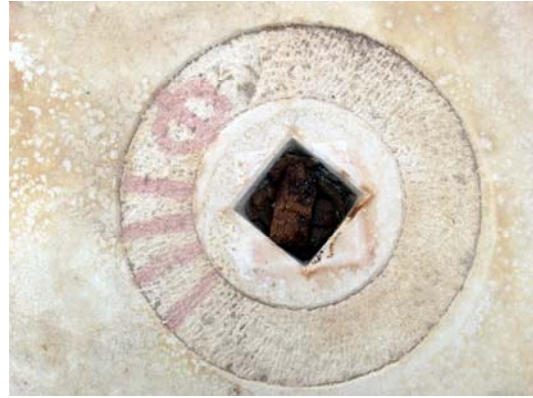
Figure 1. Classical inscription indicating the position of the fourth drum of the fourth column of the east portico, counting +from the north.

On the upper surfaces of most of the column drums, inscriptions were found consisting of one letter of the alphabet (indicating the column) followed by parallel lines (indicating the position of the column drum) (fig. 12). The letters indicating the columns of the east colonnade are (from north to south): E, Θ, K, Φ, X, Λ.

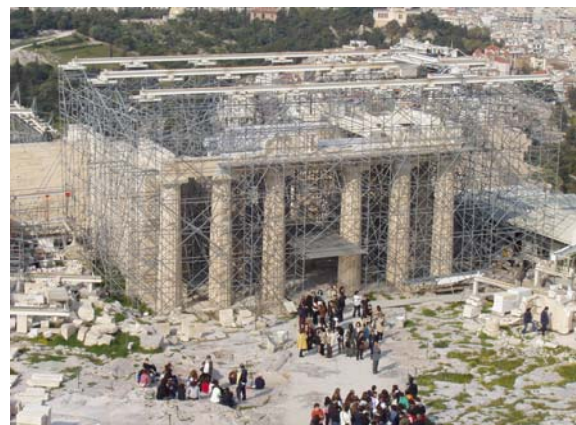
Figure 1. The east front of the Propylaea in March 2007.

At the moment, that is the half of June 2007, in the eastern portico the restoration of the columns and the entablature has been completed up to the course of the Doric frieze; inside, three beams and their substructure have been restored. In the western hall the restoration has been completed up to the level of the Ionic epistyles, including two Ionic capitals. The capitals were carved by hand, restoring the original forms according to existing fragments, and their making took, on an average, the work of two men for 27 months (Tanoulas, 2006b). Thanks to the technical ingenuity of our marble technicians, the original design has been rendered with technical integrity worthy of that of the ancient originals. Through this work, invaluable knowledge on the making of such complex an architectural form has been gained.

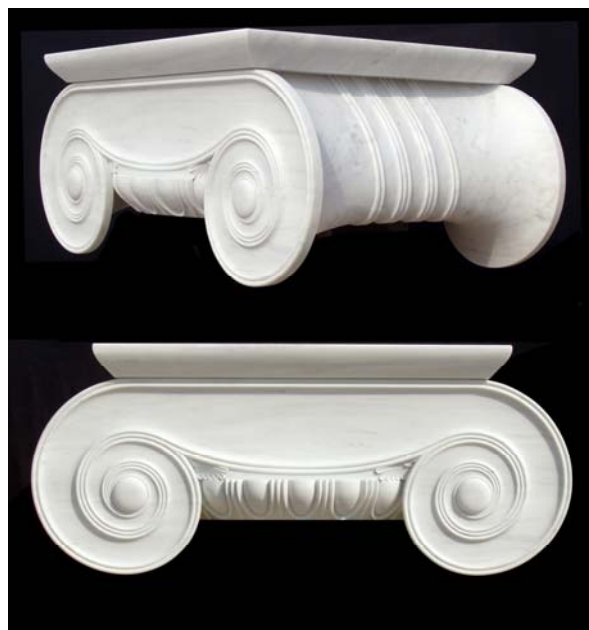
Figure 5. One of two modern replicas of the original Ionic capitals of the Propylaea.

Another important task was the identification of the surviving fragments of the six original Ionic capitals of the Propylaea in six groups of adjoining fragments. At the same time I produced drawings restoring the original form of the capital in full scale; these drawings proved indispensable for the accurate reproduction of two new Ionic capitals which, as it will become clear later, were required for the new restoration (Tanoulas, 2000b, pp. 283-285, fig. 5-9).
