BLOCKAGE OF NATURAL DRAINS DUE TO URBANISATION AND ITS AFTERFITS

H. K. Shastri¹, D. B. Desai², Prof. G.S. Parthasarthy³

Commission VI, Working Group IV/10

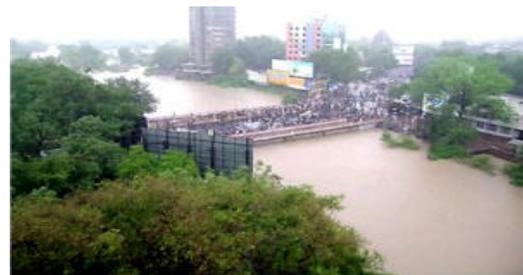
Picture 1 : Vishwamitri River flowing near danger mark at heart of Baroda.

Rainfall in this region occurs in mid-June to mid-September annual average rainfall is about 931.9 mm. Due to cyclonic circulation of upper air from 25 June to 3 July 2005, the otherwise moderate rain regions of Central and South Gujarat received unprecedented rainfall of 110 cm in 9 days. The floodwaters washed away villages, damaged/destroyed houses causing loss of life and extensive damage to property. The heavy rains has left many of the major dams full while the medium and small dams are overflowing, the worst being the case of Pratap Pura lake in Vadodara district where nearly 100-feet long breach developed in check dam-cum-reservoir as it overflowed and water gushed out towards the villages downstream. Much of the overflowing water was being drained into the Vishwamitri river flowing through the Baroda city. The situation has eased for the villages as the water level has stabilised after the rains have stopped, but the water released from reservoir made river flowing near danger mark.

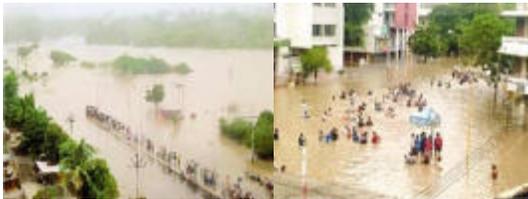
Picture 2 : Flooded Baroda City

eastern and western parts from each other. With State Government and Baroda Municipal Corporation along with the Non Government Agencies and Indian army working round the clock to get citizens out of trauma, water from most part of the city resided in less than 12 hours. Well-planned drainage network of the entire city worked very well after rain. However, the situation was far from normal in north-west part of the city, area of about 25 - 30 km² (Nizampura, Sama, Chani) still inundated in knee deep waters. These areas remained waterlogged despite Vadodara not receiving any rain for next 48 hours. The floodwater in this region was not stagnant as observed in most flood-affected areas but there has been water flowing with a heavy current.

Major reason of this as said by local people and news agencies is the Bhukhi drain that was flowing from this part of the city. Commissioner Rajesh Topno announced that all illegal landfill of the natural drainages, slopes and nalahs which played major role obstructing water flows in the recent havoc caused by the unusual rains will be removed and the authorities have reportedly began the surveys of such illegal landfill obstructing the water flow causing flooding of residential areas around them. A satellite survey was also ordered to assess the situation and for removal of obstructions is gaining ground.
