# MULTI-SPECTRAL DATA ACQUISITION AND PROCESSING TECHNIQUES FOR DAMAGE DETECTION ON BUILDING SURFACES

M. Hemmleb<sup>a</sup>, F. Weritz<sup>a</sup>, A. Schiemenz<sup>b</sup>, A. Grote<sup>c</sup>, C. Maierhofer<sup>a</sup>

<sup>a</sup> Federal Institute for Materials Research and Testing (BAM), 12200 Berlin, Germany (Christiane.Maierhofer@bam.de)

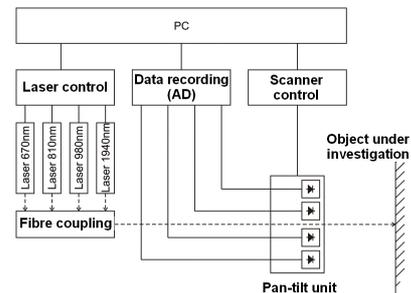
Figure 1. Set-up of the multi-spectral laser scanner with pan-tilt unit.

For the realisation of a scanning measurement system, two different devices were selected and tested under laboratory conditions: a pan-tilt-unit as carrier for the multi-spectral-head (as shown in Figure 1 and 2) and a mirror-scanning device, as known from 3D laser scanners. Geometric and radiometric calibration experiments were carried out.

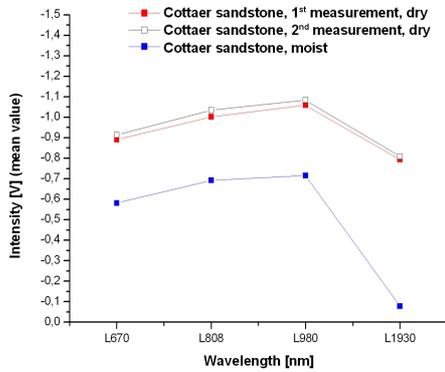
Figure 3. Intensity of reflection for dry and moist sand stone at different wavelengths. The wavelength axis is not scaled.

the reflection properties of several different building materials (especially historic bricks and stones). As material parameters, the moisture content and the roughness of the surfaces have been varied (see Figure 3 and 4). For optimising the measurement parameters, the required power of the laser diodes and the distance of the scanner units to the measured surface were investigated systematically.

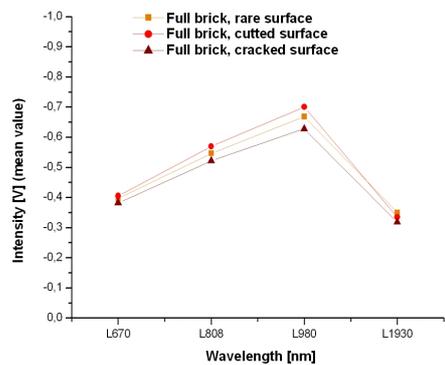
Figure 4. Intensity of reflection at different surfaces (roughness). The wavelength axis is not scaled.

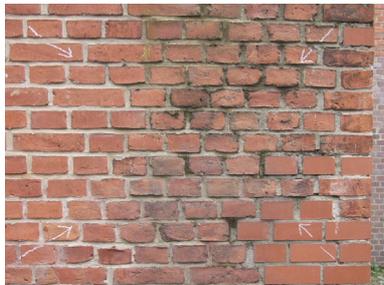
Figure 7. Damaged masonry wall, overview image taken with digital camera.

Damage on historical buildings frequently appears on facades with masonry or natural stones. Exemplarily a damaged masonry wall and a sand stone base wall were selected for the investigations. Figure 7 shows an evidently affected masonry wall. Damage like moisture and biological cover (moss) is clearly visible on the building surface. The region, selected for image acquisition, contains old and new bricks, dry and wet areas. As second investigation object a damaged sand stone wall was selected (Figure 9). Beside unaffected regions, damage like weathering, biological covering, salt blooming and contaminated areas is visible.

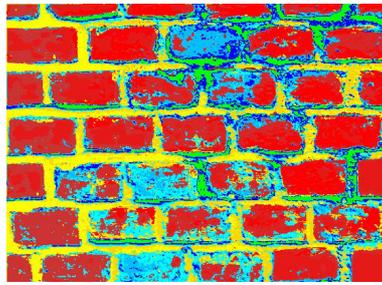
Figure 8a. Pixel-based unsupervised classification of masonry (cluster analysis).

**Masonry wall:** Figure 8a/b shows the results of the pixel-based classification of the masonry wall. While unsupervised classification partly yields to incorrect results, especially in shadow regions, the supervised classification of biological covering (green) gives good results, because the chlorophyll absorption is measured very well by the infrared data. It has to be considered, that moisture content isn't covered by a water absorption line, that means, moisture is only covered by changes of spectral signature (light and dark blue). Object-oriented classification delivers similar results. In contrast to pixel-based classification, bricks, mortar and damaged areas are covered separately in discrete objects. The additional information from the texture channel allows the classification of the state of the bricks (old, new, damaged; see Figure 8c). Beside moisture and biological covering, salt blooming is detected and visualized in a separate class (see Figure 8d).

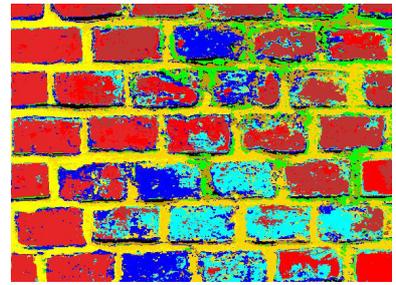
Figure 8b. Pixel-based supervised classification (maximum-likelihood).

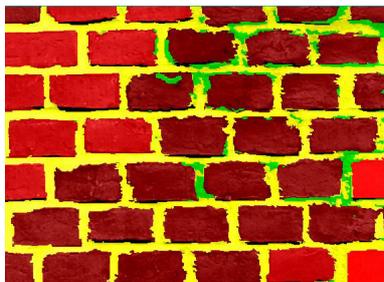
Figure 8c. Object-oriented classification, classification of the state of the bricks.

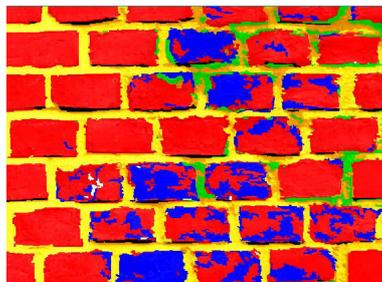
Figure 8d. Object-oriented classification, classification of damages.

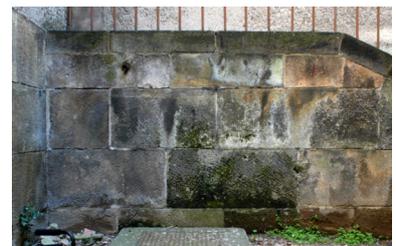
Figure 9. Damaged sand stone wall, overview image taken with digital camera.

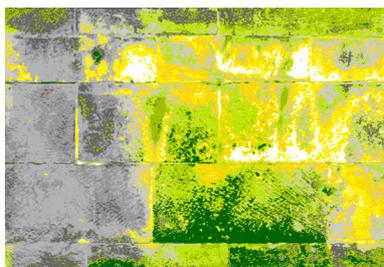
Figure 10a. Pixel-based unsupervised classification of sand stone (cluster analysis).

**Sand stone wall:** The results of the pixel-based classification of the sand stone wall are shown in Figure 10a/b. In contrast to the widely preserved sand stone (yellow), damage like biological covering (green), weathering (grey) and salt blooming (white) is clearly visible. In case of a supervised classification (Figure 10b), in addition contaminated areas (brown) and vegetation in the foreground (light green) are recognizable. Because of insufficient results of object segmentation with texture filters, a joint map was used for the object-oriented classification in order to get separated stone objects. Thus, a delimitation of different sand stone cuboids and the subdivision in filled and open joints is possible. Results (see Figure 10c) are comparable to the results of the pixel-based classification. In both cases, the classification between preserved and weathered sand stone is difficult.

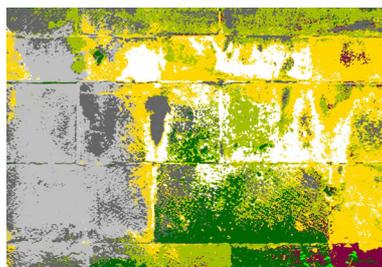
Figure 10b. Pixel-based supervised classification (maximum-likelihood).

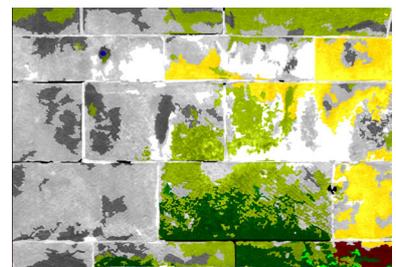
Figure 10c. Object-oriented classification of damages on sand stone wall.
