AN UAV-BASED PHOTOGRAMMETRIC MAPPING SYSTEM FOR ROAD CONDITION ASSESSMENT

KEY WORDS: UAV, Mapping, Transportation, Road, Condition Assessment

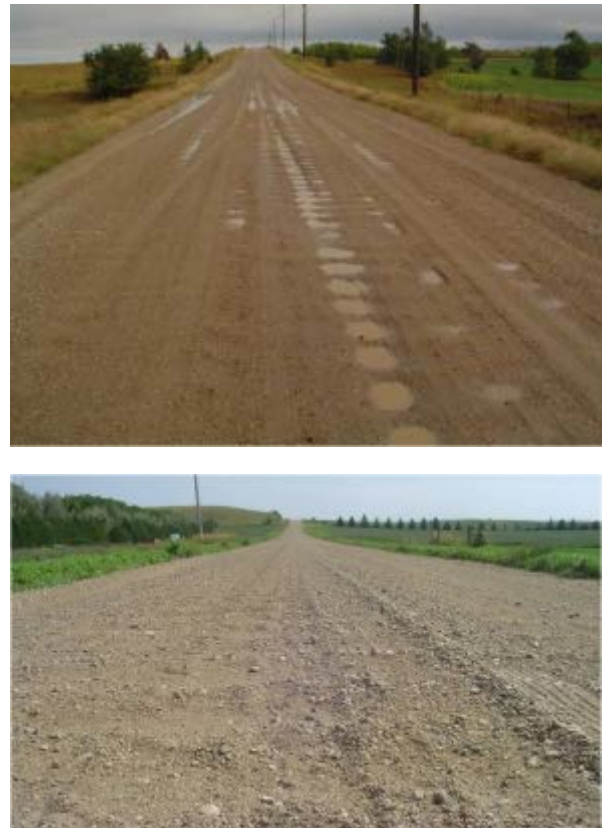
Figure 2. Ground images of deteriorated unpaved roads. Above: Serious distress with potholes and bad surface drainage. Below: Loose aggregate with corrugation.

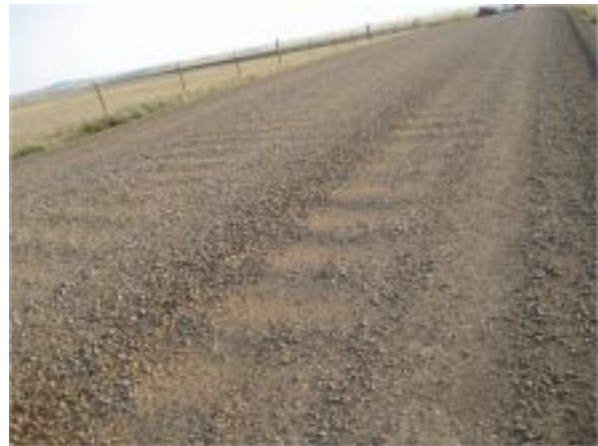
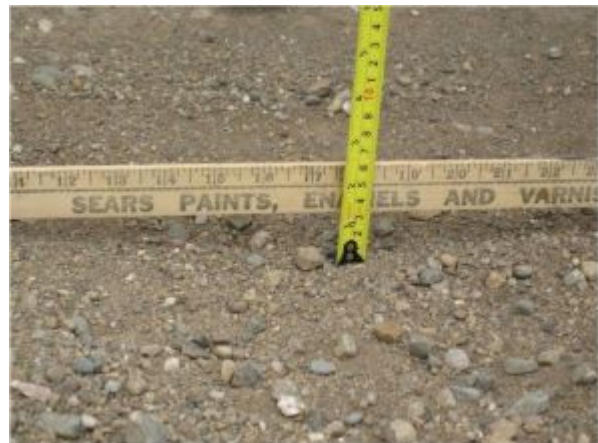
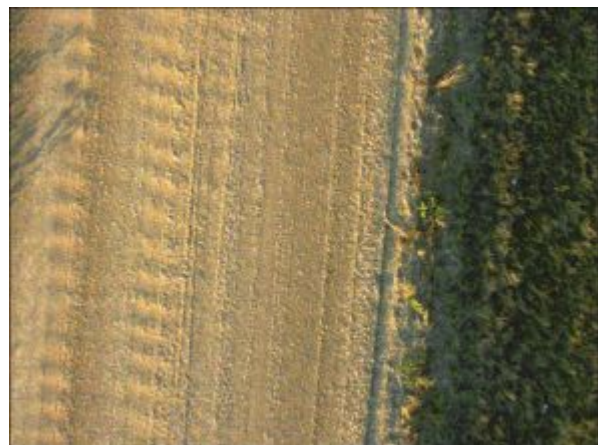
Figure 3. Road segment with moderate corrugation as seen from ground image (top), measurement of the depth of corrugation (middle) and UAV Image (bottom).

The first data collection using the above UAV system was conducted in a test site near Rapid City, South Dakota. The UAV flew at an altitude of about 50m above ground, capturing details of the road surface. Figure 3 is an example of the road imagery collected over a road segment with corrugation (washboarding). Ground shots presented in Figure 3a and Figure 3b indicate the very mild washboarding defects with depth around one inch. However, these washboarding features are clearly visible in the UAV image presented in Figure 3c.

The existence and the extent of the washboarding is one of the most important factors in determining the condition of an unpaved road. A cluster of washboarding on the road makes a distinct pattern on UAV imagery (see Figure 3) with closely spaced ridges and valleys at fairly regular intervals. The ridges are perpendicular to the traffic direction. Therefore, the washboards can be detected by pattern recognition and image classification techniques. The result of washboarding detection over the road segment in Figure 3 using pattern recognition technique is shown in Figure 5 where the detected washboarding is presented in red. From the resultant images,

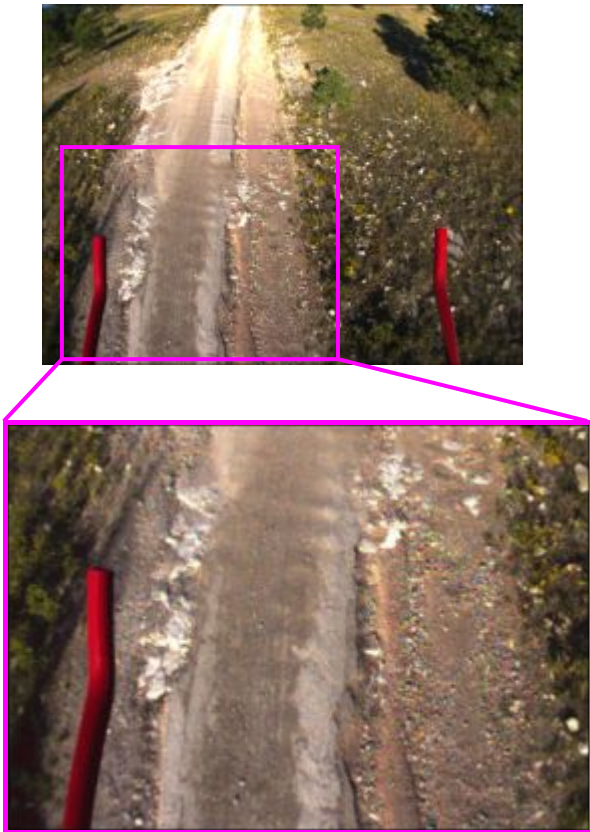
Figure 4. An image of a road segment with serious distresses collected from the UAV platform.

Figure 4 is an image of a road segment with more serious distress affecting the entire road cross-section geometry. An overview of this segment is given in the upper part of the Fig 4. The initial low resolution shot of the overall cross section reveals the potential to evaluate potholes, rutting, loss of aggregate cover, drainage issues, and the poor overall cross section. The imagery was acquired early in the morning right after sunrise. Large shadows of trees clearly appear in the image. The details of the distresses are demonstrated in lower part of the figure.

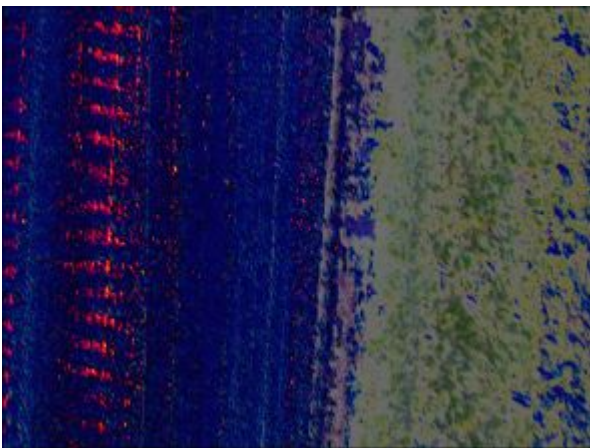
Figure 5. Detection of washboarding in a road segment shown in Figure 3. The washboards are successfully extracted and are presented in red.

the number of washboarding ridges, and the width of the ridges in the direction perpendicular to the traffic can be computed as an indicator of severity of the distress.
