GEOSTRUCTURAL ANALYSIS OF THE ATHENIAN ACROPOLIS WALL BASED ON TERRESTRIAL LASER SCANNING DATA

Special Session SS-19: Recording and documenting the Acropolis of Athens

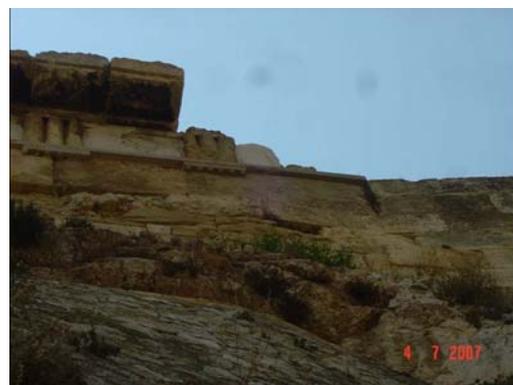
Figure 2. North part of Acropolis circuit wall. Characteristic displacements of structural blocks. By D. Egglezos

The continuous exposure of the wall in the action of damaging factors during its history has provoked major or minor failures, related to geometry and/or mechanical strength of wall structure and materials. The term geometric failure refers to changes of the original shape of the wall, considered as a whole structure and comprises typically: rotations (figure 9), displacements (figure 2), intense deformation of shape (e.g. barreling) and so

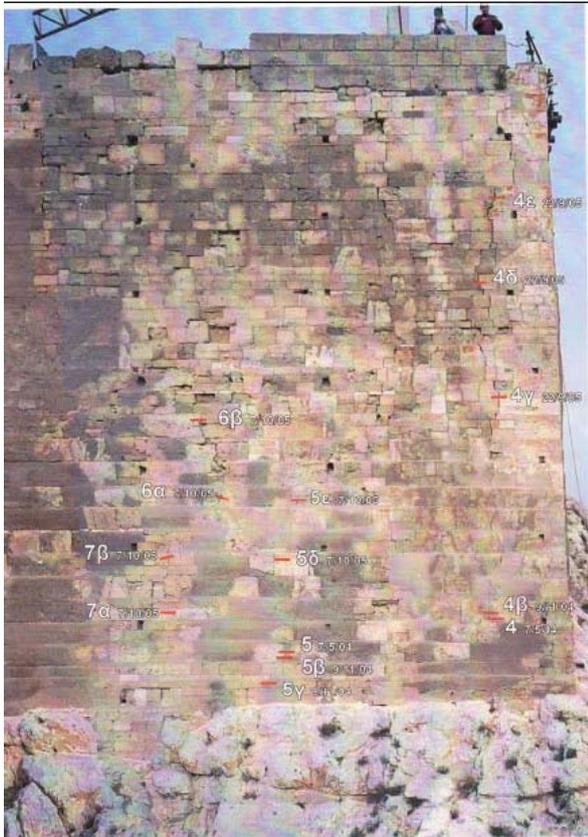
Figure 3. Characteristic fractures in the SE corner of Acropolis circuit wall. By D. Egglezos

on. On the other hand, the term mechanical failure applies mainly to material blocks and comprises block fractures (figure 3), joint dislocations (figure 4), superficial weathering, disorganization of major areas due to mortar loss, instability of underlain rockmass, and so on.

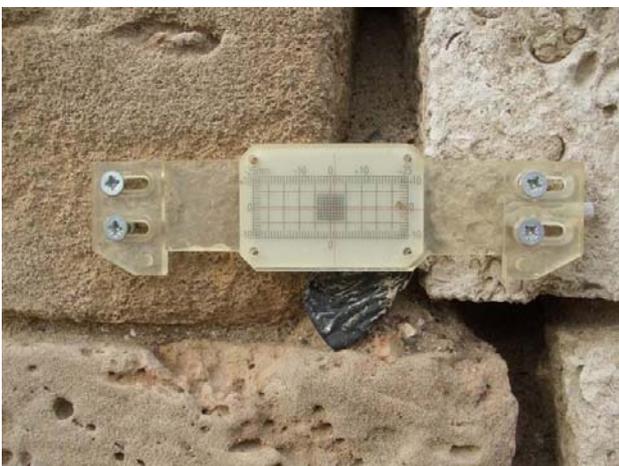
Figure 4. South part of Acropolis circuit wall. Characteristic dislocations of joints of structural blocks. By D. Egglezos

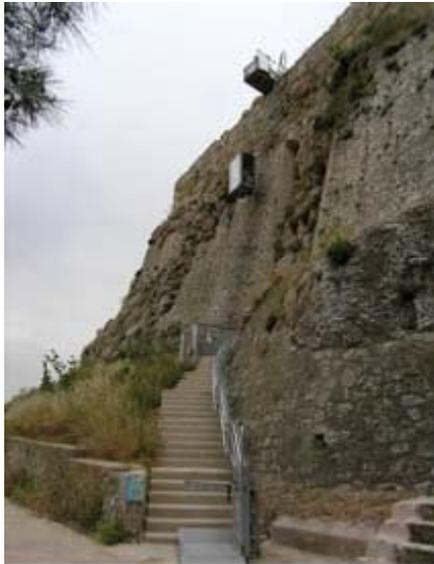
Figure 5. North circuit wall. By P. Konstantopoulos.

The recording and the documentation of the Acropolis circuit walls is a vital part of the restoration planning. Due mainly to its size (~ 760m perimeter, maximum height 18m) and its inaccessibility (figure 5) the only fast and accurate method that could be applied is a proper combination of photogrammetry and 3D laser scanning.

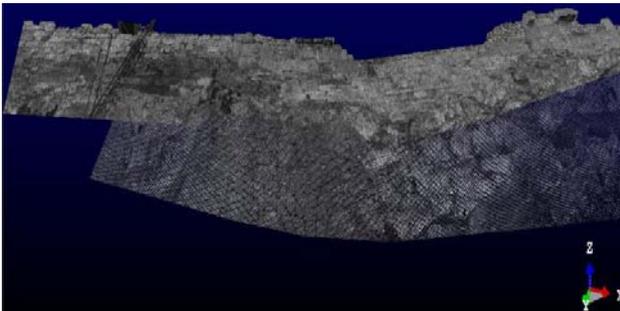
Figure 6. Point cloud of the north circuit wall.

One of the main steps to achieve the goal of the wall's documentation has already been completed: the production of full 3D surface model of the wall and the foundation rock, deriving from 3D Laser Scanning. The wall has been recorded using a Trimble GX200Plus terrestrial laser scanner at a resolution of 1cm and the rock at a resolution of 5 cm (figure 6). This work is part of the project "Development of Geographic Information Systems at the Acropolis of Athens", financed by the European Union and the Government of Greece, and supervised by the Acropolis Restoration Service, Hellenic Ministry of Culture. The partners in this project are Elliniki Photogrammetriki Ltd (Elpho), Athens, Geotech O.E., Athens, Institute for Mediterranean Studies, Foundation for Research & Technology (FORTH), Rethymno, Crete, National Research Council, Canada, ETH (Swiss Federal Institute of Technology), Zurich.

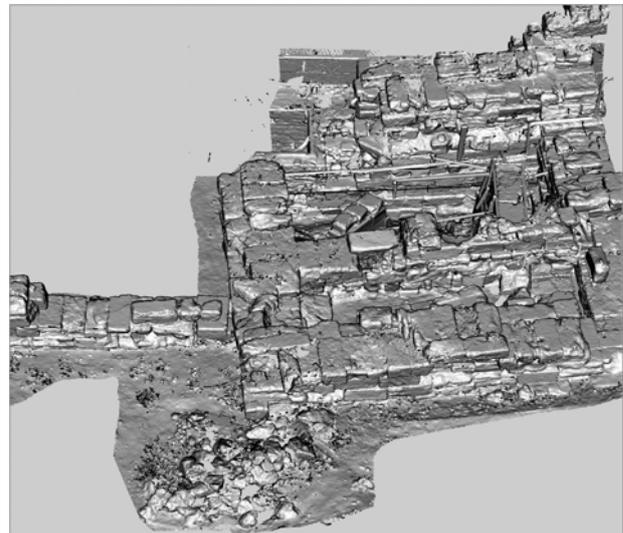
Figure 8. Arrephorion. Shaded surface model. By L. L. Grammatikopoulos, E. Kalisperakis, and V. Pagounis.

The Arrephorion is situated next to the circuit wall and, in fact, its north wall is in contact with the north circuit wall of the Acropolis. The detailed documentation was necessary because the monument had to be reburied for protection, since there was no other way of saving its remains. The production of a full 3D surface model in order to have all the necessary details and profiles is completed (figures 7 and 8). The site has been recorded using a CYRAX 2500 scanner at a resolution of about 5mm to 1cm (by L. Grammatikopoulos, E. Kalisperakis, and V. Pagounis). (cf. Moullou et al., 2007).

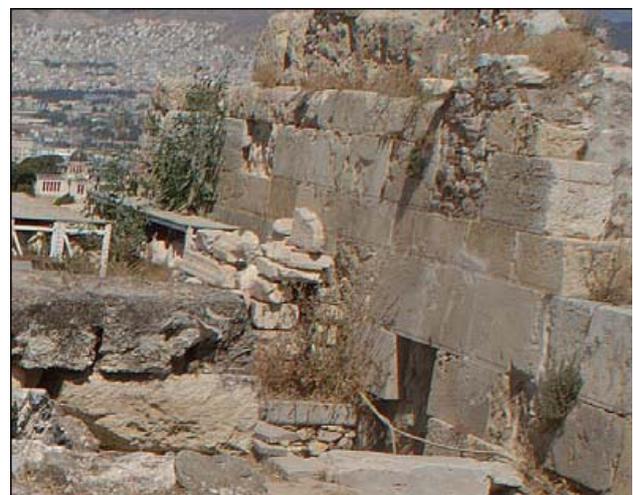
Figure 9. North part of Acropolis circuit wall. Rotated section of the circuit wall. By D.Egglezos

A. Preliminary Case Study of rotated/distorted cross-section of the North Wall (figures 9 and 10):

In the proximity of Arrephorion reburial exists an intensely rotated section of the ancient North Wall with about 5m height. The horizontal displacement of the wall crest in relation to the

wall base, according to the 3-D model is almost 7cm, and the observed rotation is about 1°. In addition, the backfill of the wall has a recently deposited extra charge from the arrangement of scattered marbles.

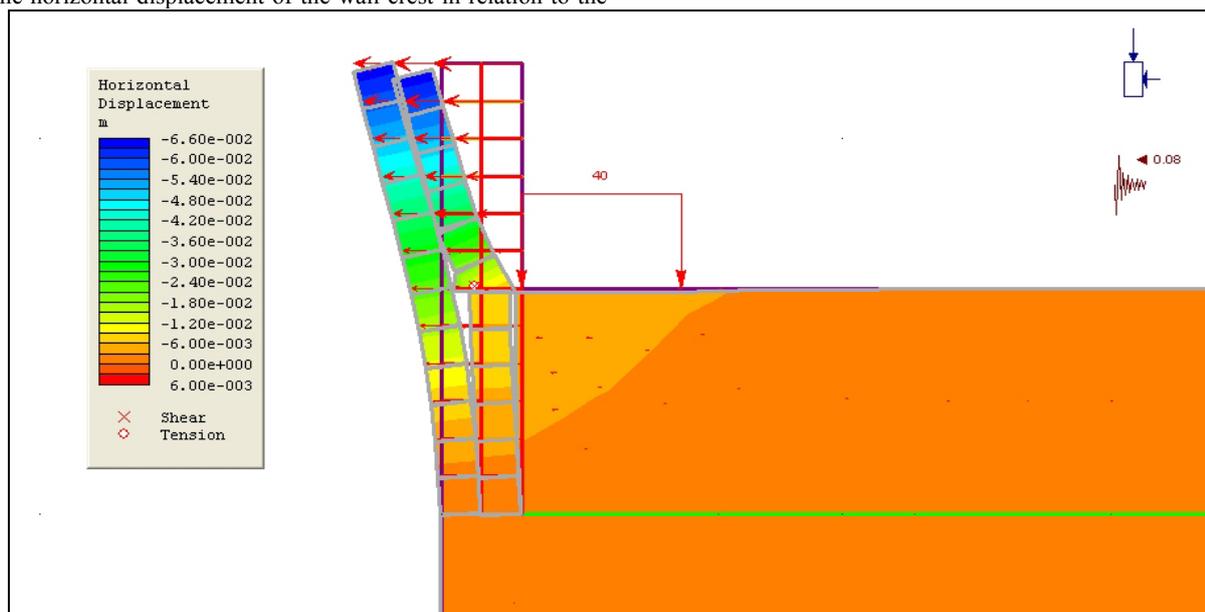
Figure 10. Results from back analysis on distorted North Wall section (exaggerated).

Finally, it is worth noting that, according to archaeological evidence, this part of the wall has sustained no visible intervention in contrast with neighbouring wall sections. The structural back-analysis performed in this case aims at the reproduction of the distorted geometry, based on reasonable assumptions for both the loading history of the section (soil thrust, earthquake etc.) and the calibration of material parameters involved. From the analysis results a 6.6cm displacement at the top of wall, for acceleration 0.08g. This value of assumed acceleration is in agreement with available historical evidence in the area of Athens (Papazachos et al, 2003).

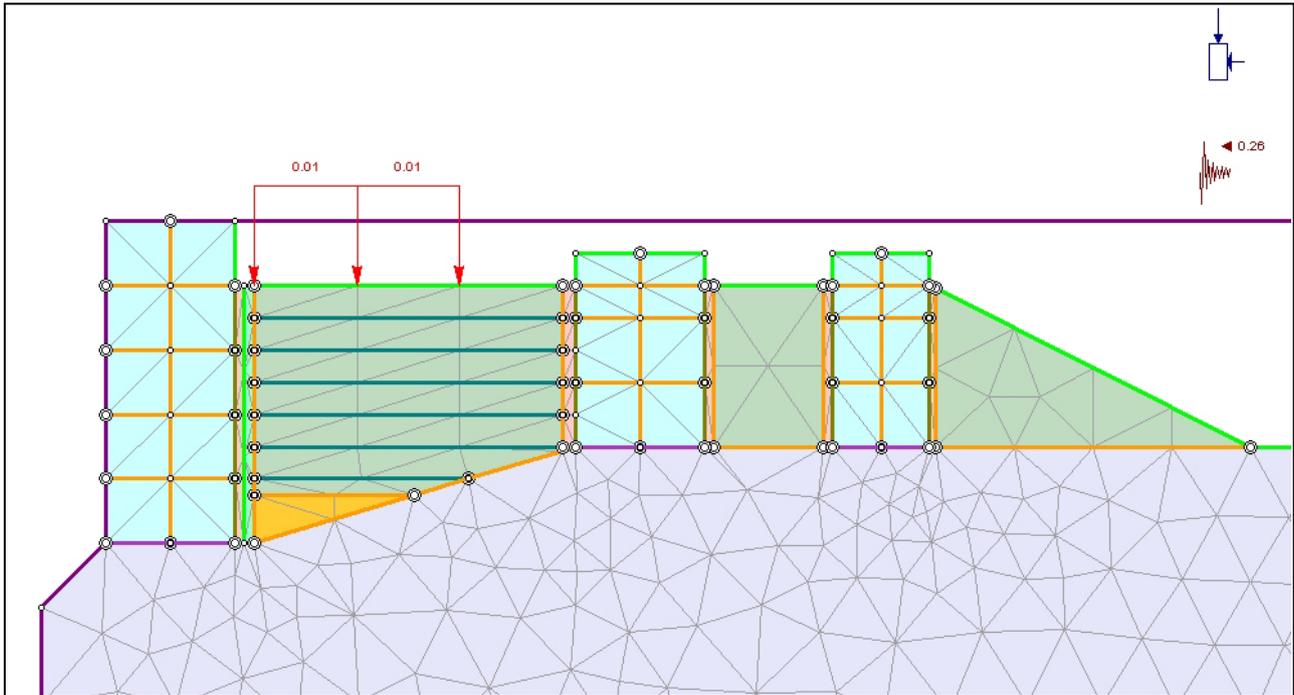
Figure 12. Simplified 2-D FE model for geostructural analysis of Arrephorion.

The following preliminary geostructural analyses concern two characteristic cases in the north part of the circuit wall: a) a case history from back-analysis of an intensely distorted part of the wall, and b) the effect of Arrephorion reburial embankment on the stability of the circuit wall in contact.

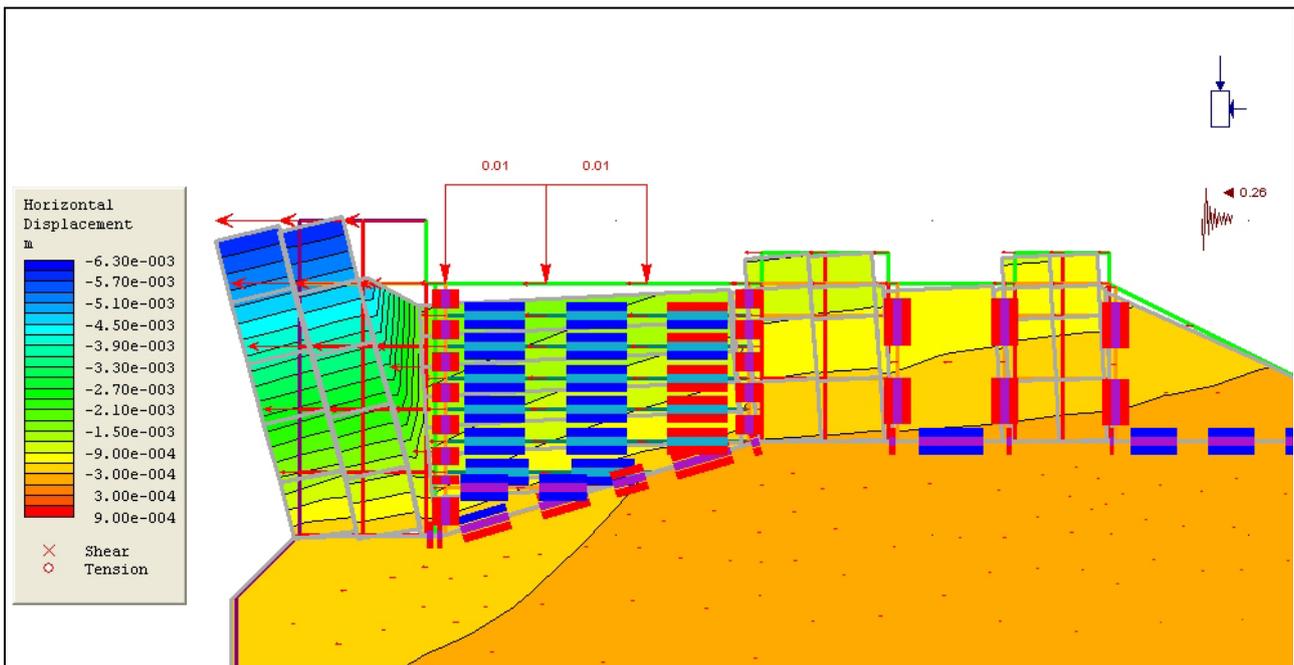
Figure 13. Results from geostructural analysis of Arrephorion. Effect of reburial on the horizontal displacement of North Wall in contact (exaggerated).

The accurate geometrical information obtained, was used as input for the PHASE 2-6.0 geotechnical software of Rockscience Inc. for preliminary geostructural FE analysis and allowed a) the reproduction of case history of an intensely distorted part of the North Wall through back analysis procedure and the calibration of mechanical parameters of materials involved as well and b) the evaluation of potential effect of reburial embankment on the North Wall in contact, with use of the calibrated parameters derived from the previous case.
