MONITORING OF CORROSION IN FAIRY CHIMNEY BY CLOSE RANGE PHOTOGRAMMETRY

KEY WORDS: Fairy Chimney, Corrosion, Selime, Turkey, Close Range Photogrammetry

In this study, corrosion on the Fairy Chimney in Selime has been investigated by close range photogrammetry.

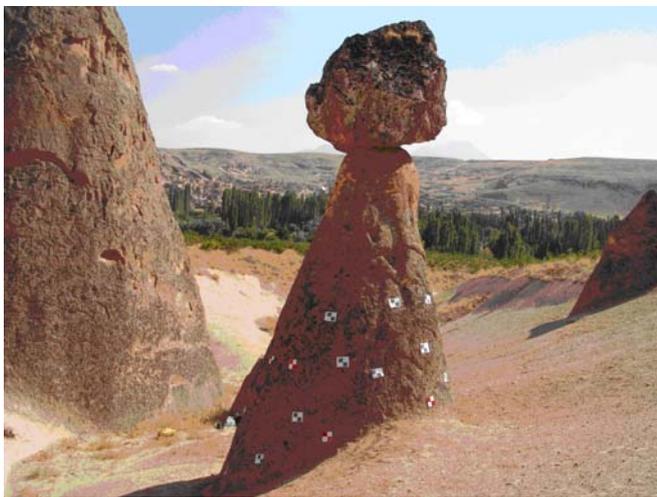
Figure 3, A Fairy Chimney in Selime

The study area is inside of Selime Town in cappadocia region. (Figure 1). This town is west entrance door of cappadocia region (Figure 2), (URL-2). There are fairy chimneys and Selime Cathedral in this town. For this study, it was selected a fairy chimney which is located on the east direction of this town (Figure 3).

The fairy chimney has approximately 9 m. heights, 4.5 m. diameter and a hat. The east and north sides of fairy chimney is covered with bigger fairy chimneys. On the other hand, the south and west sides of fairy chimney is open.

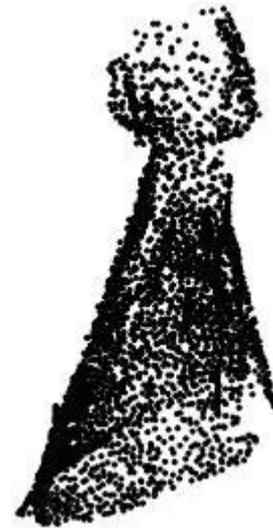
Figure 4, 3D model of Fair Chimney at February 2007

Close range photogrammetry was used in this study. A local net was constituted around the fairy chimney. Sheet remark plates were settled on the fairy chimney. These plates were used as control points in photogrammetric evaluation. The coordinates of control points were measured by geodetic total station instrument. RMSEs in control points are 9 mm, 8 mm and 7 mm in X,Y and Z axes respectively. The fairy chimney was evaluated by photogrammetric method in February 2007. 3386 points on the fairy chimney were measured by photogrammetric

method. 3 dimensional model of fairy chimney was obtained by means of these points (Figure 4).

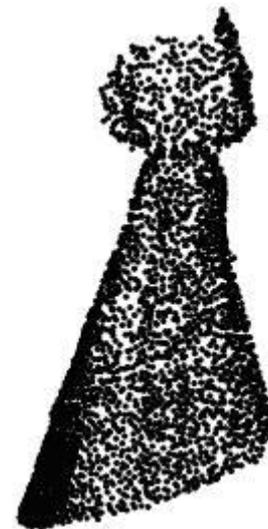
Figure 5, 3D model of Fair Chimney at February 2008

The fairy chimney was re-evaluated by photogrammetric method within the same coordinate system in February 2008. 3406 points on the fairy chimney were measured by photogrammetric method. 3 dimensional model of fairy chimney was obtained by means of these points (Figure 5).
