STUDY AND DETERMINATION OF MORPHOLOGICAL CHANGES OF DOUGH RIVER IN NORTH OF IRAN USING GIS

KEY WORDS: River Morphology; Bed Erosion; Human Impact; Morphological Parameters; Gorgan River

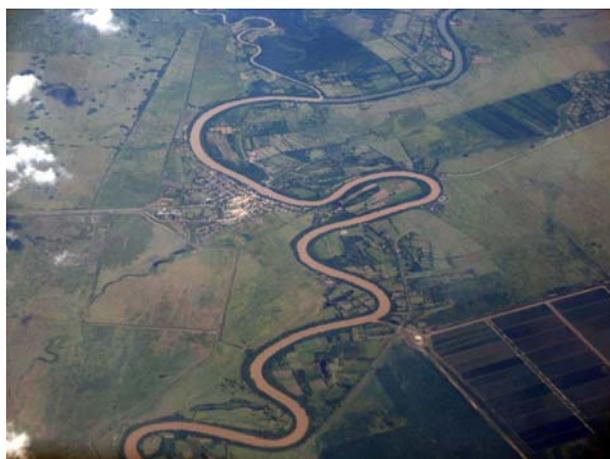
Figure 1. A river menader in Rio Cauro, Cuba

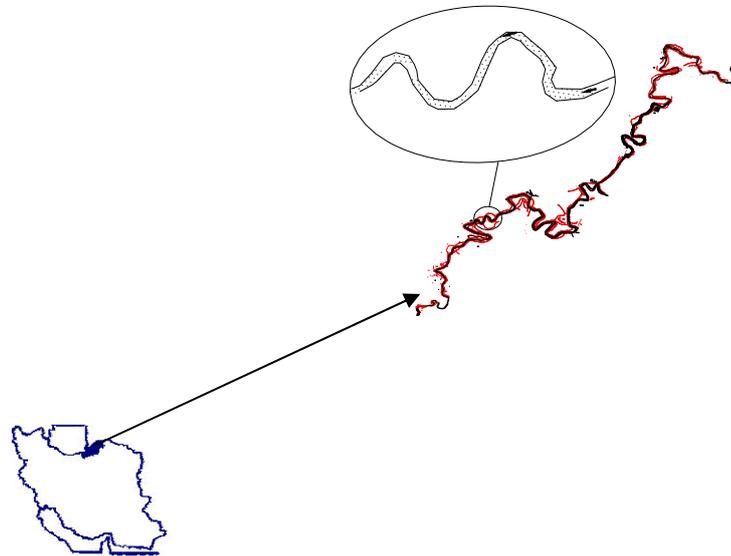
Figure 2: Longitudinal section of study reach and one of its meanders

August 2001. In this research in order to assessment of Gorganrood morphological changes in vicinity of Gonban, initially, a reach with length of 13km was selected, coordinate of start and end point of this reach is shown in Table1 and Figure 1 is illustrating the plan of study reach in vicinity of Gonbad and morphological parameters of one of its meanders.

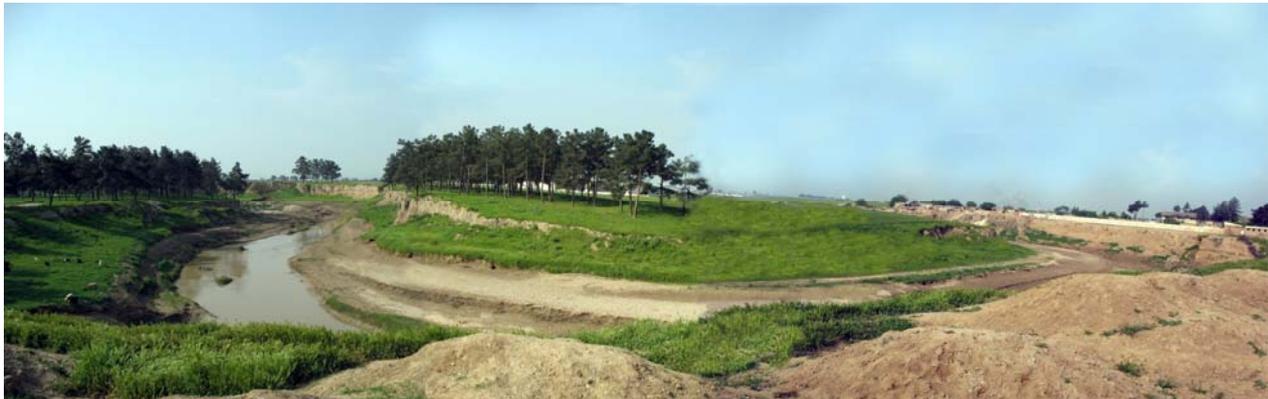
Figure 3. An oxbow meander in Madarsoo river, Iran
