HIERARCHICAL MULTI-SENSOR APPROACH FOR THE ASSESSMENT OF FLOOD RELATED DAMAGES

KEY WORDS: SAR Imagery, UAV, Close Range Photogrammetry, Flood Analysis

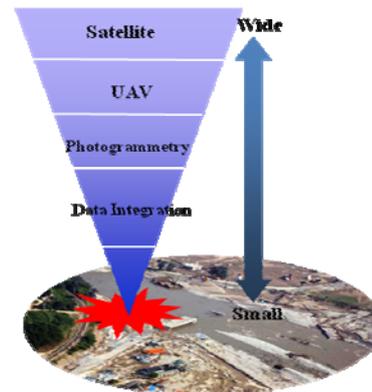
Figure 1. Layers for acquiring damage information

As shown in Figure 1, satellite data are used for the analysis of wide area, close range photogrammetric approach is used for the smaller area, and UAV (Unmanned Aerial Vehicle) data is utilized for the intermediate area. For the satellite data, we

Since a single sensor cannot cover scale-dependent damages, we proposed a so called hierarchical multi-sensor approach. Figure 1 shows the schematic diagram of our approach. Two things are to be considered for the effective damage investigation using remote sensors. First thing to consider is the ground coverage area. Second thing to consider is the detailness of the information.

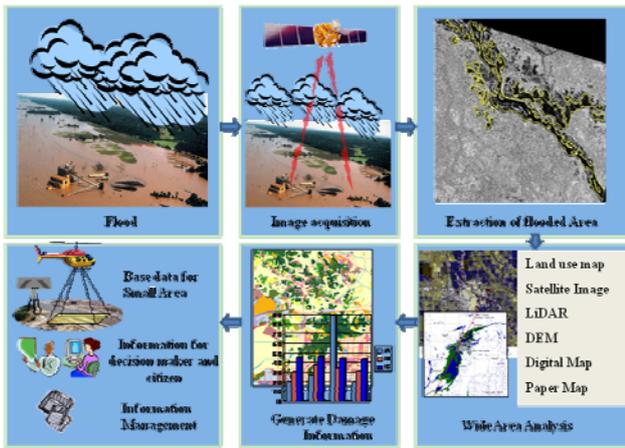
In the previous section 2.1 we provided general approach for disaster monitoring. In this section the detail approach for each sensor is explained. For the wide area, we utilized satellite SAR imagery. Figure 2 shows approach for using SAR imagery and additional information such as digital map, land use map, and DEM (Digital Elevation Model) for wide area flood monitoring.

Figure 2. Wide area analysis concept by satellite SAR imagery

The reason we are using SAR is that its ability to penetrate cloud cover and its day and night imaging capability. We assumed we can obtain SAR imagery when the flood is occurring. Critical step for using SAR imagery is georeferencing. Since it is difficult to obtain GCP (ground control point) from SAR imagery, it is important to reduce the number ground control point without losing the accuracy of georeferencing. Sohn and others (2004) proposed a method to use a single ground control point to get similar accuracy with nominal number of ground points.

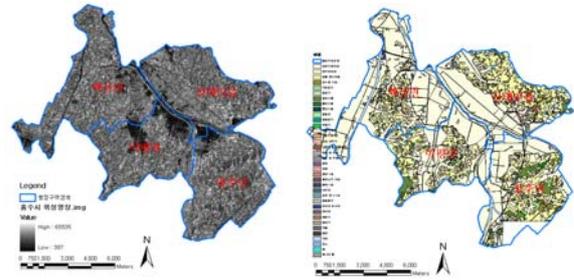
Figure 3. Overlay with flooded area and existing land use map during flood August 3rd, 2005 in Jung-up, Korea

The further analysis of automatically extracted flooded area is done using existing land use map or other source of information. It is possible since we are using georeferenced SAR imagery throughout the analysis. From this we can create approximate information about damages such as area, type of land use, and public sector or private sector. Figure 3 shows example of extracted flooded area and its comparison with existing land use map. Due to its resolution SAR imagery is only used for appropriate damage analysis. But this is still very helpful step for decision maker to send crew members for the detail analysis.

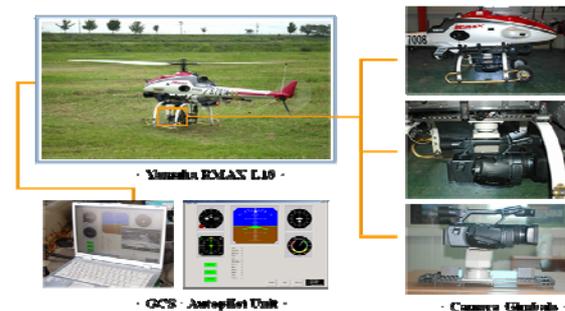
Due to its mobility and inexpensive platform UAV would be beneficial in many fields (Siribodhi, 2001). For the flood monitoring of intermediate area, UAV equipped with digital HD video camera is used for our study. Figure 4 shows UAV system we used for the intermediate area flood monitoring. It is Yamaha RMAX L18 with GPS. It can fly about an hour. We designed our own camera gimbals as shown in Figure 4.

Figure 4. UAV system used for intermediate area analysis

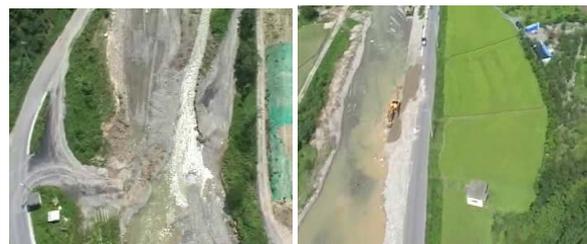
Figure 5 shows the captured two different video images obtained from our UAV system. The near-vertical video data were acquired from the UAV-helicopter mounted SONY DSR-PD150 camcorder at 500m altitude. It is only one frame shot out of 30 frames per second.

Figure 5. Video image captured the day after flood

A series of images were taken in an unstable geometric condition because the camera mounted UAV rolled over in the direction of flight due to air current. Thus the imagery acquired from UAV needs geo-referencing via geometric matching between an acquired images pixel and GCPs from a digital map or GPS (Global Positioning System) survey. The preprocessed imagery was geo-referenced with affine transformation using GCPs extracted from digital topographic map of the study area. Since detailed explanation of the image processing and noise removal is out of scope for this research, we want to skip the procedure.

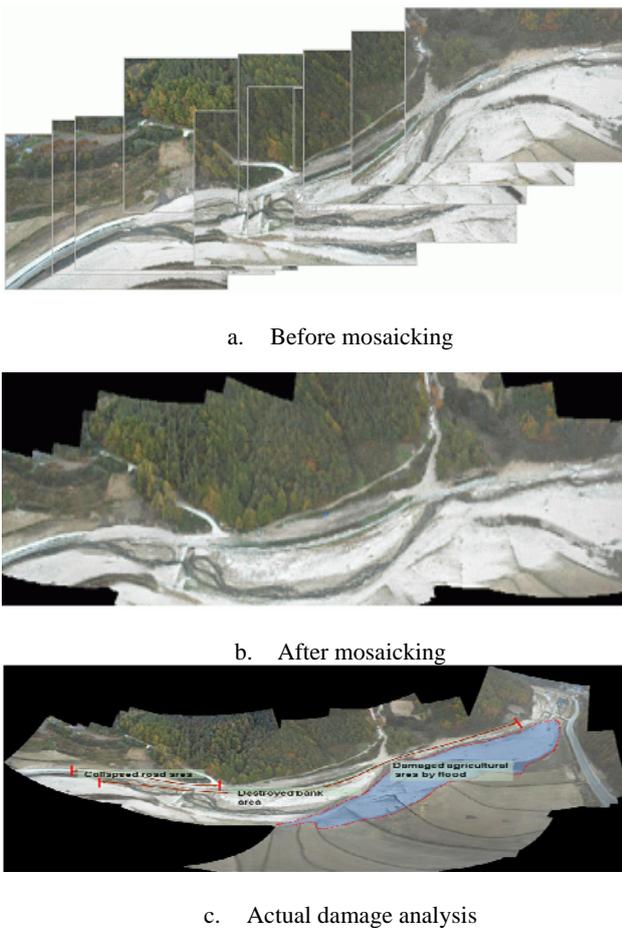
Figure 6a shows the image before mosaicking several sequence of UAV video frame. Georeferencing and mosaicking were performed for the selected still frames.

Figure 6. Twenty eight still frames for flood damage area

Using the mosaicked image of Figure 6b, we could identify the detailed information of flood related damages (Figure 6c). The total length of collapsed road was 58 m, the total length of destroyed bank was 330 m, and the total area of agricultural land due to inundated water was 16,645 m².

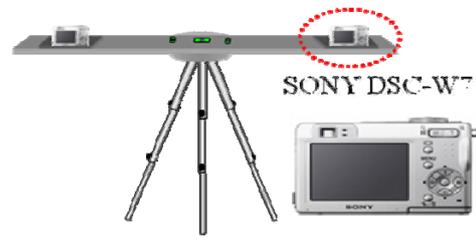
photogrammetric system for the quick flood analysis. Since it is important to get fast and accurate information, we fixed the baseline and orientation of the camera body. The reason for designing system like this is that the personnel who are going to use the system are governmental officer.

Figure 7. Close range photogrammetric system using amateur digital camera

We checked accuracy of our system and it is less than 50 cm, which is good enough for the quick flood monitoring. Figure 8 shows the result of our system for flood analysis. Actually several images are merged together for the analysis.

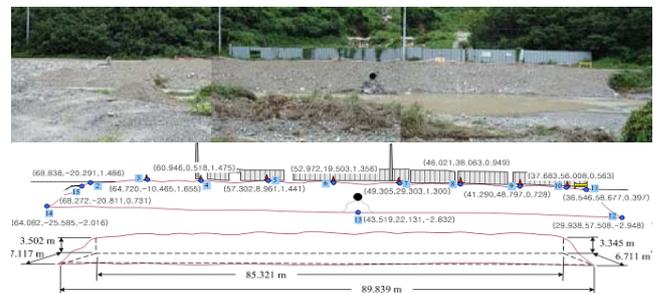
Figure 8. Analysis of flood damage using close range photogrammetric system

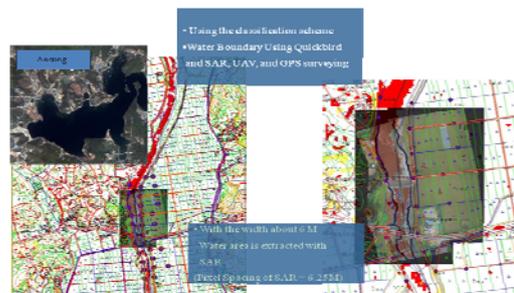
We checked accuracy of each sensor under different condition. Since it is important to check the accuracy of multi-sensor approach, we utilized test-bed close to Seoul, capital of Korea. The name of city we used for test-bed is Ansung. We used SAR imagery ordered in advance and at the same date and at the same time the UAV and close range system get the data over the test site. Additionally we also utilized Quickbird imagery. GPS surveying for GCPs and check point analysis is performed. Figure 9 is the result of overlay several sensors together.

Figure 9. Accuracy check of multi-sensor approach over a test-bed in the city of Ansung

As shown in Figure 9, along the small width of river, SAR imagery with its nominal resolution 6.25 m could identify the water area. And all the other sensors match well with an existing 1:1,000 digital map as shown in Figure 9.
