# CLOSE RANGE DIGITAL PHOTOGRAMMETRY TECHNIQUES APPLIED TO LANDSLIDES MONITORING

**KEY WORDS:** Landslides, Non Metric Digital Camera, Geomorphic Change, DTM Evolution, Historical Photographs

## ABSTRACT:

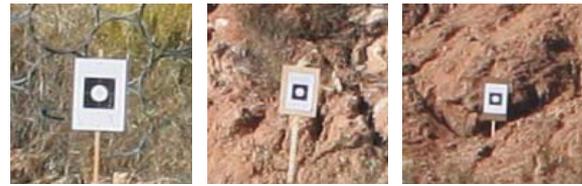
Figure 2. Targets at different distances (approximated). Left: 23 m (the metal net of the barrier is visible behind the target); Centre: 44 m; and Right: 62 m.

Field works were carried out for obtaining a local coordinate system and the control points for the photogrammetric and LIDAR surveys. So a permanent station, preserved from the previous works in year 2000, was selected and eight targets were measured with the total station. These targets were white circles against a black background with a measuring cross in the centre. The target (70 mm diameter) was designed for proper measurement with the total station, photogrammetry and laser scanner. With respect to photogrammetry, this size was optimal for measuring the target centroid (by means of optimal thresholding) in the closer targets (20-30 m) and manual measuring in those ones placed further away (>60 m). Figure 2 shows some targets at different distances.

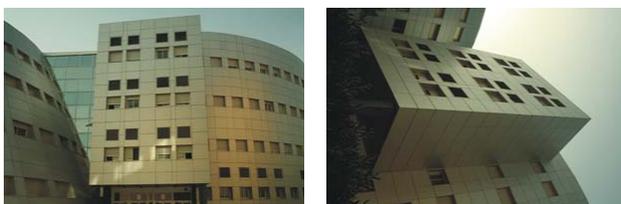
Figure 5. Some photographs of the calibration range.

At first, the camera was considered as calibrated. Inner parameters had been previously obtained by calibration using a test range (a building with known control points, figure 5). This calibration (at infinity) had been carried out several months before this work. Meanwhile, the camera was employed in another works, so the 35 mm interchangeable lens was removed several times from the camera and the focus ring altered. In fact, this was going to be a check for the stability of the inner parameters. With these inner parameters and the 2007 images, a triangulation was performed with 4 control points, 4 check points and more than 50 tie points (Table 1, column A).

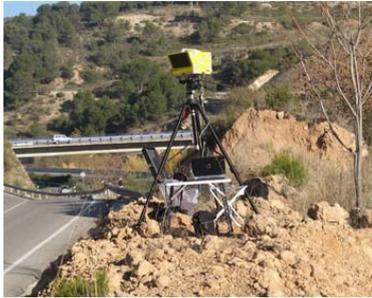
Figure 13. Optech Ilris 3d laser scanner

3D scanner has been employed (Figure 13). Data of the LIDAR survey are still at process, but some of the results can be shown. Three scan stations were set and the point clouds were correlated amongst them in order to referencing data to the
