# LASER SCANNING IN OSTIA A COMPARATIVE STUDY OF ACCURACY OF THE DRAWINGS IN 1950S AND FIELD SURVEY ON TALL STRUCTURES

**KEY WORDS:** Laser Scanning, Ostia, G. Calza, 1950s, Sinking Tall Structure, Capitrium, Casa di Diana

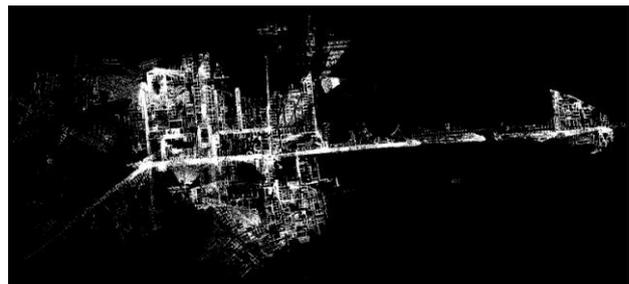
Fig. 2 Measured area using laser scanning

In 2008, the field survey applying the laser scanning technology has been carried out at Ostia. We introduce an advanced measuring method: 3D scanning system, in which the object can be described as the aggregation of dots having three dimensional coordinates. The measuring of whole of Foro area has been completed within this season, and of east side of the Decumanus Maximus from Via Epagathiana. The Casa di Diana and Capitorium has also been measured in order to detect the movement of high-rise buildings' wall. The evidence for following results is based on the preliminary analysis of more than 150 stations (Fig. 2), which is now being subjected to detailed analysis of the structure.

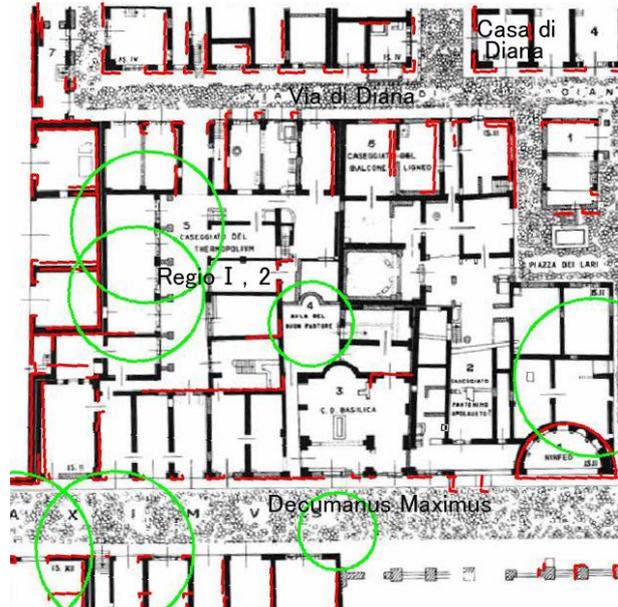
Fig. 4 Divergence between Calza's map and scanning data (in red) on Via di Diana (a present vegetation map in yellow green)

high remained walls from its shadow. Therefore Calza may trace the wrong line. For example, 2) the Terme del Foro in his map deviates north-westwards and this line coincides with a location where the shadow of the high building lay across. As well as this, 3) walls along Via di Diana in Calza's map deviate north-westwards because of shadow. Around Via di Diana, north buildings are higher than south ones, and the shadow of the buildings may lay across longer than south one (Fig. 9). Therefore there is considerable divergence in Via di Diana.

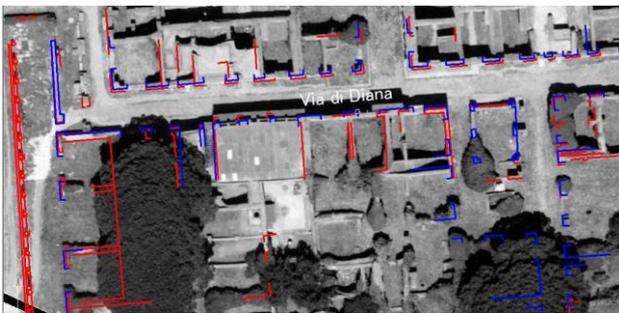
Fig. 7 Superimposed scanning data (in red) and Calza's plan of frontages (in blue) on an aerial photograph in 1995

“Atlante di Ostia antica” includes a map, which is traced from an aerial photograph by Manucci. This map is traced from aerial photograph taken in 1995, which has good resolution, so surveyors traced correctly (Fig. 7). On the aerial photograph in low resolution in 1944 (Fig. 8), so it is difficult to distinguish

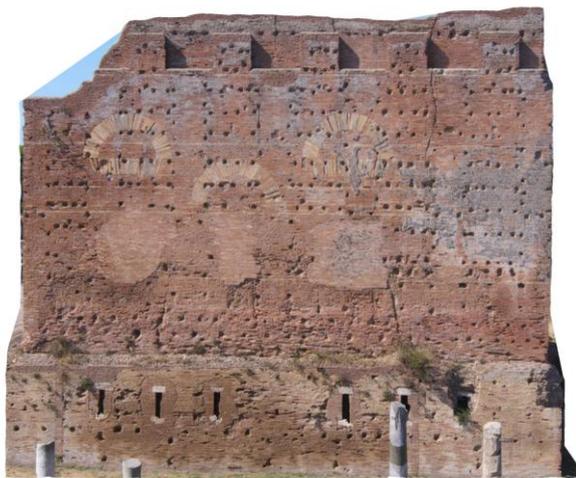
Fig. 18 Orthographic photo of the east elevation of Capitolium

however there is no evidence of sinking at present. There are not to a certain extent symptoms of cracks and a tilt in the north elevation. In an orthographic photo of the north elevation of that tall structure, which has been created from 3D data (Fig. 1

8), where the cracks are observed on the east surface, the high walls without openings, which act as a prudent expedient to ward off cracking, do not support the weight of the roof, but is still resisting against wind loadings.
