PHOTOGRAMMETRIC MEASUREMENT OF THE MEKE LAKE AND ITS ENVIRONMENT WITH KITE PHOTOGRAPHS TO MONITORING OF WATER LEVEL TO CLIMATE CHANGE

KEY WORDS: Photogrammetry, Climate Change, Kite Photographs

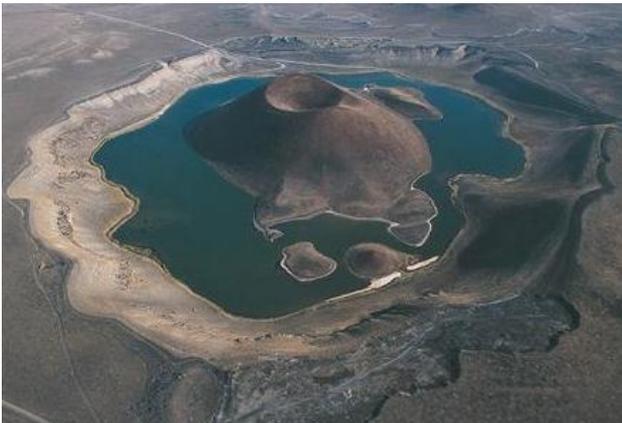
Figure 2. Meke Lake

MEKE LAKE make crater lake is; on the southwest of Acı lake, southeast of Karapınar, 8 km. from Karapınar and 2 km. from Karapınar-Ereğli highway. Meke Lake has a circular shape and there is an island in the middle of it which is called Meke. The dept of the lake never exceeds 12 m. The water of the lake comes out from the ground and its water is salty which contains magnesium and sodium sulfate. Meke salty area covers 0.5 km². The lake was formed in a circular shape collapse which had occurred in the first era. And after that, an eruption caused a chimney to rise in the lake. In geology, this rise is called as "Secondary Rise". After this formation volcanic Meke height is formed in the middle of the lake. Formations didn't end up with these and later on with various eruptions seven other formations were formed (they are called as little Meke) some adjacent to main cone and some as separate islands. These formations are called in geology as "parasite cones" In the middle of the Meke lake (main Meke) which is 981 m. from sea level there is a volcanic cone. This cone is 50 m. high from the water level and there is a salt water lake in it with 25 m. depth. For a while, this lake is utilized for its salt. The special volcanic mess that forms the island has an ability to absorb even the most heavy rain showers. That is the reason why Meke has preserved its shape for thousand years for the Global Warming.

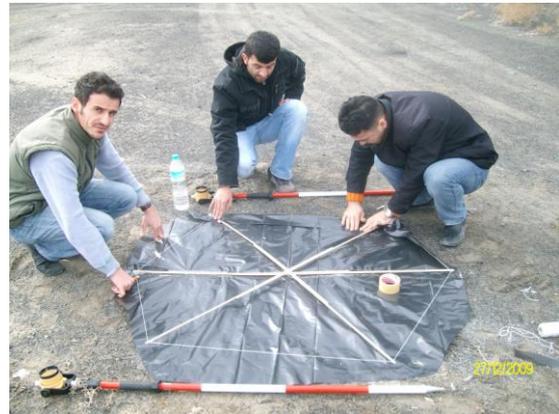
Figure 3. Kite

In this study, kite and remote-control camera has been used. Taking photos using kite has been purposed to obtain photos of study region. Firstly, kite size has been determined for better seen from to photos of control points. The kite size is 150*150 cm in hexagon geometry. To mounted camera on kite, many test flight has been actualized until suitable weather condition right. Many photographs were taken when the kite gets at appropriate height. Best fit images were selected for photogrammetric process.

Once, because of the strong wind, the kite's construction has been damaged. The arrangements have been made to make the kite fly again, but this time some balance problems have been seen. The arrangements for the kite's tail have been made to fix this problem. While these tries, the camera platform fell down many times and to fix the platform, a lot of time has spent. After these experiences, the kite and the camera platform became suitable for the experiments. Sometimes, there wasn't any wind so the experiments have been delayed. To get the mathematical evaluation from kite, 50 pieces of 50*50cm control points has been provided and measurements have been finished.

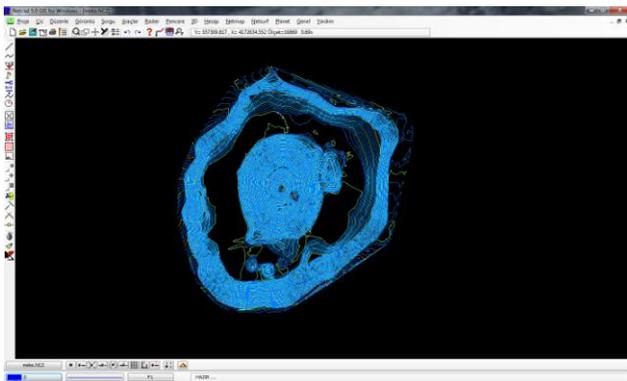
Figure 5. The present timemap of Meke Lake

Photogrammetric orientations parameters and adjustments have been calculated with PhotoModeler software and 3D coordinates of 50 points on the surface of the object have been measured for the modeling its geometric surface. With calibrated cameras and points on ground, the lake's surface has been evaluated photogrammetrically and got merged with present time map.

In Lake Meke, it's impossible to make a geodetic measurement on the water-covered surface. Because, on the way of the lake, there's rarely well ground but, generally 3-5m mud and swampy ground, so, it's not possible to take measure of the water surface. For this purpose, a photogrammetric measurement has been done. Before all the research, to produce topographical map, the nearest land surveying triangulation network has been founded and 8 traverse station points established. To calculate the coordinates and elevation point, GPS session has been done as a 2 hour interval. Total station has been used to measure all area at intervals 25-30m. At last the present time map has been done. From September to March, the level of water has been determined.

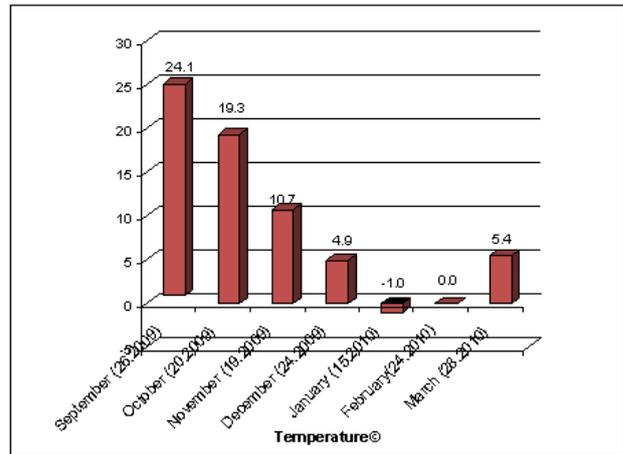
Figure 6. Monthly temperature variation of Meke Lake

The average monthly temperature variation and sunshine duration is shown below charts as the daily meteorological data.

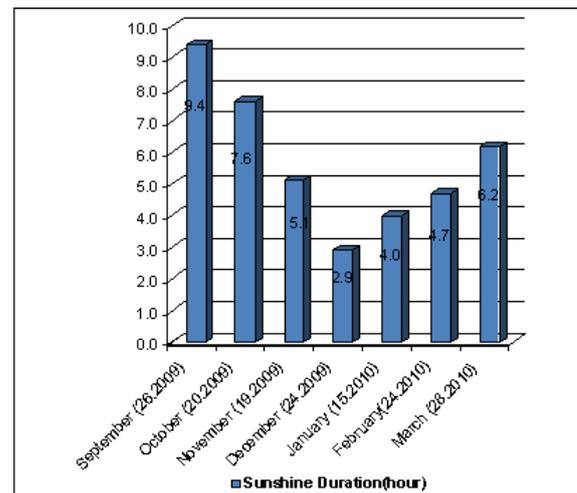
Figure 7. Monthly sunshine duration of Meke Lake

Meke lake environment from the daily meteorological data obtained by the average monthly sunshine duration is to show.

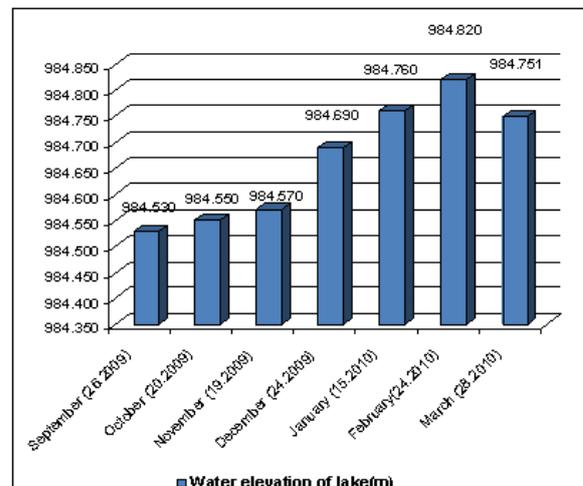
Figure 8. Monthly water elevation of Meke Lake by classic measurement method
