## REPRODUCTION OF TURKISH TRADITIONAL WALL-PAINTING USING CLOSE RANGE PHOTOGRAMMETRY, A CASE STUDY IN GAZIANTEP

M. Korumaz<sup>a</sup>, A. Gulec Korumaz<sup>a</sup>

<sup>a</sup> Selcuk University, Department of Architecture, 42003 Konya, Turkey  
(mkorumaz@gmail.com, gulec.armagan@gmail.com)

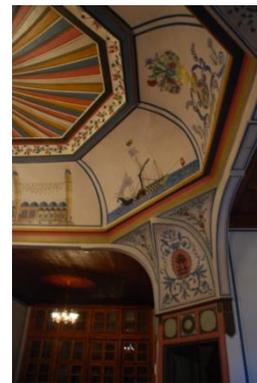
Figure 5 Hand-carved painting from province Karaman, Turkey.

In hand-carved decorations, design is drawn on semi-transparent paper, after that this paper is pierced by needles along the design's lines. Design is transferred on surface shaken coal dust with the buffer. Designs boundaries are drawn with thin brushes and in side of the design are filled with different colors. The

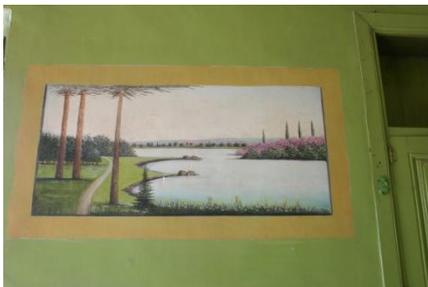
Figure 6 an example of surface mount wall-paints in Konya/Turkey

Surface is plastered with lime mortar. Like hand-carved decorations, design is transferred on the plaster and artist is drawn his sketch on the plaster as if it was a canvas.

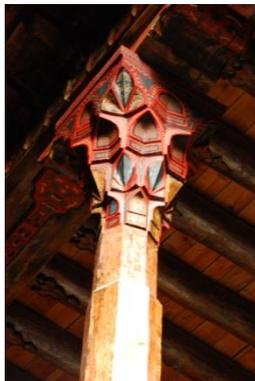
Figure 7 wooden mount wall-painting, Eşrefoğlu Mosque in Konya

Wooden Mount wall-paint techniques are secondly widespread techniques than surface mount wall-painting. This technique is used inside of tomb decorations, special spaces' ceilings in mosques, and traditional houses' ceilings. Wood surface is covered with a paste for obtaining smooth painting area. After finishing the process of drawing, painted picture covered with a protective patina.

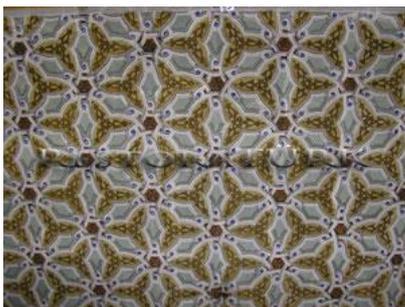
Figure 8 an example of fabric and lather mount wall-painting (Baser, 2010).

This technique was mostly used in baroque and empiric styles in 17<sup>th</sup> century. It is drawn a leather surface which is stretched and then stacked on a wooden frame. It is painted with oil paints or powder paints.

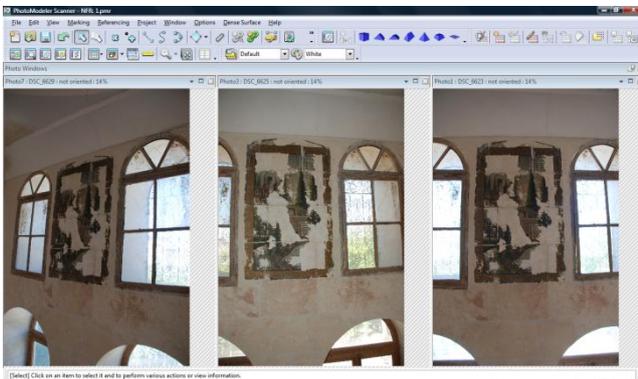
Figure 10 Photo Modeler Software for obtaining orthophotos.

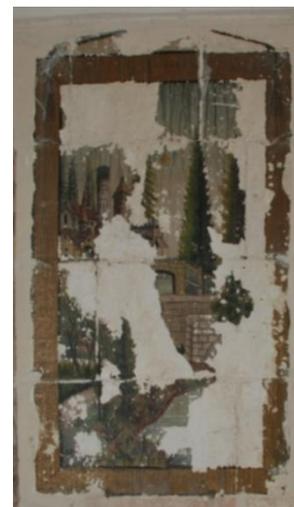
Figure 11 An Example of Ortho photo for digital image processing.

It is the best way in order to get wall-painting drawings is the orthophoto. This method is very productive and gives sensitive outcomes all figures, ornaments and details can be acquired from these orthophotos and they can be easily transferred to reproduction or documentation works. Architects generally insert these orthophotos to Restoration Software with their actual size and they edit.

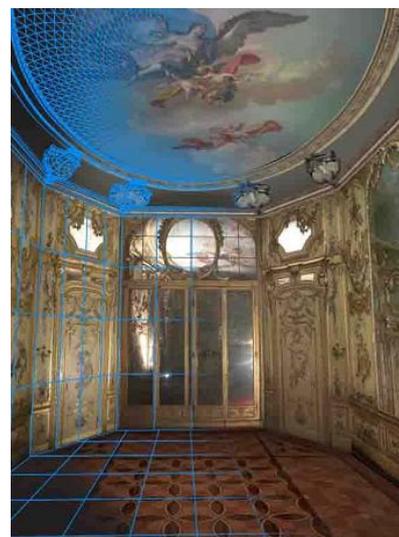
Figure 16. A Lazarscanner example of Italy (Bonora V. at all,2003).
