DETECT THE COASTLINE CHANGES IN THAILAND BY REMOTE SENSING

Absornsuda Siripong*

*Marine Science Department, Faculty of Science, Chulalongkorn University,
Khet Pathumwan, Phya Thai Road, Bangkok 10330, Thailand – sabsorns@chula.ac.th

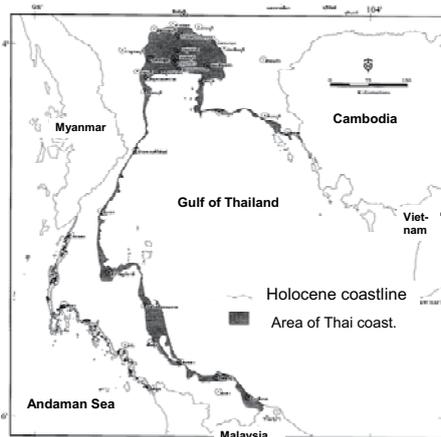
Figure 1. Thai coastline at Holocene (last 6000 years ago) Sinsakul et al. (2002).

The coasts of Thailand have been evolved in the past due to the changing of sea level. Since 6,000 years ago, the coast of Thailand has been accreted especially at the Inner Gulf of Thailand, from approximately 70 kms to the present Chao Phraya river delta. At the other areas, the sea covered the low plains more or less according to the topography of the coast, see Figure 1.

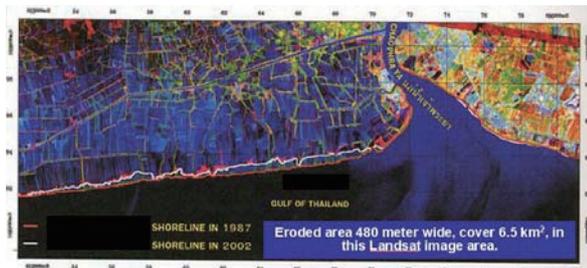
Figure 2. Shoreline change from 1987 (red) to 2002 (white) from Landsat data.

Landsat satellite data has been used to detect the coastline change at this delta area (Figure 2). The cutting of mangrove trees for converting to the fish and shrimp ponds and human settlement is one cause of coastal erosion in this area.

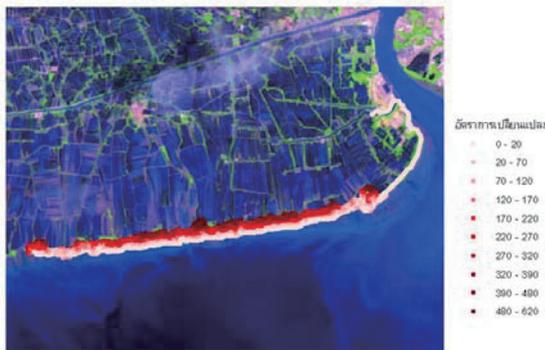
Figure 3. Rate of shoreline change from 1987 – 2002 interpreted from Landsat imageries at 30 meter resolution.

The land-use changes are the evidence of the impact of human activities on coastline change (Figures 3 and 6). Extensive cutting of mangrove area promotes erosion rate. Where the mangrove trees were preserved such as at the Naval Base, the coastline has been accreted instead of erosion (Figure 4). The high rate of subsidence due to sediment load and pumping underground water is very high about 55 cm per 17 years (1978-1995) at the Naval Base. The constructions of major dams in the upper land have prevent the sediment to the sea and promote erosion. The ineffective coastal protections such as sea wall, breakwater, sand sausage and groyne also accelerate the erosion rate.

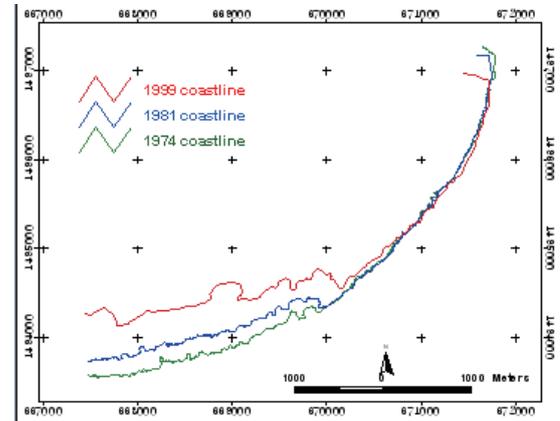
Figure 4. Coastline changes from 1974 to 1999, W side of Chao Phraya River-mouth from Landsat.

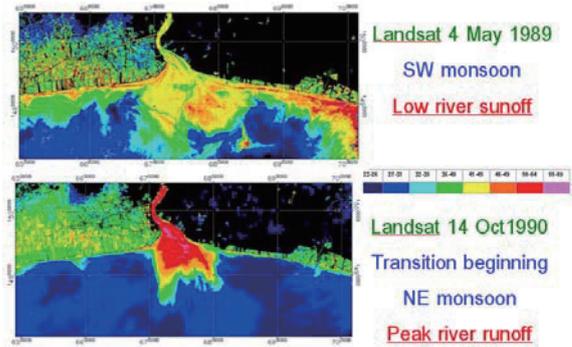
Figure 5. Relationship of sediment plume with river runoff and monsoon wind at Chao Phraya River-mouth from Landsat.

The patterns of sediment plume from this river during the peak and low river discharge were analyzed to study the effects of river discharge and monsoon wind pattern on coastline accretion and erosion (Figure 5). During southwest monsoon and low river discharge, on 4 May 1989 (Figure 5, upper image), the wave-driven current showed the deposition

of the sediment along the east side of the Chao Phraya River-mouth. However, during the northeast monsoon and peak river discharge on 10 October 1990 (Figure 5, lower image), The large plume of river sediment extended further to the sea and some deposited on the west side of the river-mouth.

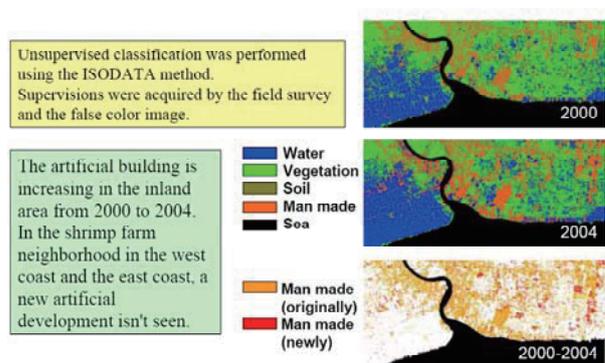
The land coverage classification 2000-2004

Figure 6. Landuse change at the Chao Phraya River-mouth.

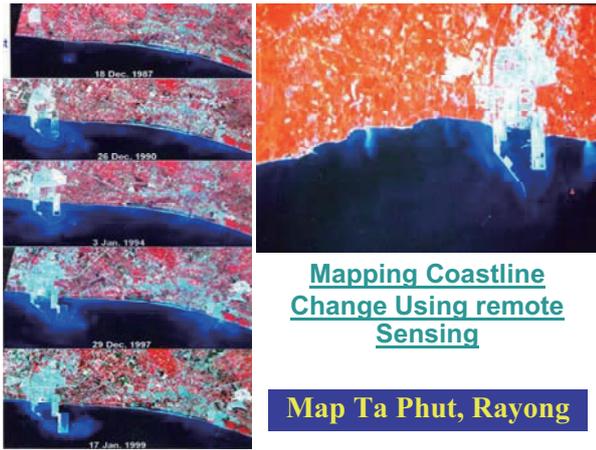
Figure 7 Coastline change 1987 – 1999 from Landsat showing the effect of harbour development at Map Ta Phut, Rayong province.

on the coast of Rayong province since 1989. After construction of the big sea ports, reclaimed lands, and other coastal activities, the coastlines have been changed drastically. The Landsat images in 1988, 1994 and 2000 before and after the constructions of the reclaimed lands were used to study the coastline changes by image difference method. The result show that the accretion and erosion of the western coastline during this period were estimated as 5,250 and 6,975 metre² per year, while the eastern coastline were 4,650 and 11,400 metre² per year (see Figures 8 and 9). The 8 Landsat images were analysed by colour density slicing method to detect the effect of monsoon wind on sediment distribution which can cause accretion and deposition of the coast here.

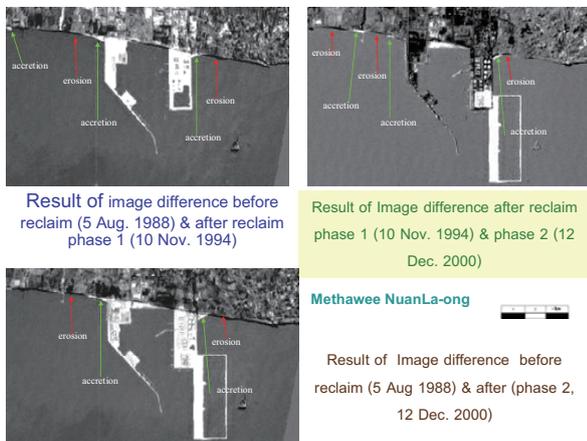
Figure 8. Effect of the constructions of the reclaimed lands from landsat on coastline changes at Map Ta Phut .

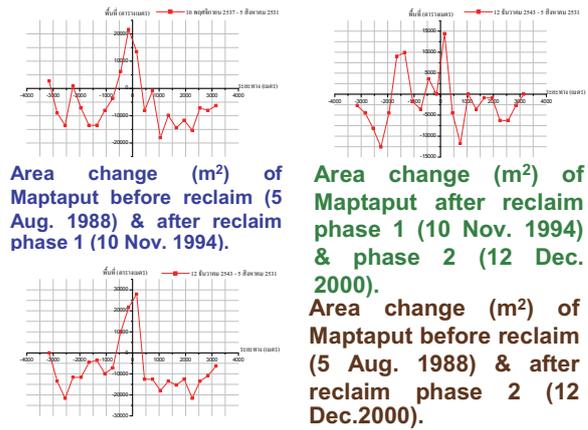
Figure 9. Quantified area changes before and after construction of the reclaimed lands at Map Ta Phut by Landsat.

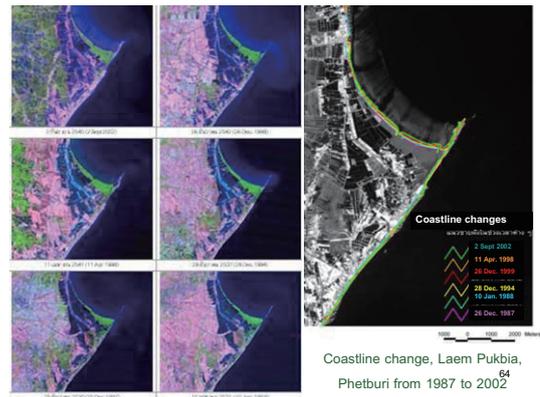
Figure 10. Coastline change at Laem (spit) Pukbia, Phet-buri province from 1987 to 2002, by LANDSAT.

The construction of seawall at Laem Pukbia, Phetburi province, in Figure 10 caused the spit, which normally is the accretional coast to be eroded after construction because of scouring and beach drawdown. The construction of seawall and few small fishing ports at Ta-gieb Hill, Prachuap Khiri Khan province in Figure 11 caused downdrift erosion from the hill. After the construction of the jetty at Cha-um, Phetburi province, the deposition occur at the downdrift and erosion at the updrift on the longshore sediment transport, as shown from Landsat images in Figure 12.

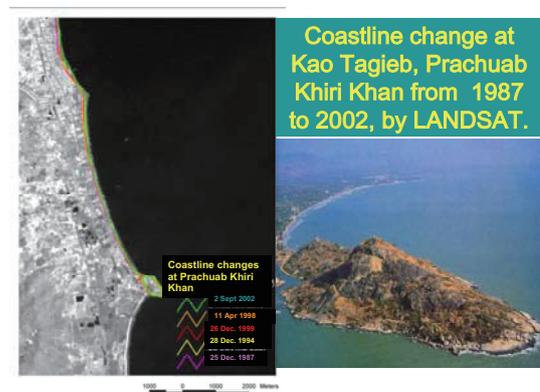
Figure 11. Coastline change at Ta-gieb Hill, Prachuab Khiri Khan Province from 1987 to 2002 by Landsat.

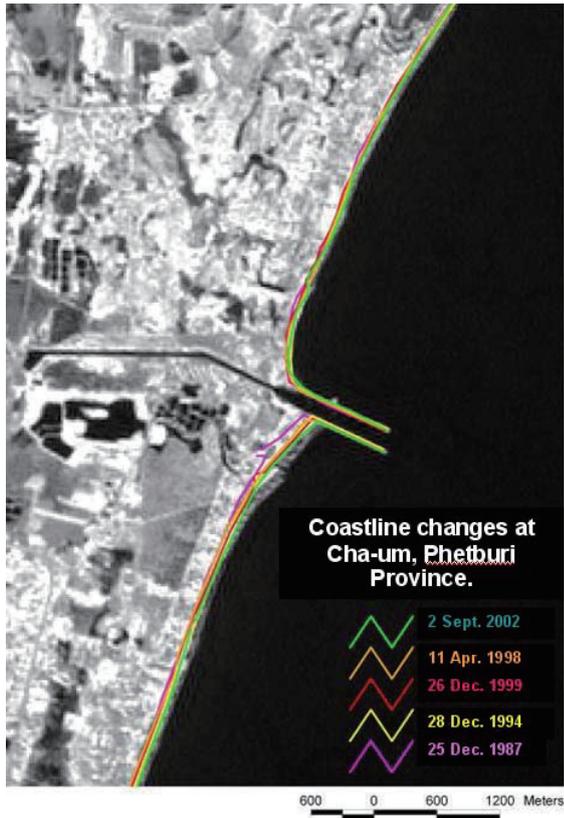
Figure 12. Coastline change at Cha-um, Phetburi province from 1987 – 2002, by Landsat showing effect of jetty.

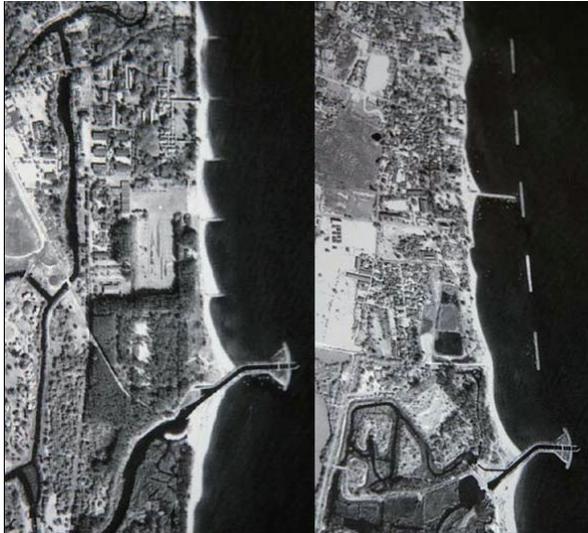
Figure 13. Effect of engineering hard structures on coastline change on 19 January 2009 by THEOS images.

The Thai satellite THEOS image show the effect of engineering constructions such as groynes, seawalls, offshore breakwaters and jetty on coastline change at Rayong. It is need to assess the effect of these structures on coastline before construction, otherwise, it is too much expensive for the remedy program.

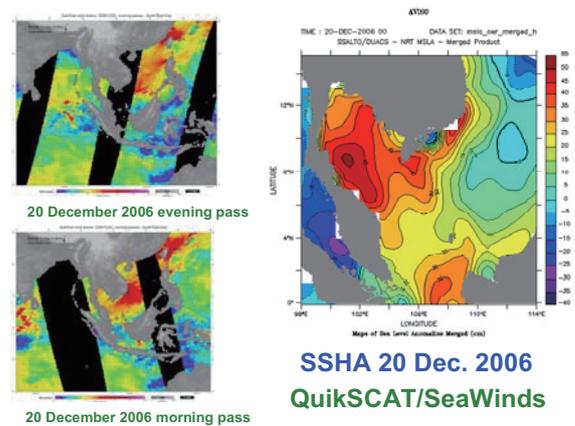
Figure 14. The QuikSCAT/SeaWinds and SSHA data on 20 December 2006.

The wind patterns from QuikSCAT/Sea Winds and sea surface height anomaly or wave data from satellite altimeter were used to detect the catastrophic coastal erosion on 20 December 2006 along the east coasts of Southern Thai Peninsular (Figure 14). The strong Cold Surge from northeast caused very high waves which attacked furiously on the Thai and Malaysian coasts and caused severe coastal erosion.

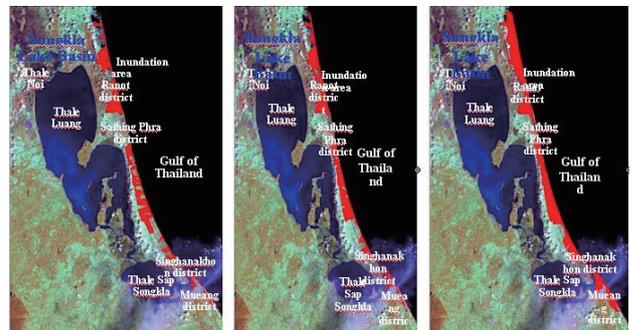
Figure 15. Effect of sea level rise in 0.5, 1 and 3 m scenarios on coastal resources and morphology of the Songkla Lake using Landsat and aerial photographs.

The effect of sea level rise at the Songkla Lake basin was studied by Tanavud & Chusrinuan (personal communication) The inundation areas due to sea level rise in a 0.5, 1 and 3 m sea level rise scenarios, They estimated the impact of sea level rise on Songkla Lake Basin using 3 scenarios overlay on 1975 aerial photographs and 2006 Landsat-5 TM imageries in GIS environment to identify the sectors along the basin coastline where the shoreline position has been changed over the last 31 years.
