Deformation Measurement of the Bandai Bridge
by Close-range Photogrammetry

1. Introduction

From 1984 to 1986, the deformation measurement of the Bandai Bridge was regularly carried out by means of close-range photogrammetry. The measurement was done in summer, 1987, and will be done in winter the same year and continued subsequently. The present paper gives the results of the measurement during the past 3 years as an interim report.

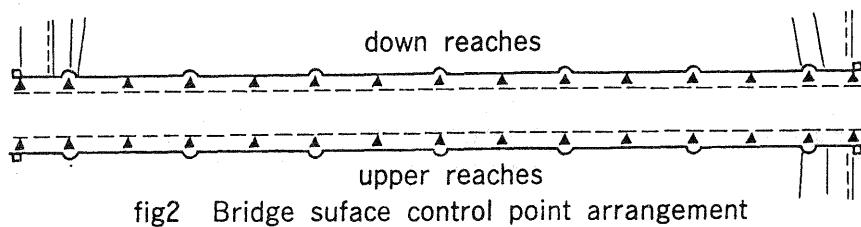
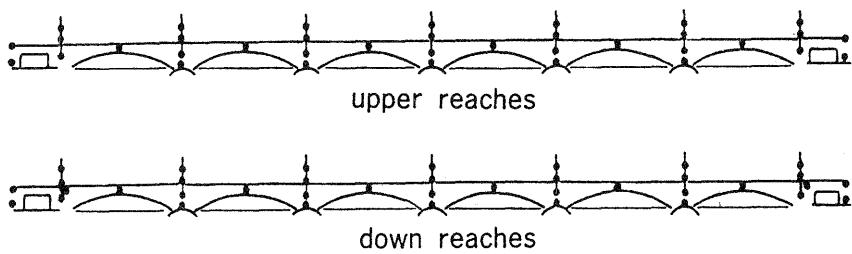
Since marks were settled on the bridge in 1945 as shown in Fig.2, the expansion and contraction between them, the changes of elevation and the amount of bending have annually been observed. In 1984, plan, side and under views were prepared for the bridge maintenance to superannuation, and new marks shown in Fig.3 were settled to grasp the conditions of the whole bridge.
