## PARTHENON RESTORATION PROJECT

N. Toganidis

Greek Ministry of Culture, Acropolis Restoration Service, 10 Polygnotou str. 10555 Athens, Greece (toganidis@gmail.com)

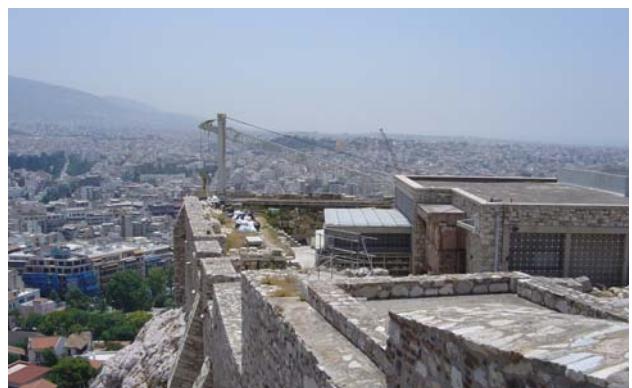
Figure 24

The project started with the installation of a crane at the SE corner of the Acropolis. With this crane we transport all the necessary materials to and from all monuments. A small chariot moving on rails connects the crane with the site (figure 24).

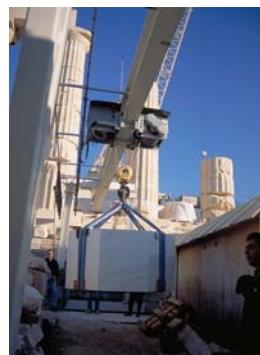
Figure 25

A portal crane with a capacity of 12, 5 tons continues the transportation of the materials and the marbles along the long south side of the Parthenon. On this side the main workshops of the marble are situated, exactly on the same location as in the antiquity (figure 25).

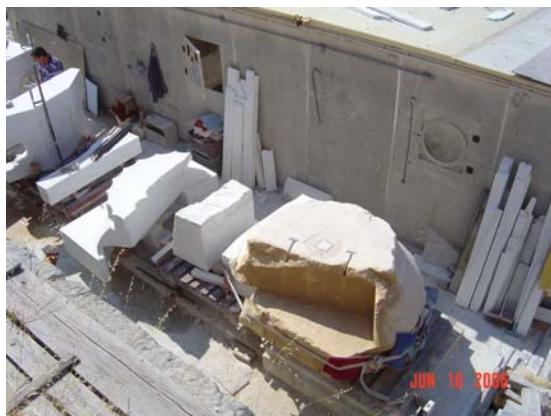
Figure 29

In order to fix the broken marble fragments, using titanium bars and white cement with very low sulfate, we developed a system consisting of heavy tables sliding on rails. After fixing the fragments, the marble member remains for about 20 days on that table, to gain its final strength before proceeding to the next step of works. We are using 7 tables of this type with a capacity of 7-10 tons (figure 29).

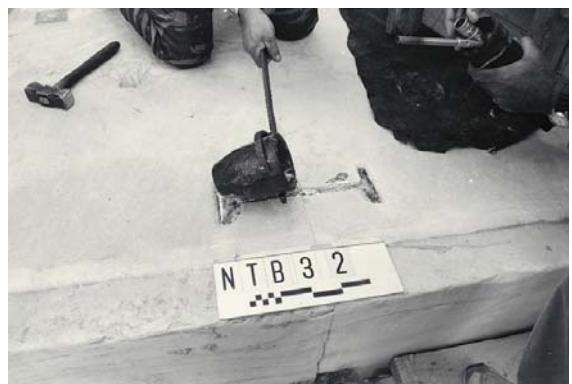
Figure 36

The technique to cast lead (figure 36) in the carved areas of the connective metal elements it is not such a simple procedure. You realize that you need to have a strong fire very close to the working point. You have to melt the correct quantity of lead to fill the entire gap. Due to the variety of the connective elements size we get an idea about the size of the metal pot for the lead melting.
