LASER SCANNING FOR HISTORICAL AND GEOTECHNICAL STUDIES AT POINTE DU HOC

R.B. Warden^{a,*}, R. Burt^a, J-L Briaud^b, M. Everett^c

^a Texas A&M University, Center for Heritage Conservation

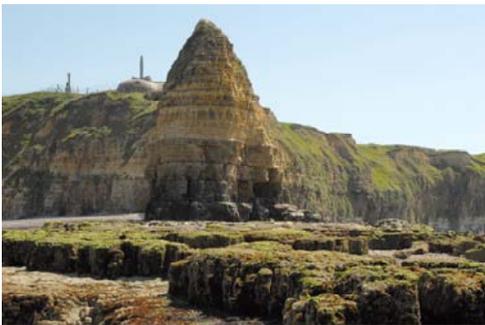
Figure 1: Observation Post and Cliff
