MEASUREMENT OF RAILWAY SURFACE FLAWS WITH THE CCD LINE SENSOR CAMERA SYSTEM

Yoshitaka Matsumoto, Osamu Murakami
CORE Corp.

Masaya Nakagawa
Technical Center, East Japan Railway Company
2-1-19 Hiro-machi, Shinagawa-ku, Tokyo, 104, Japan
TEL: +81-3-5709-3665 FAX: +81-3-5709-3666

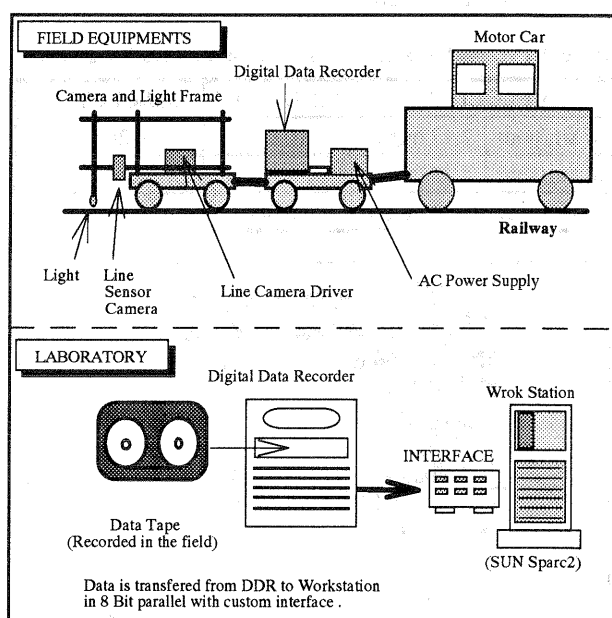
The inspecting system, now under developing, is consisted on a CCD Line Sensor Camera (Line Camera) for capturing the successive images, a Digital Data Recorder (DDR) that can record a large image data, and an engineering work station (EWS) which is processing that image data. (Figure 1.)

Figure 1. The Line Camera System Constitution

At the filed, these units (the Line Camera and the Digital Data Recorder) are loaded on the trolley and pulled by the engine which is called the Motor Car, and the image data is recorded in real time to the data tape in DDR (Digital Data Recorder). Those data are sent to the engineering work station (SUN :

This system can take the successive images from running car with a line sensor camera, and record to a data tape as a digital image data, and it is possible to process those data by a computer without an analog digital conversion.
